COMPLETION OF 5-YEAR CAPITAL IMPROVEMENT PLAN

CAPITAL IMPROVEMENT PROGRAM (C.I.P.)

PHASING OF COMPLETED WORK:

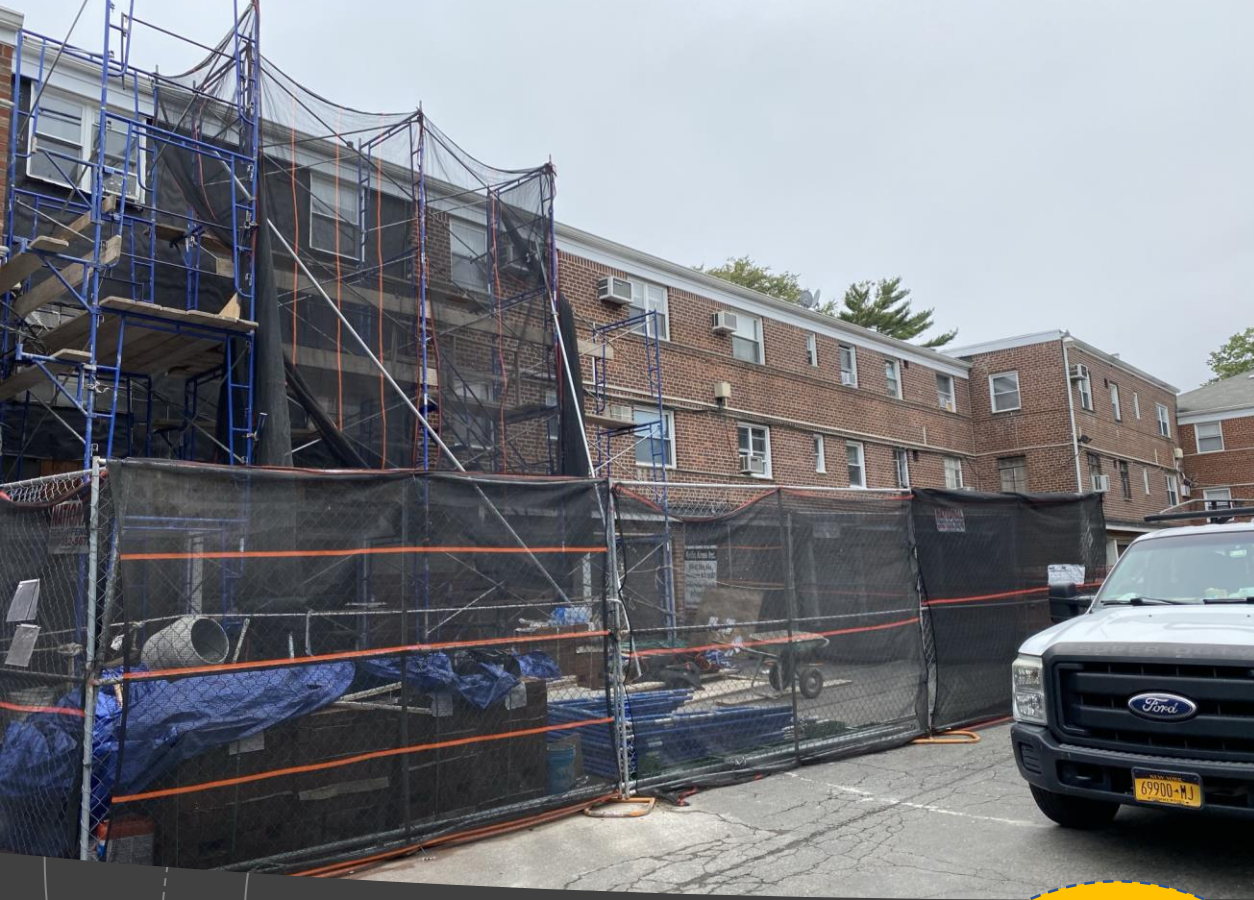
BUILDING-1

DURING RENOVATION

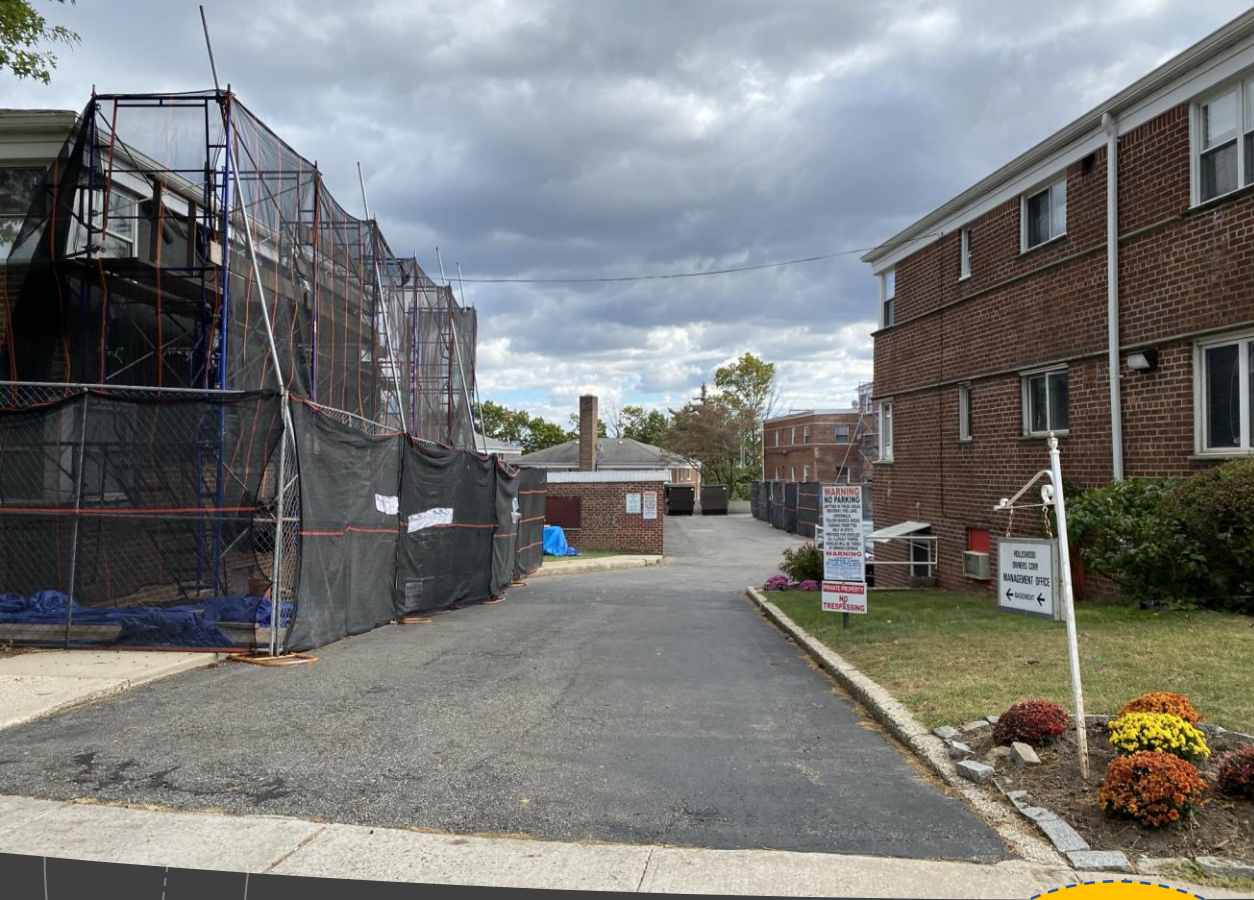
BUILDING-2

DURING RENOVATION

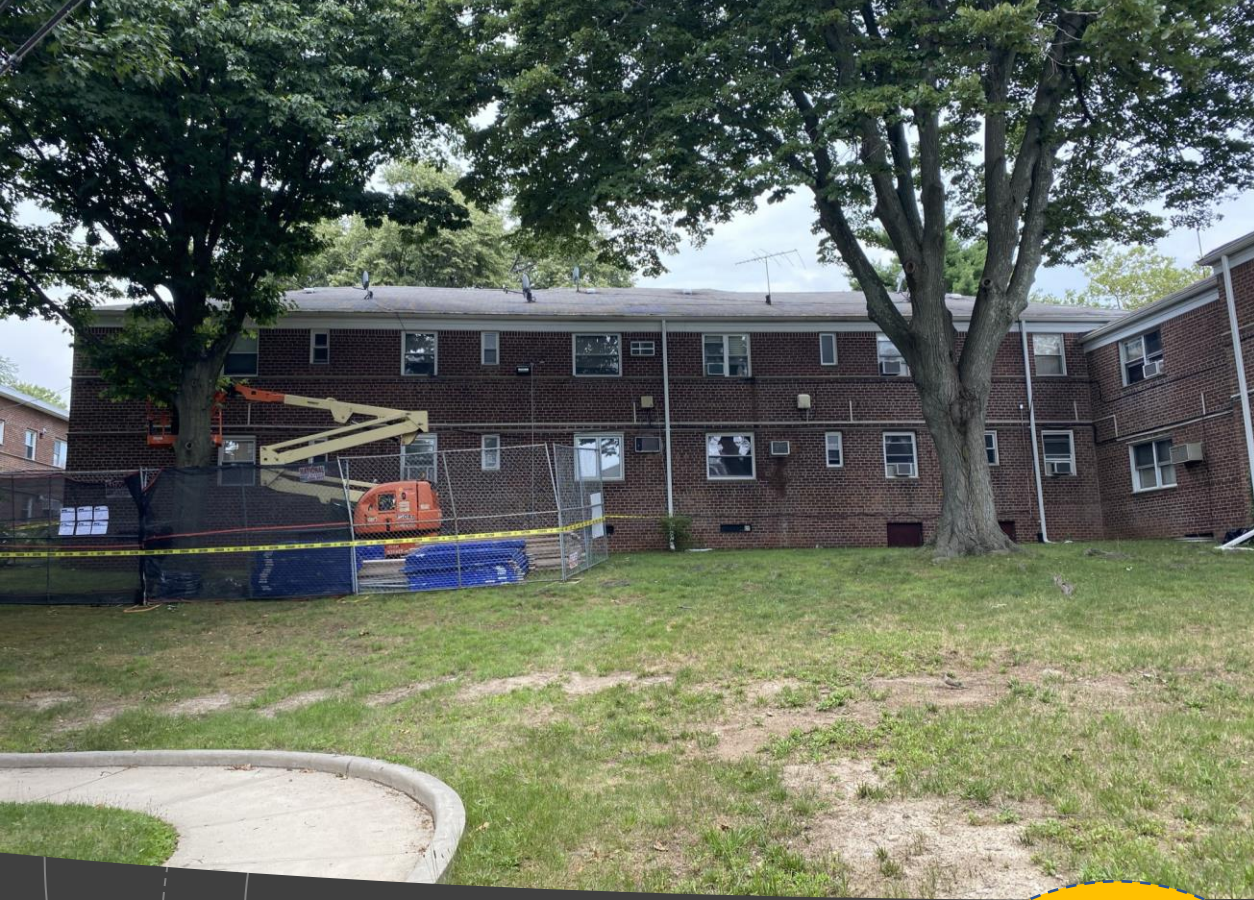
BUILDING-4

DURING RENOVATION

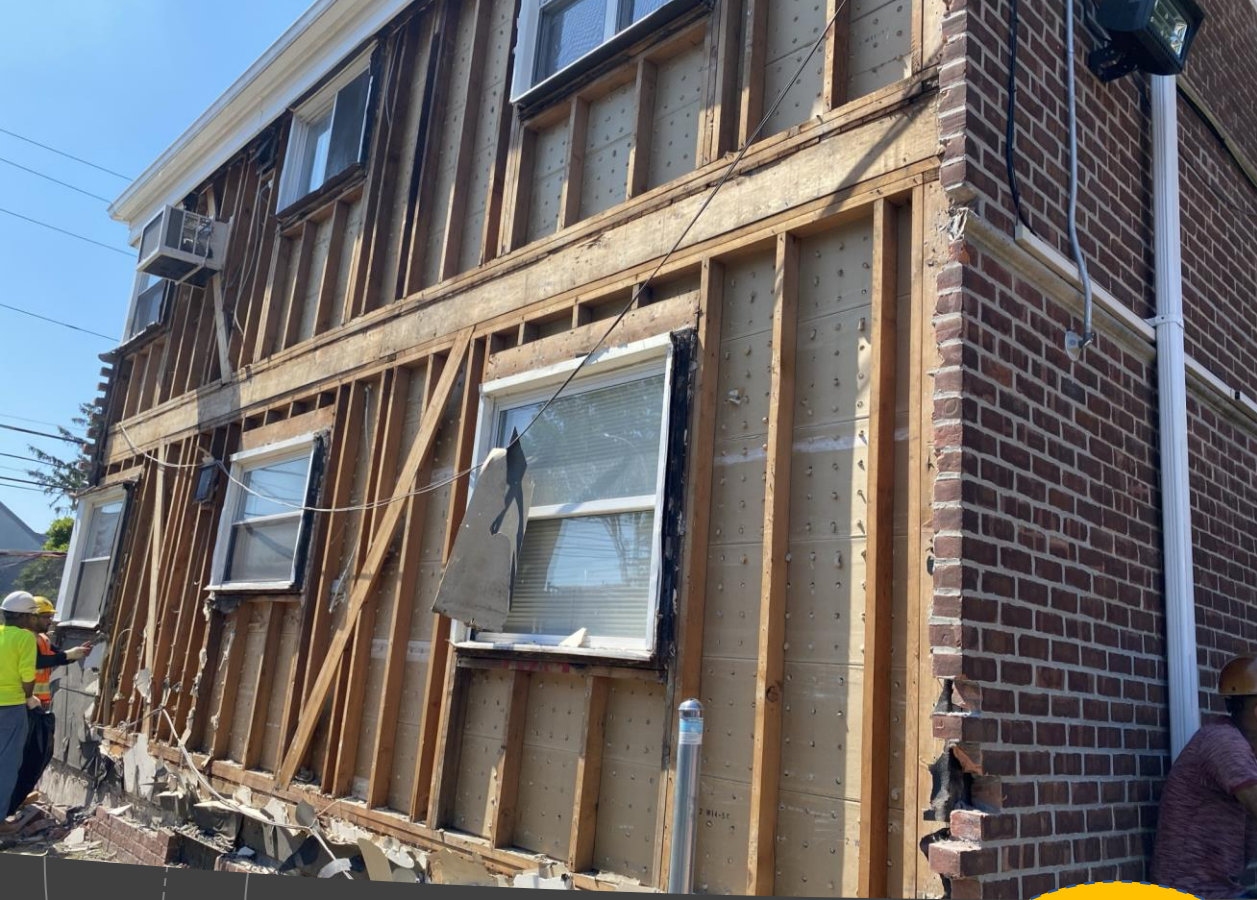
BUILDING-7

DURING RENOVATION

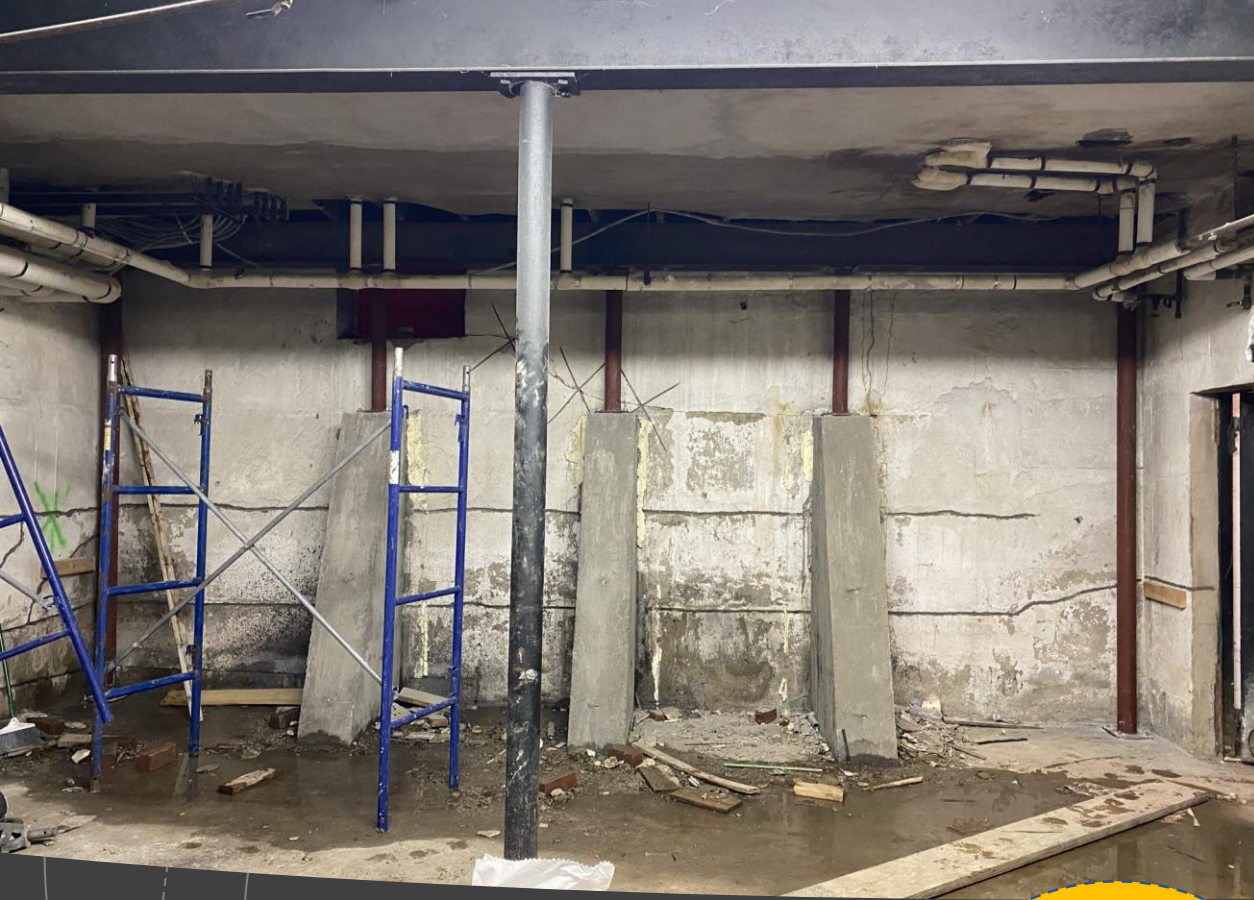
FOUNDATION WALL WATERPROOFING

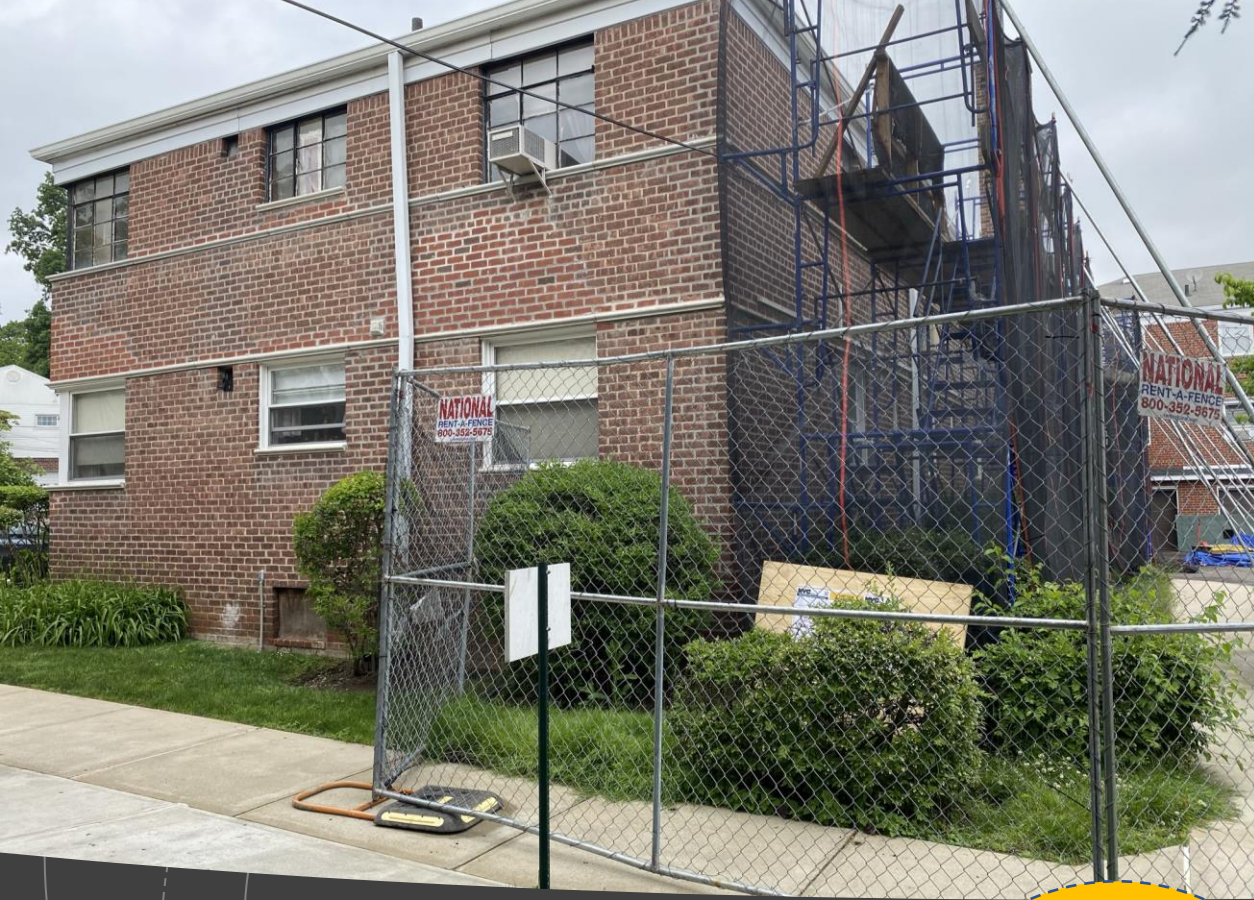
BUILDING-8

**STRUCTURAL RESTORATION OF
FOUNDATION WALL**

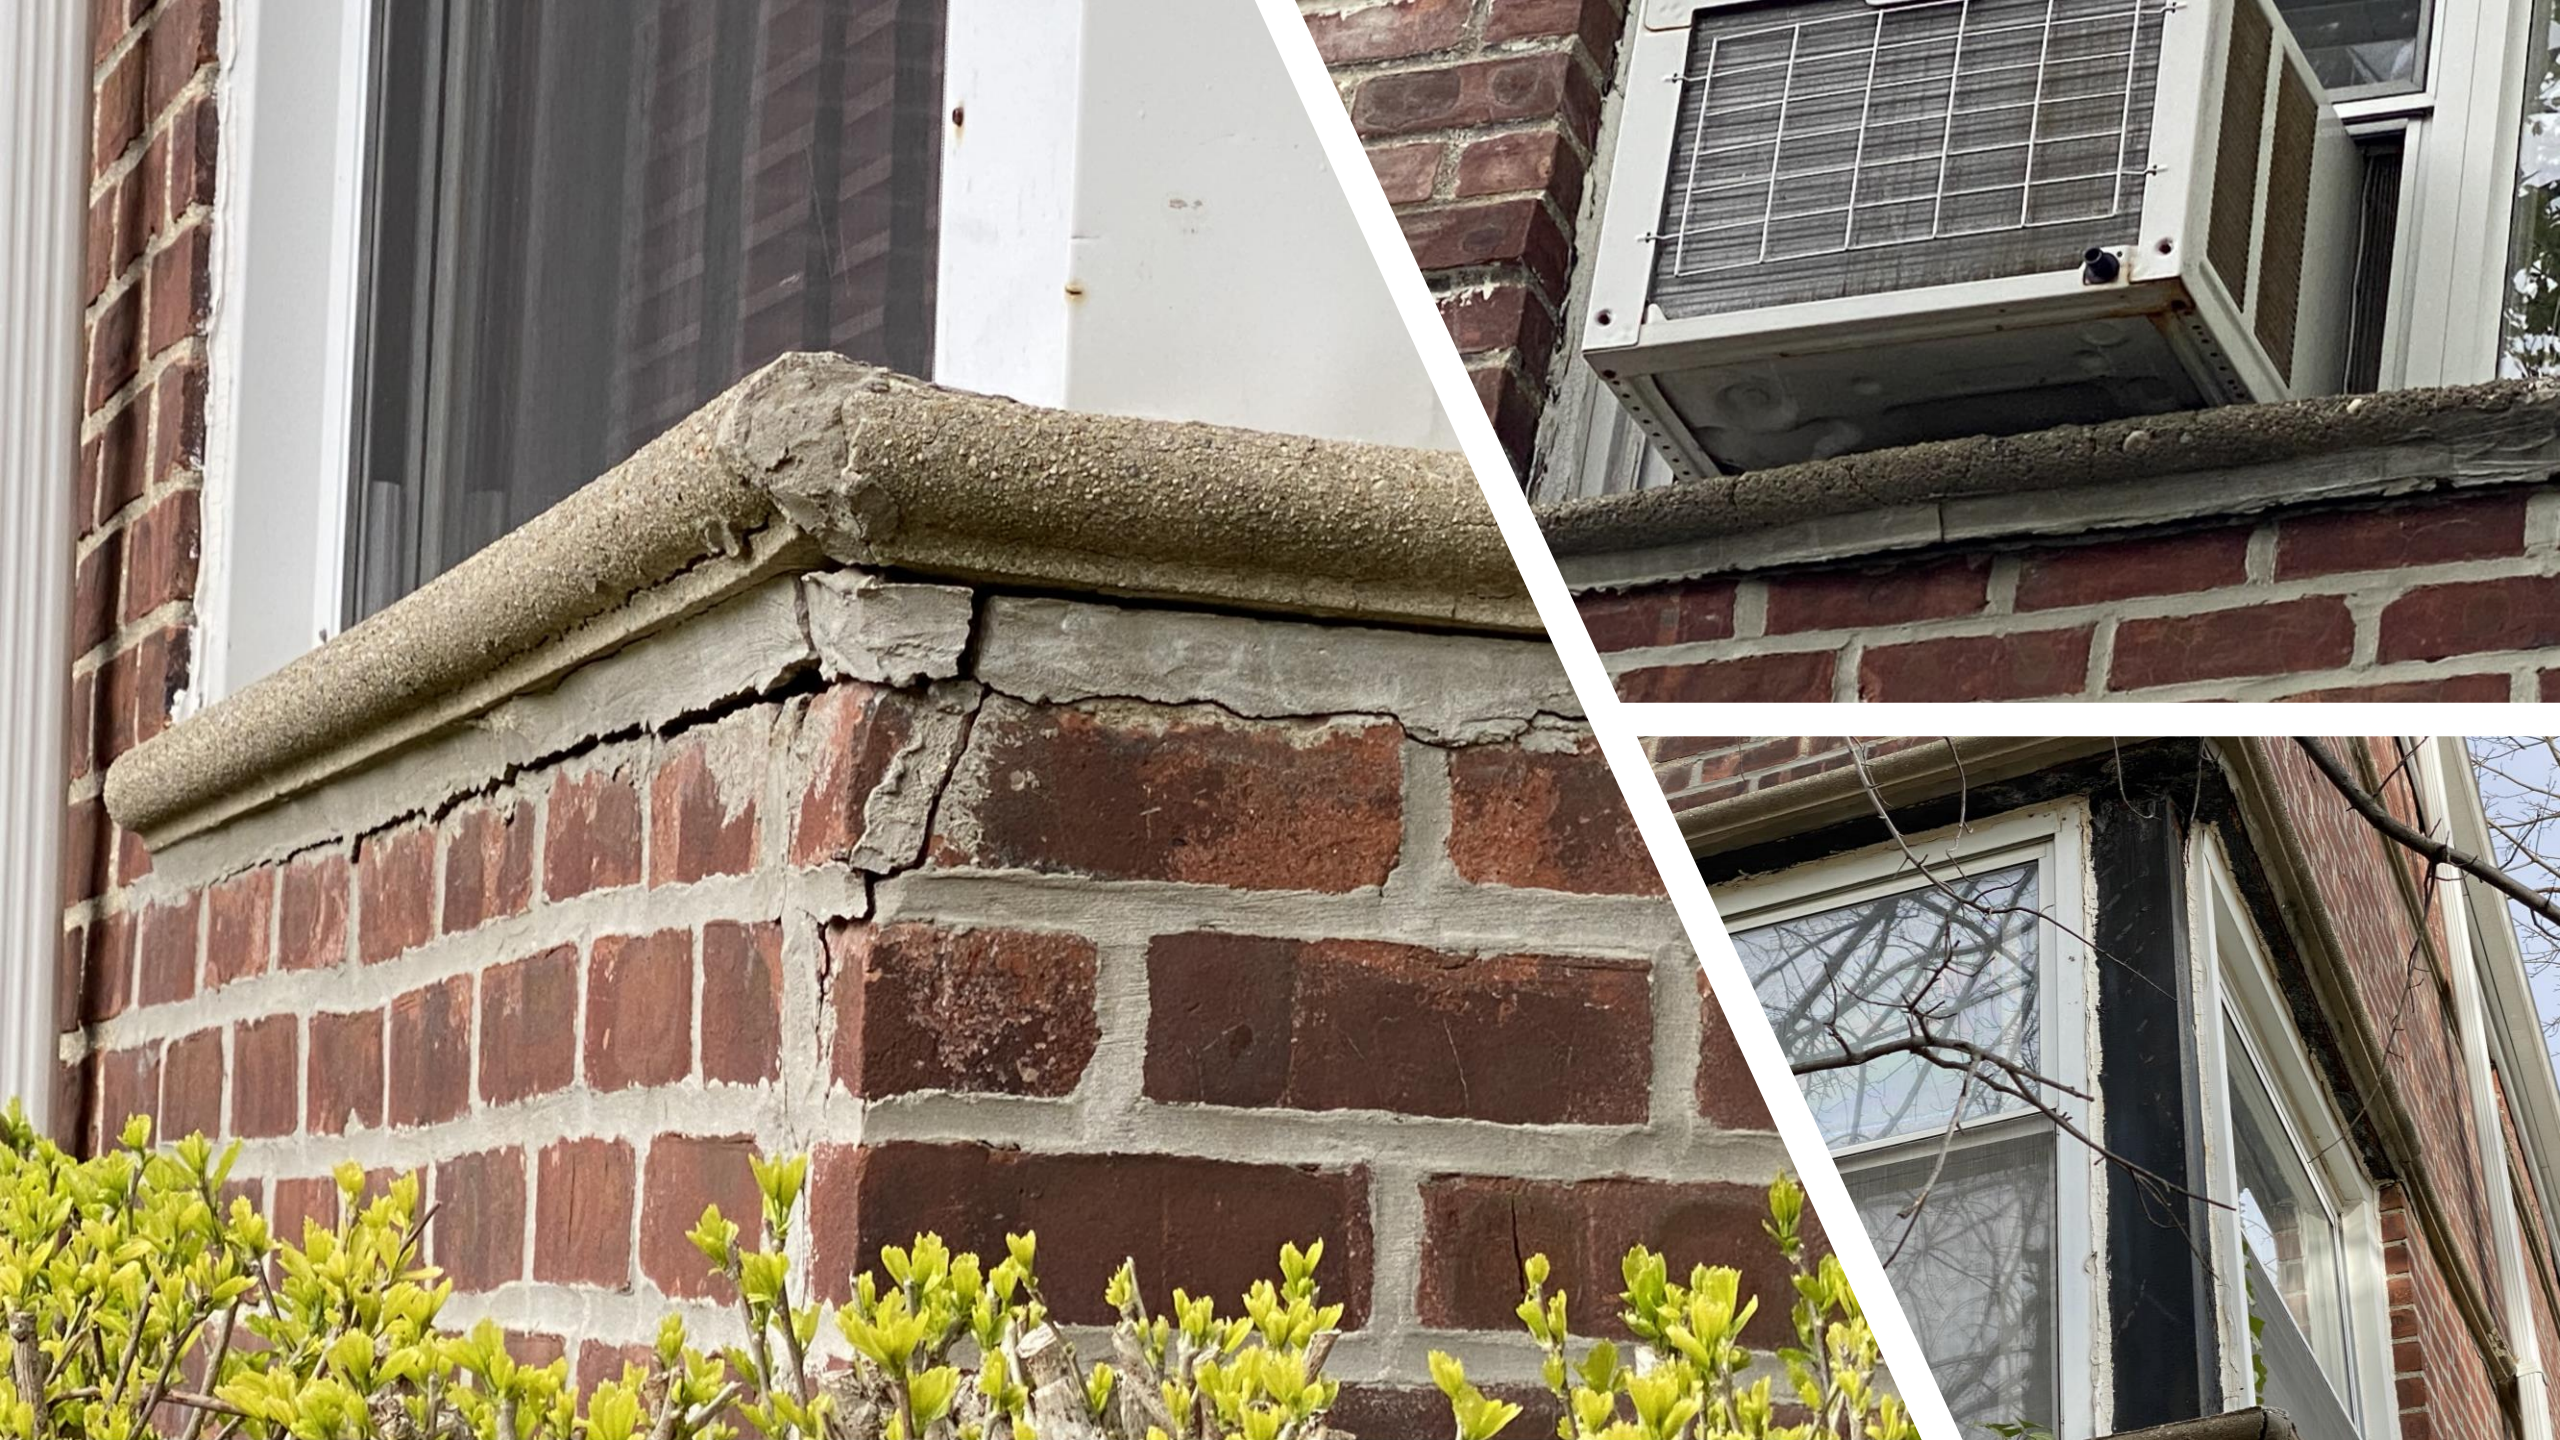
Photo-1:
Building No. 1: 196-03 Dunton Avenue.
General view of Apartment's wall where restoration work was performed.

Photo-3:
Building No. 1: 196-15 Dunton Avenue.
General view of Apartment's wall where restoration work was performed.

Photo-2:
Building No. 1: 196-03 Dunton Avenue.
Close-up view of properly installed windowsill.

Photo-4:
Building No. 1: 196-15 Dunton Avenue.
Close-up view of properly installed windowsill.

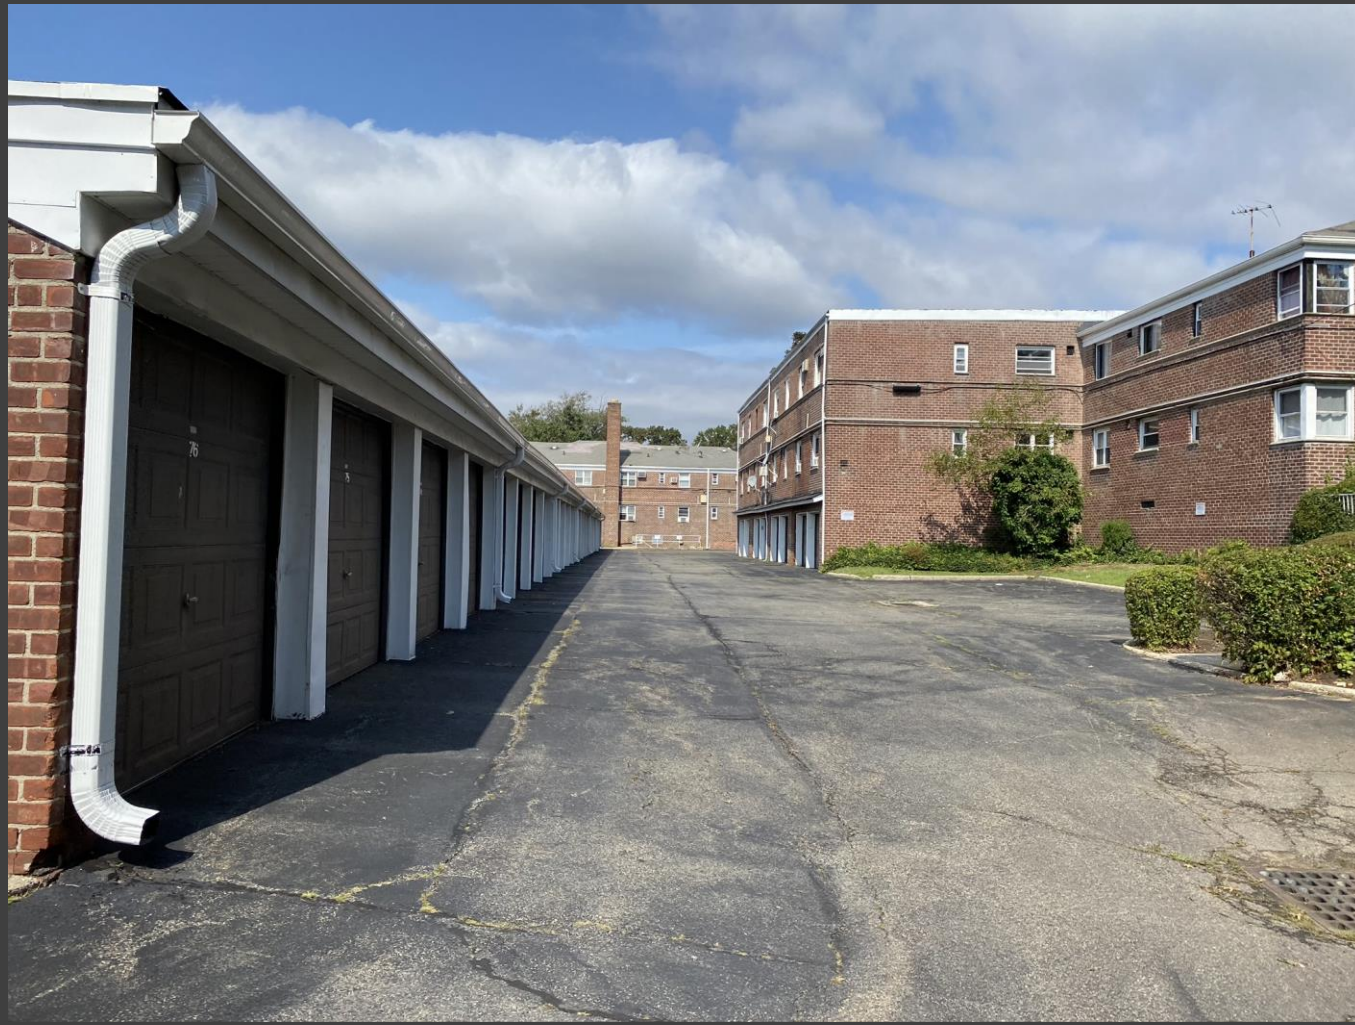
STORM & PAVEMENT: WATER PONDING AND
VEHICULAR RIDE ISSUE

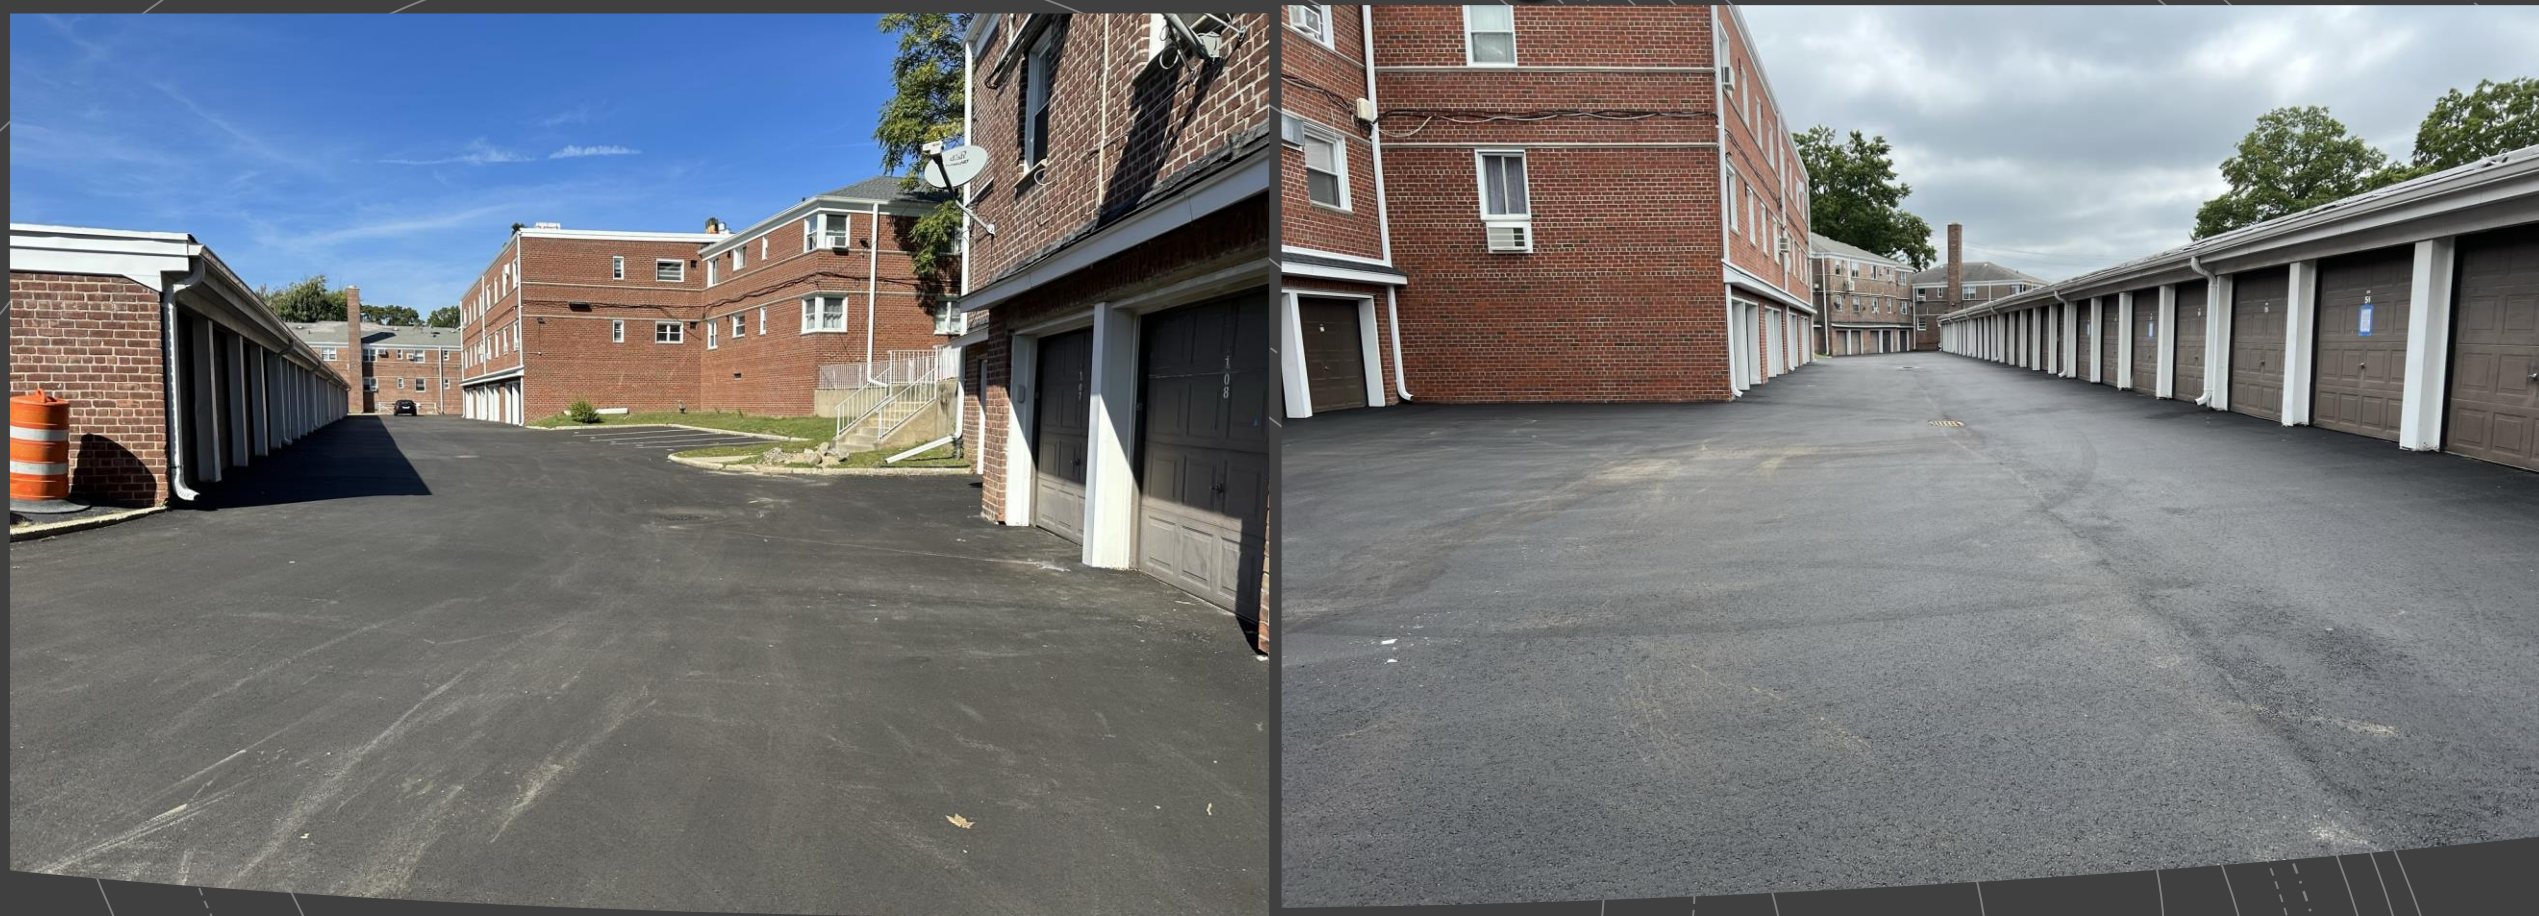
North Side of Parking Lot

AFTER RESTORATION

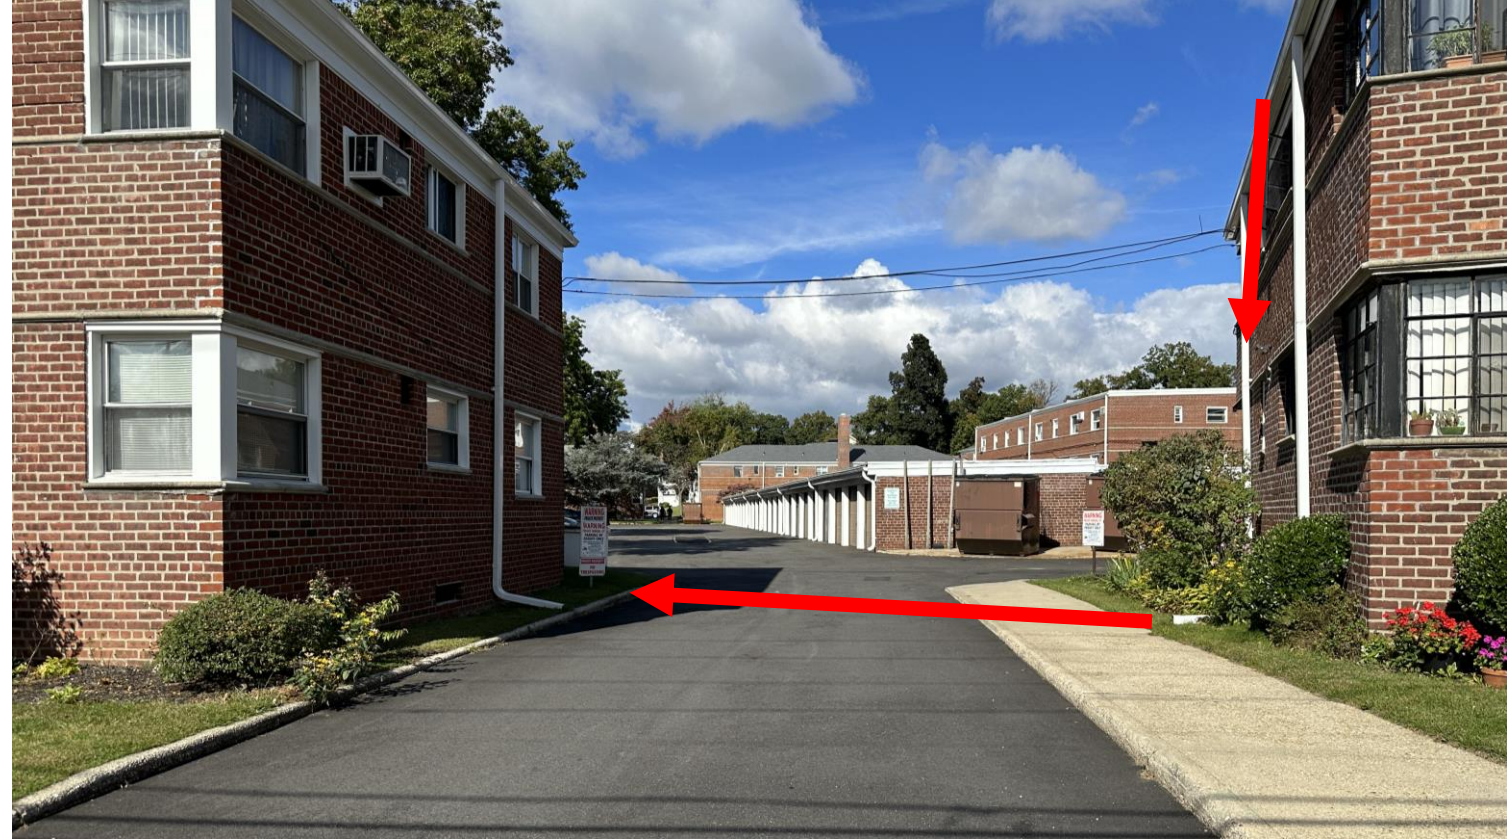
Relocation of Roof Leaders to Balance out
the Storm Runoff Load Distribution
