COMPLETION OF 5-YEAR CAPITAL IMPROVEMENT PLAN

CAPITAL IMPROVEMENT PROGRAM (C.I.P.)

PHASING OF COMPLETED WORK:

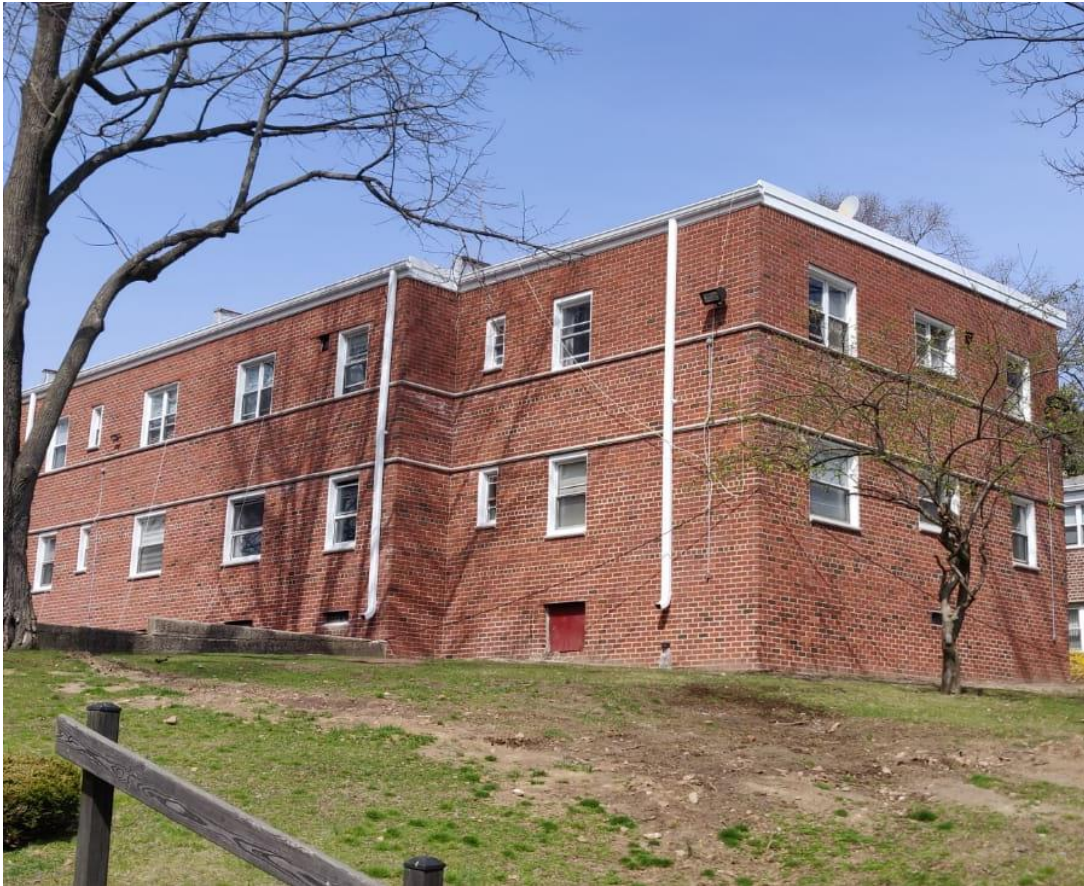
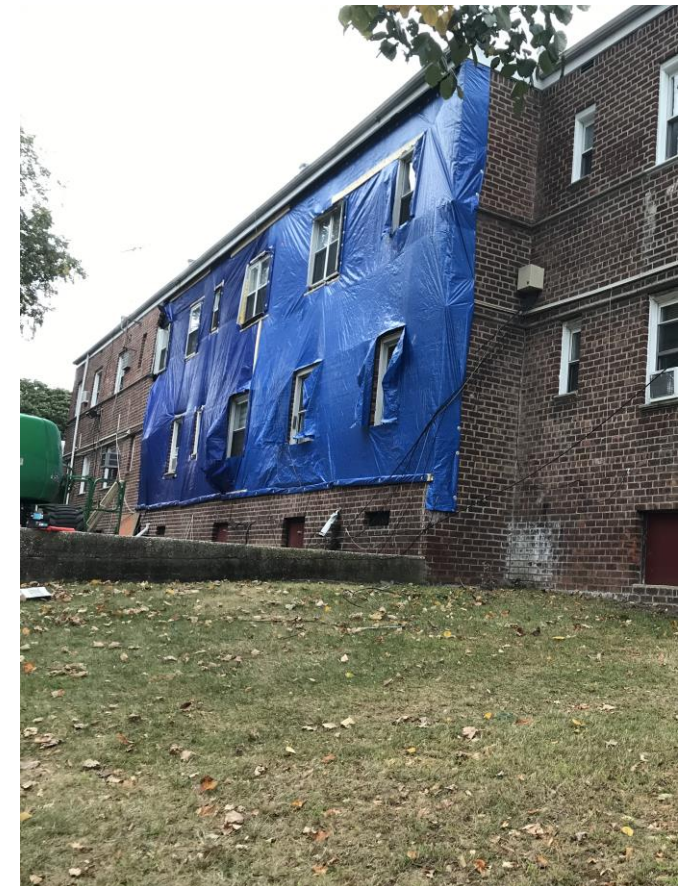
PHASE -1:

UNPLANNED COLLAPSE OF WALL AT 87-22 TO 32 MARENGO STREET

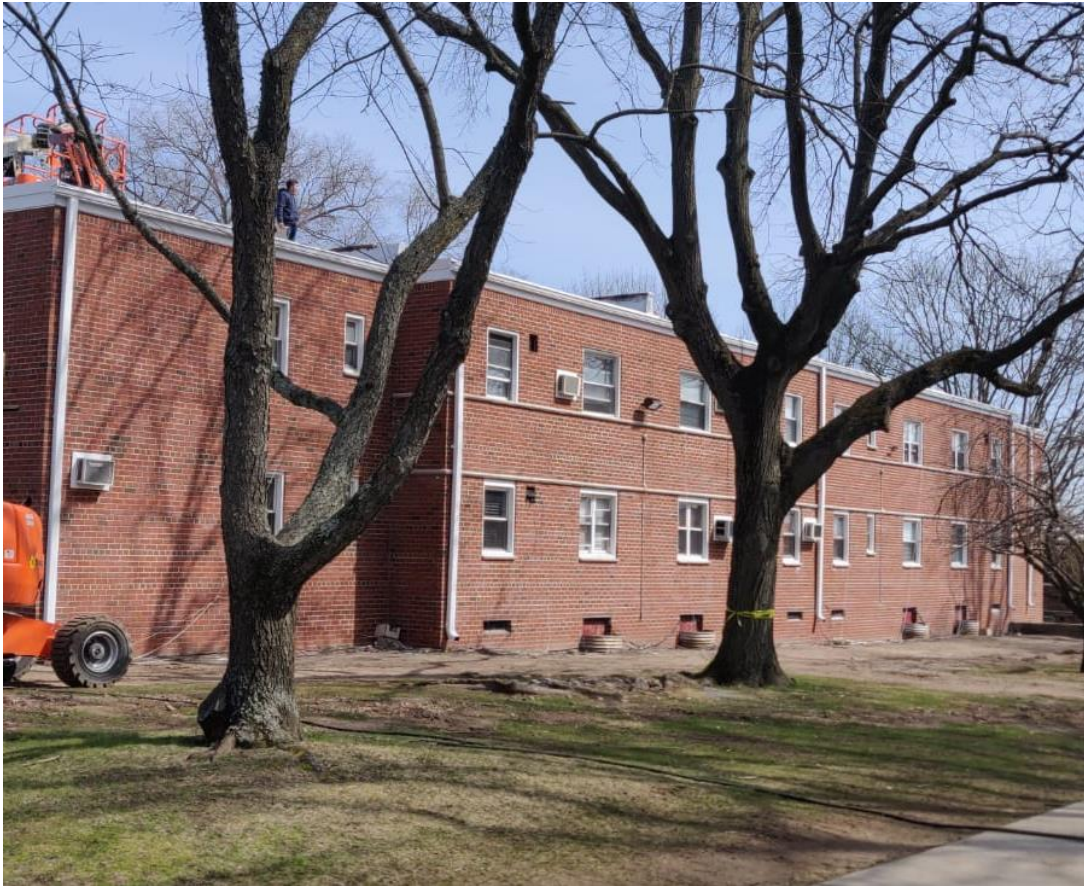
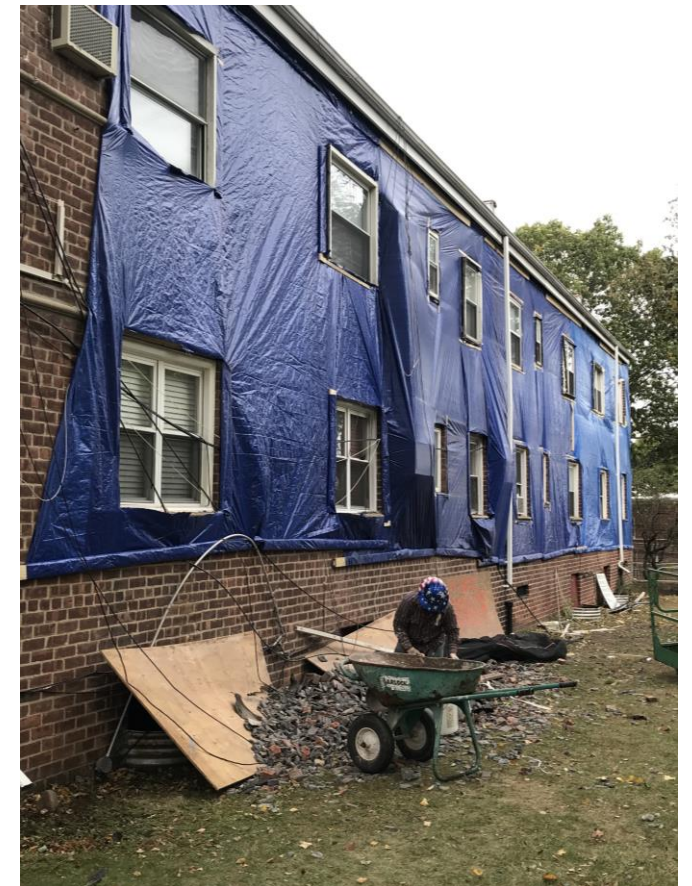
PHASE -1:

UNPLANNED COLLAPSE OF WALL AT 87-22 TO 32 MARENGO STREET

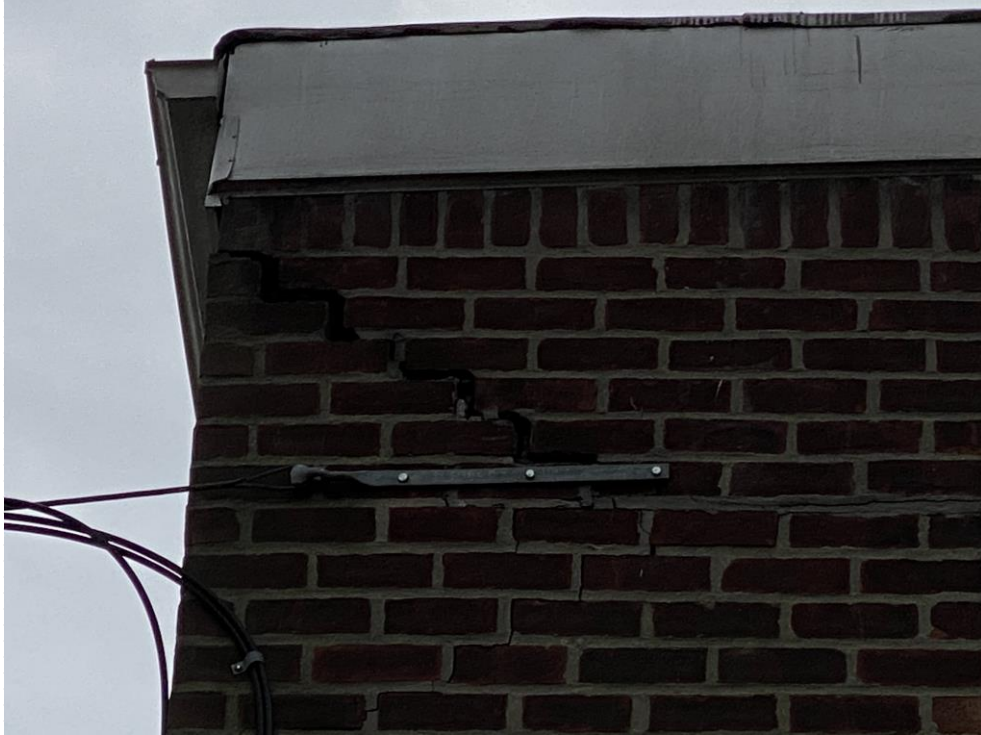
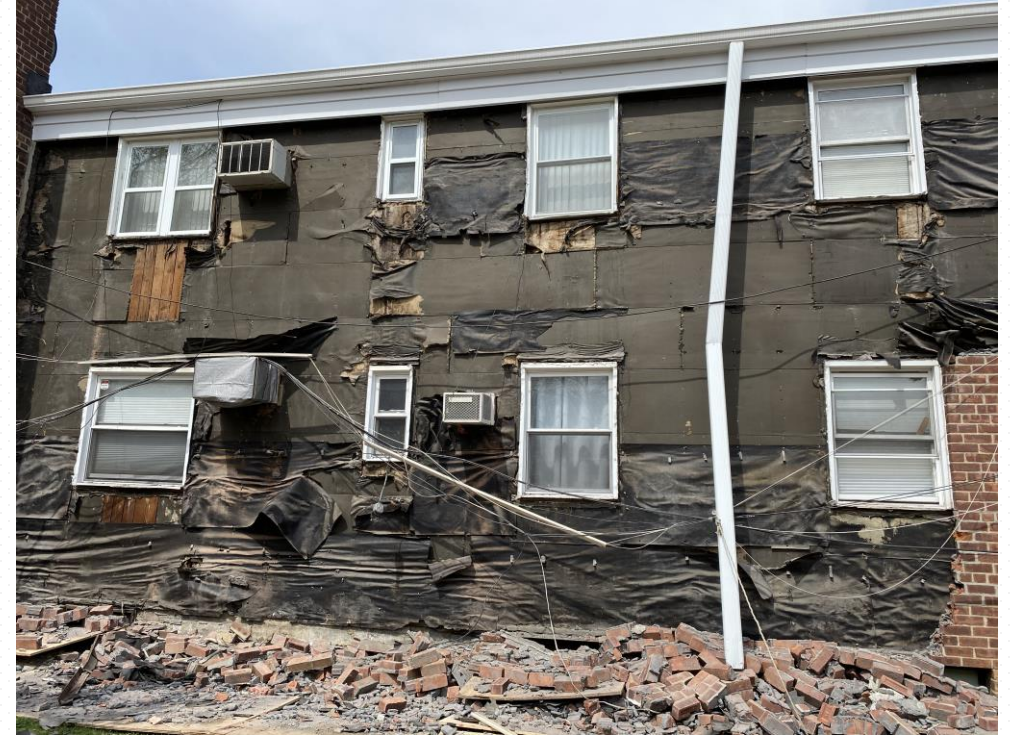
PHASE -2:

RESTORATION OF 39 STRUCTURALLY UNSTABLE FACADES

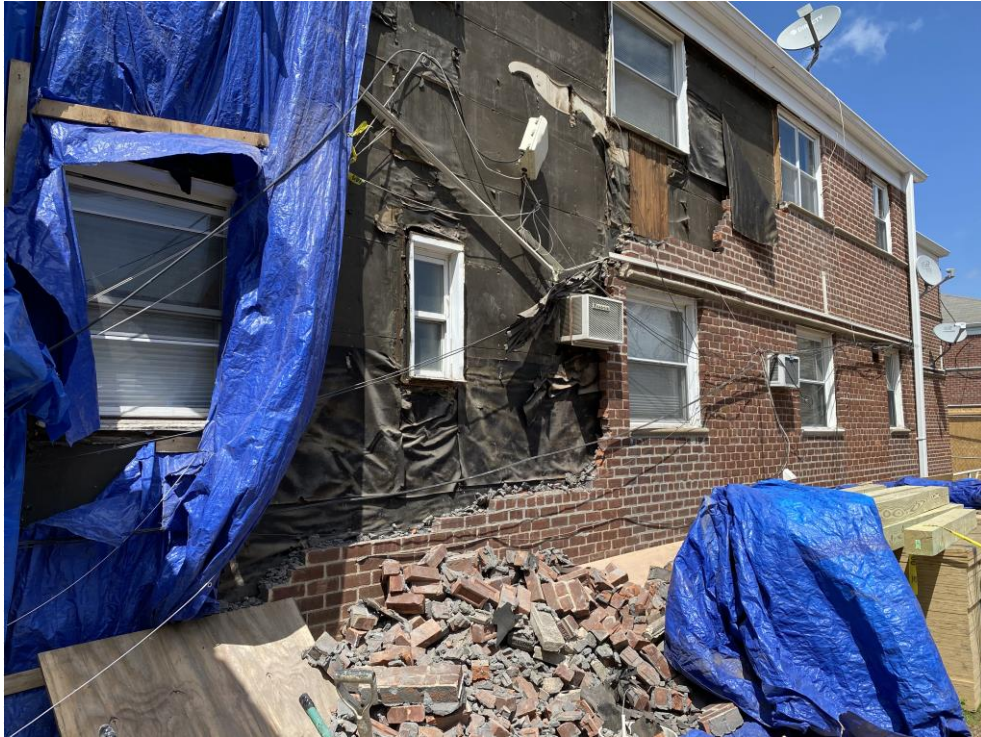
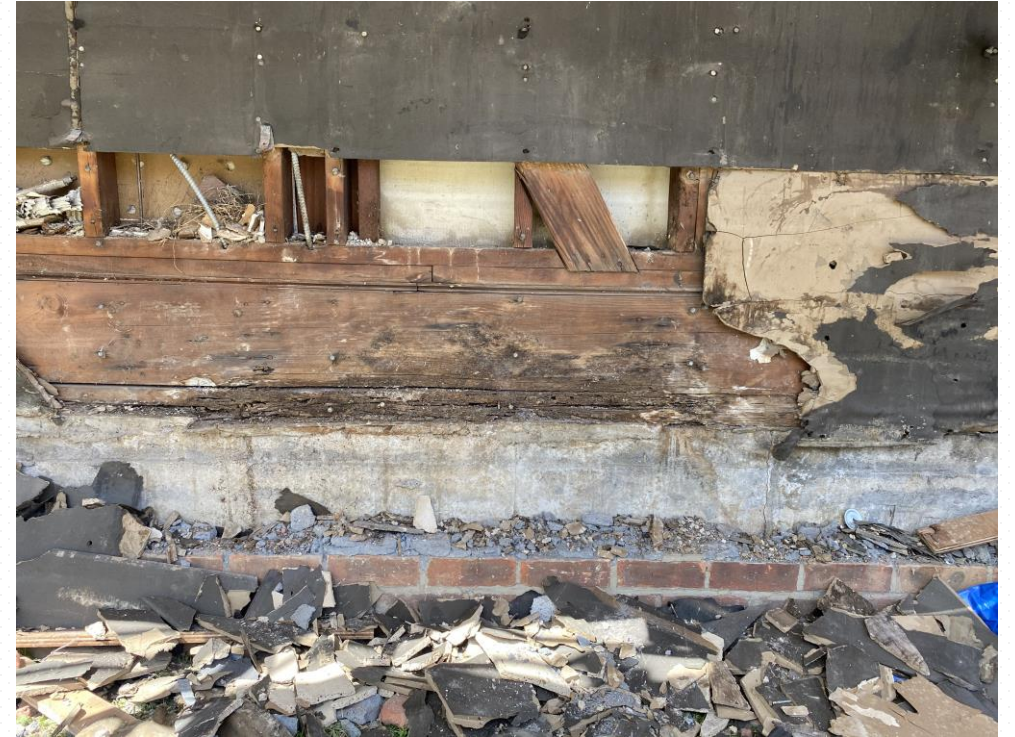
PHASE -2:

RESTORATION OF 39 STRUCTURALLY UNSTABLE FACADES

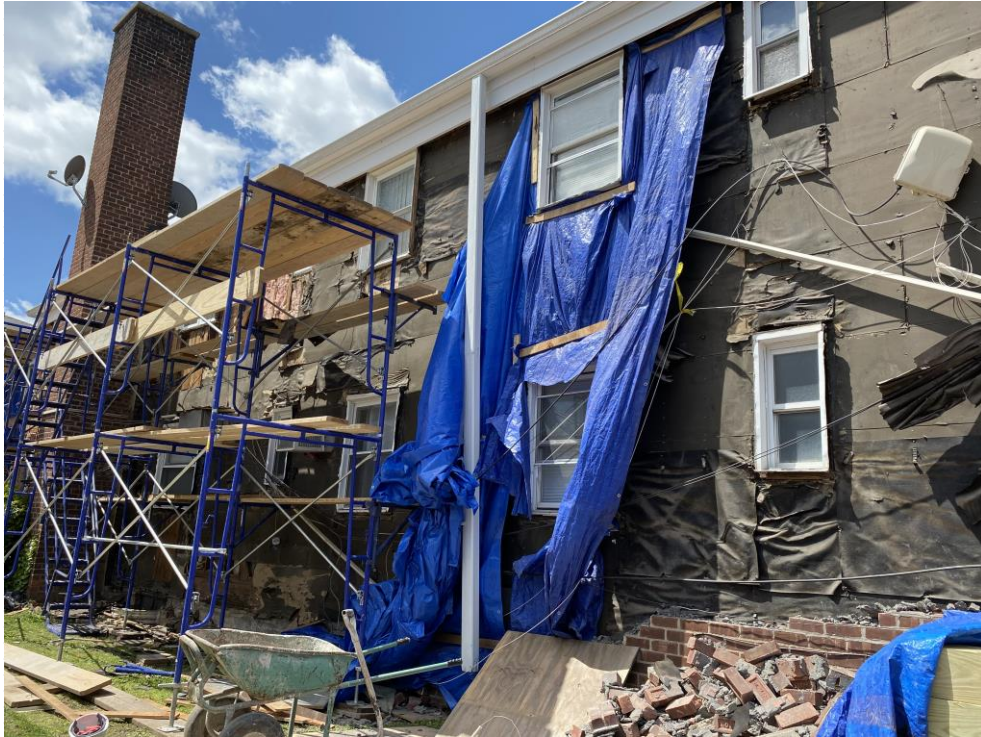
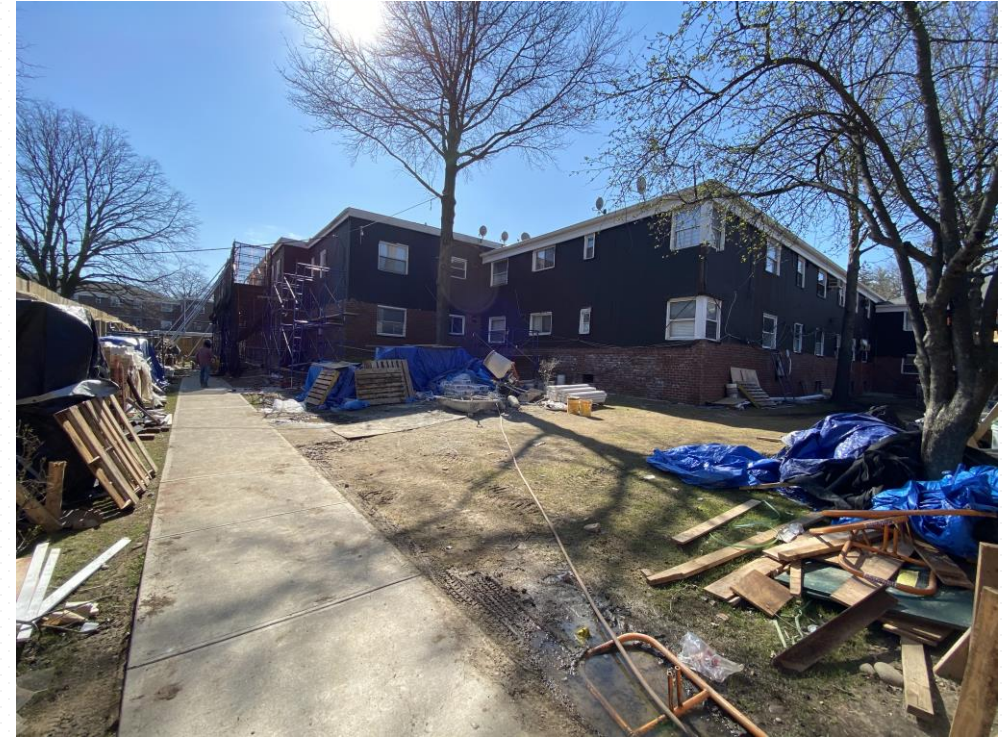
PHASE -2:

RESTORATION OF 39 STRUCTURALLY UNSTABLE FACADES

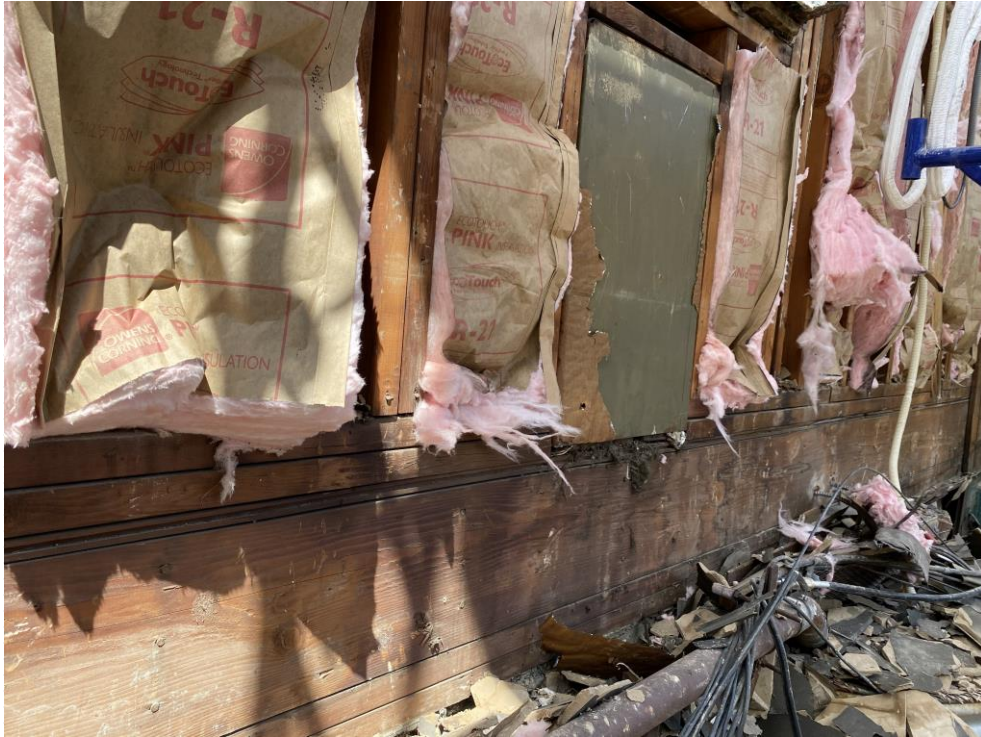
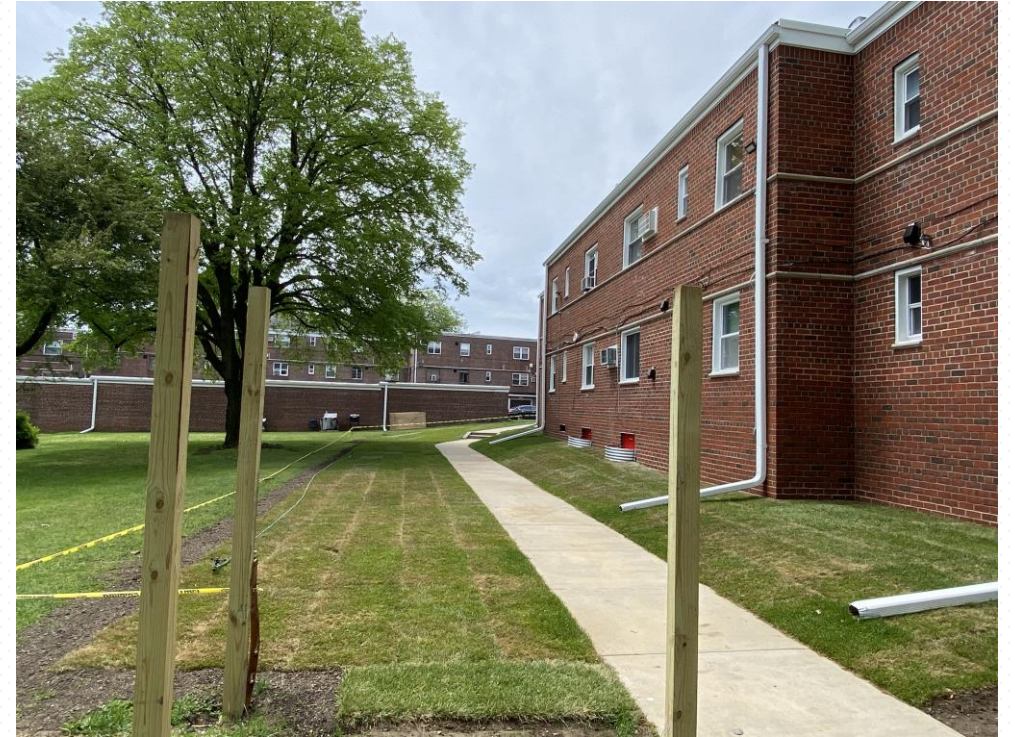
PHASE -2:

RESTORATION OF 39 STRUCTURALLY UNSTABLE FACADES

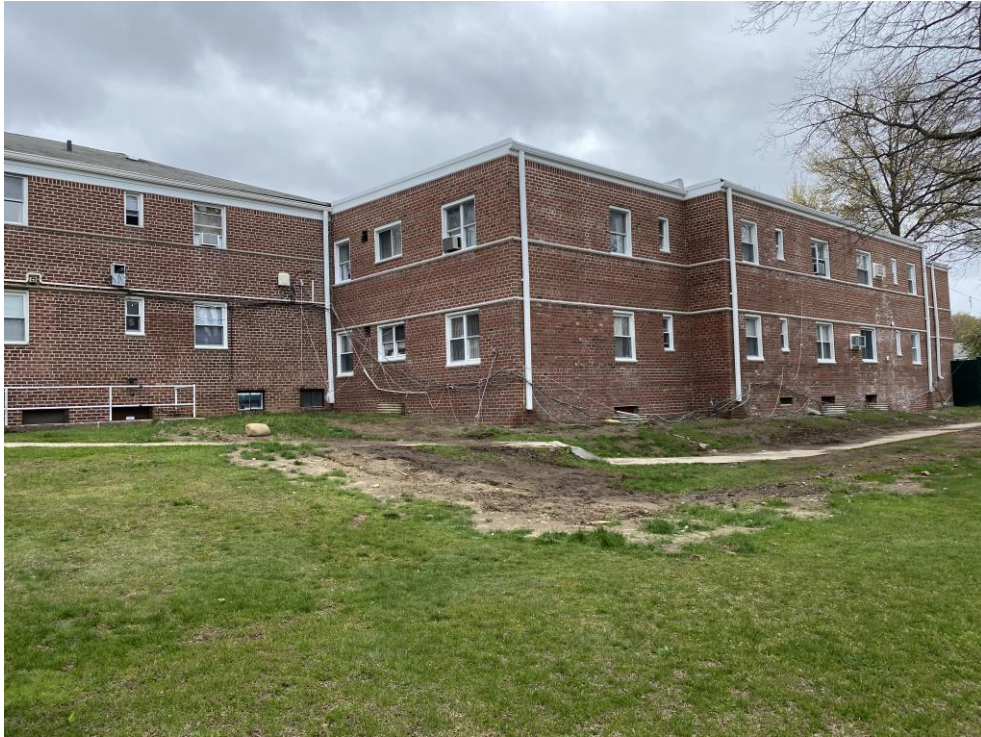
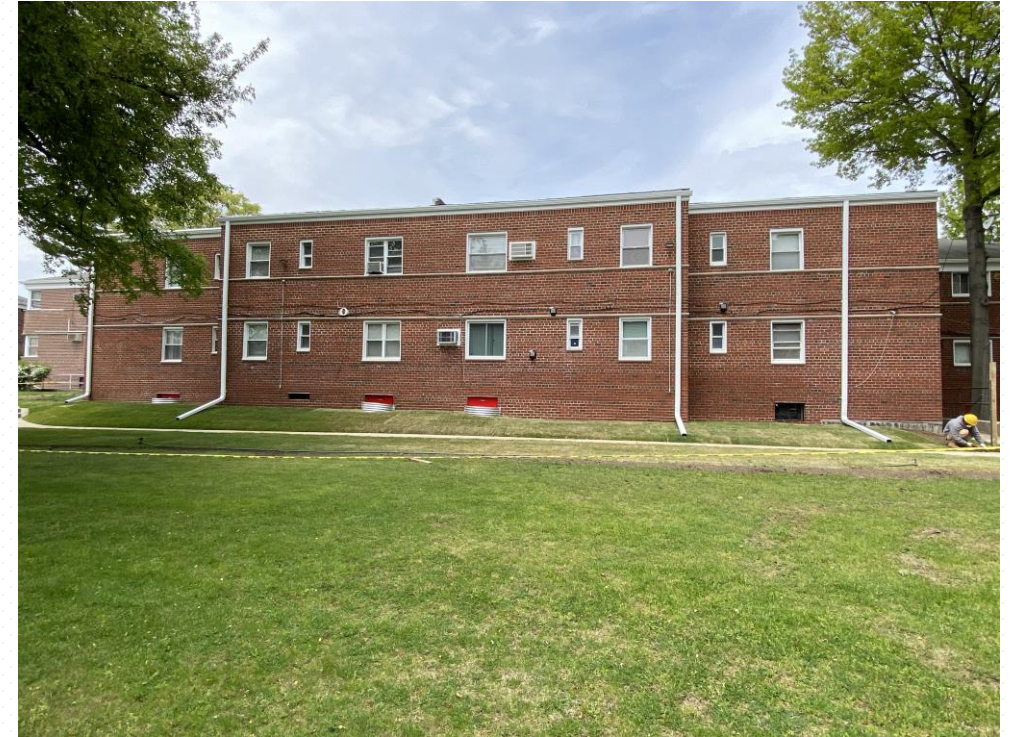
PHASE -2:

RESTORATION OF 39 STRUCTURALLY UNSTABLE FACADES

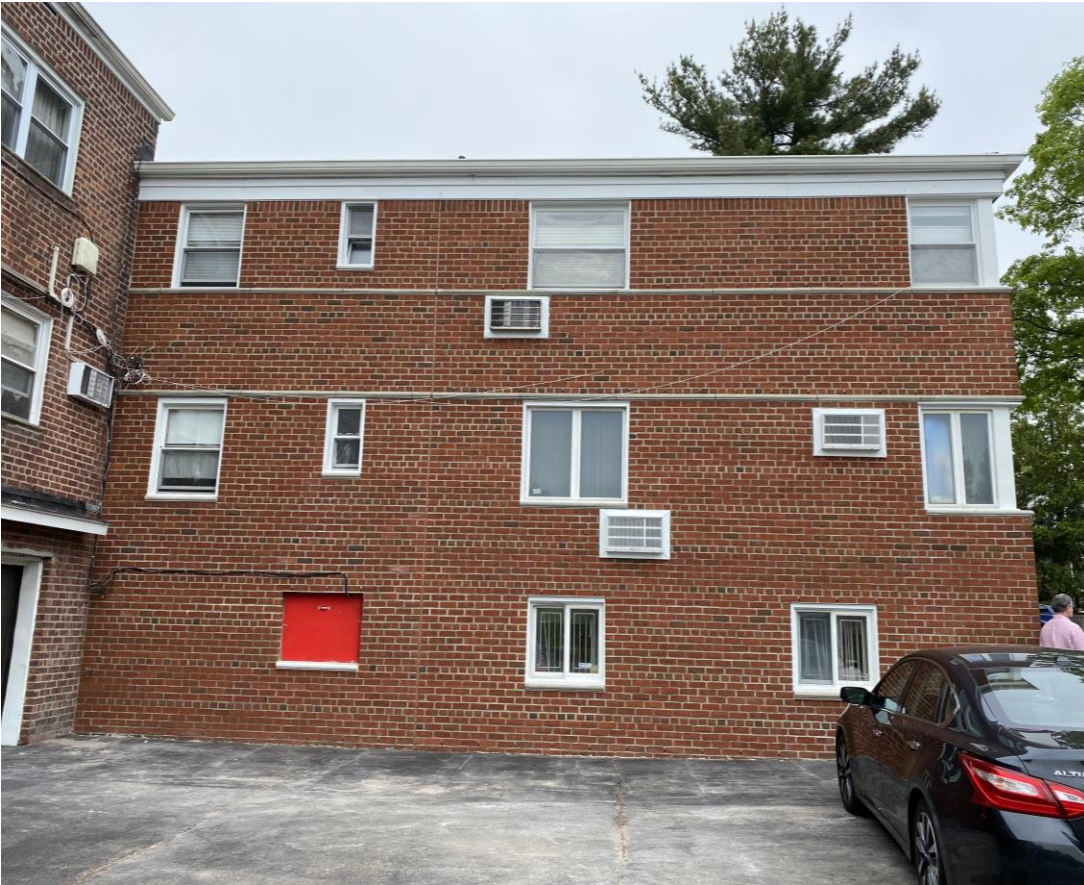
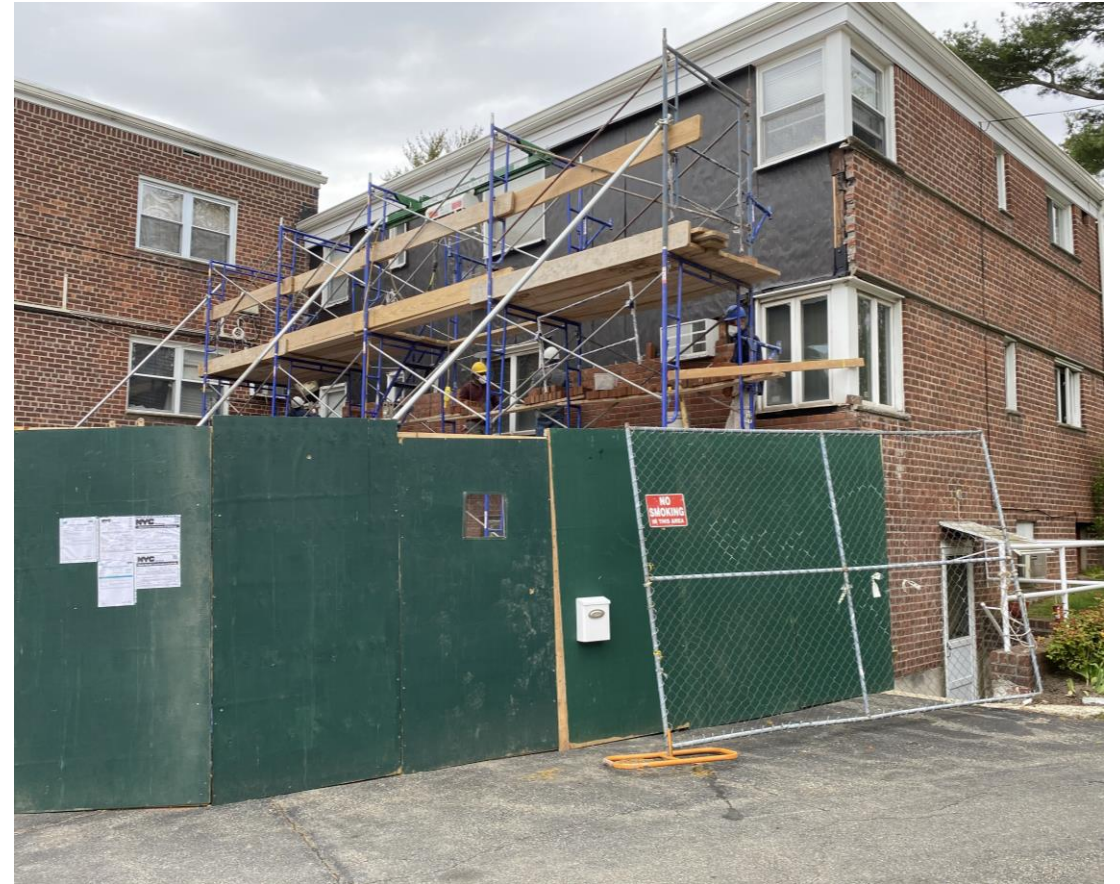
PHASE -2:

RESTORATION OF 39 STRUCTURALLY UNSTABLE FACADES

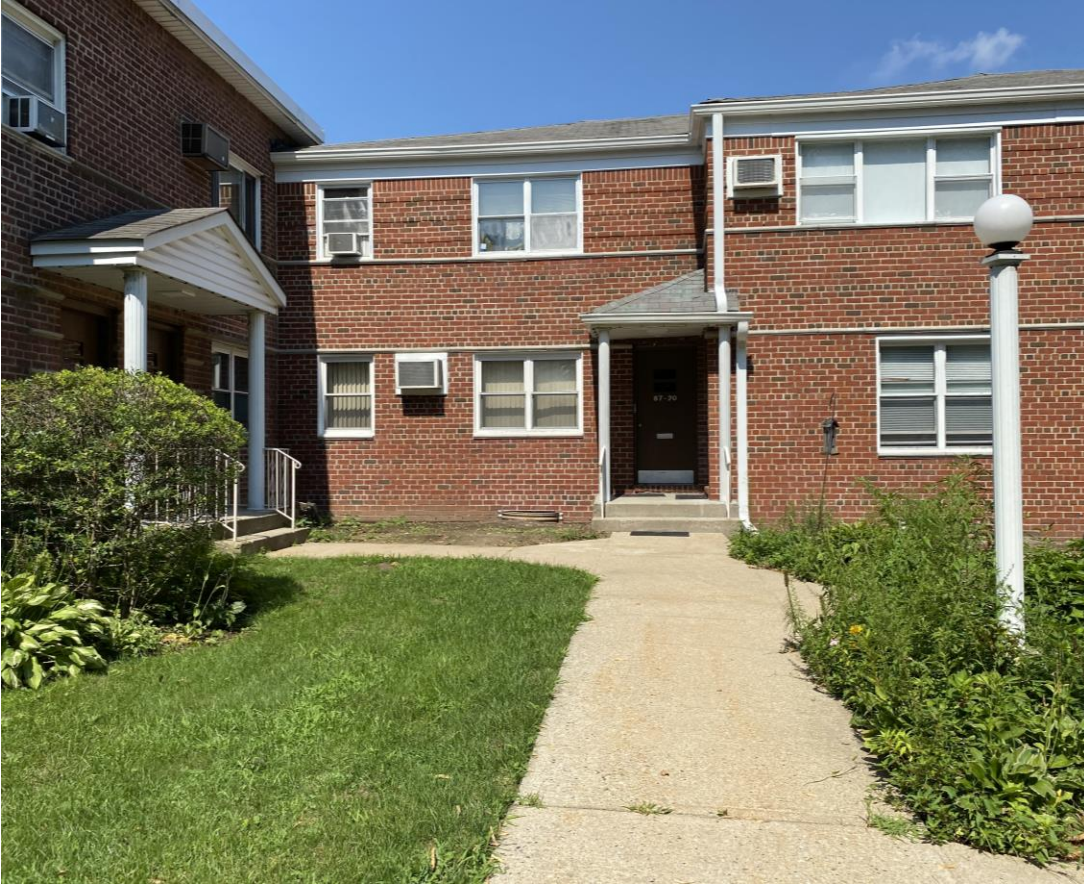
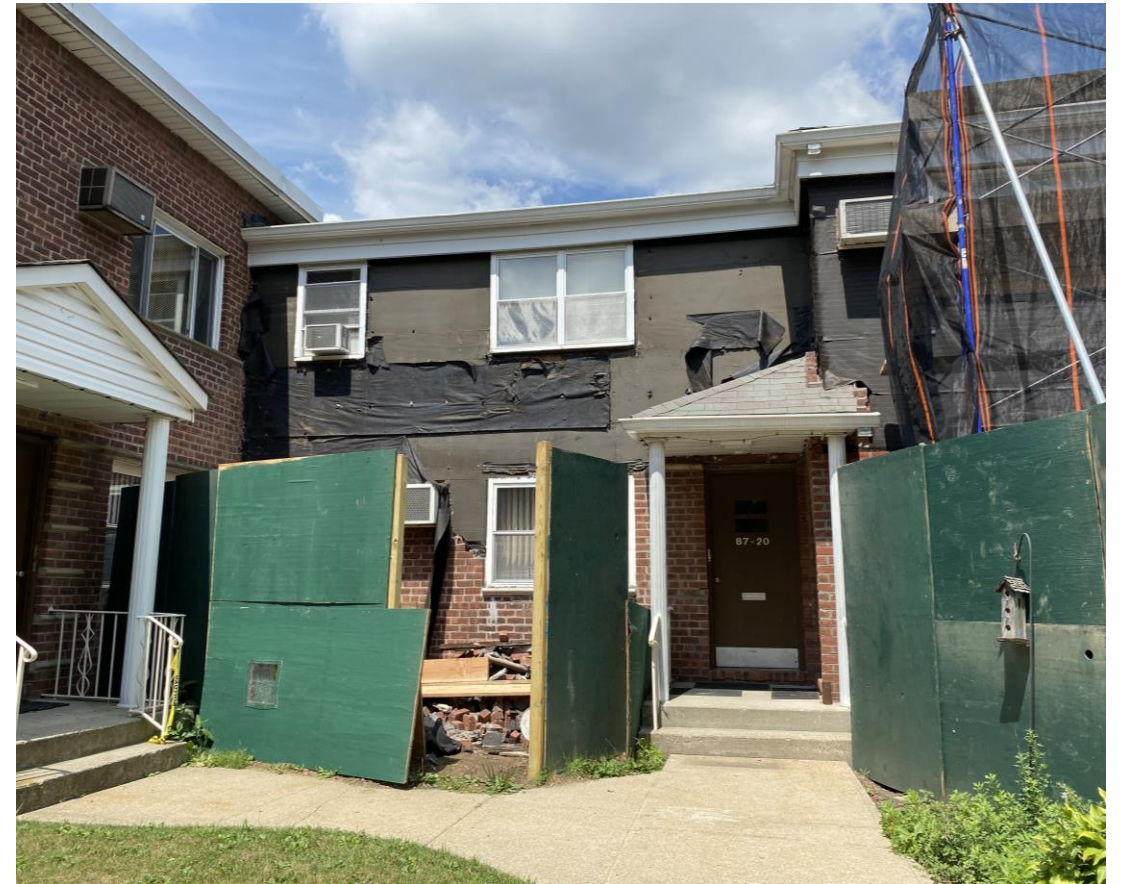
PHASE -2:

RESTORATION OF 39 STRUCTURALLY UNSTABLE FACADES

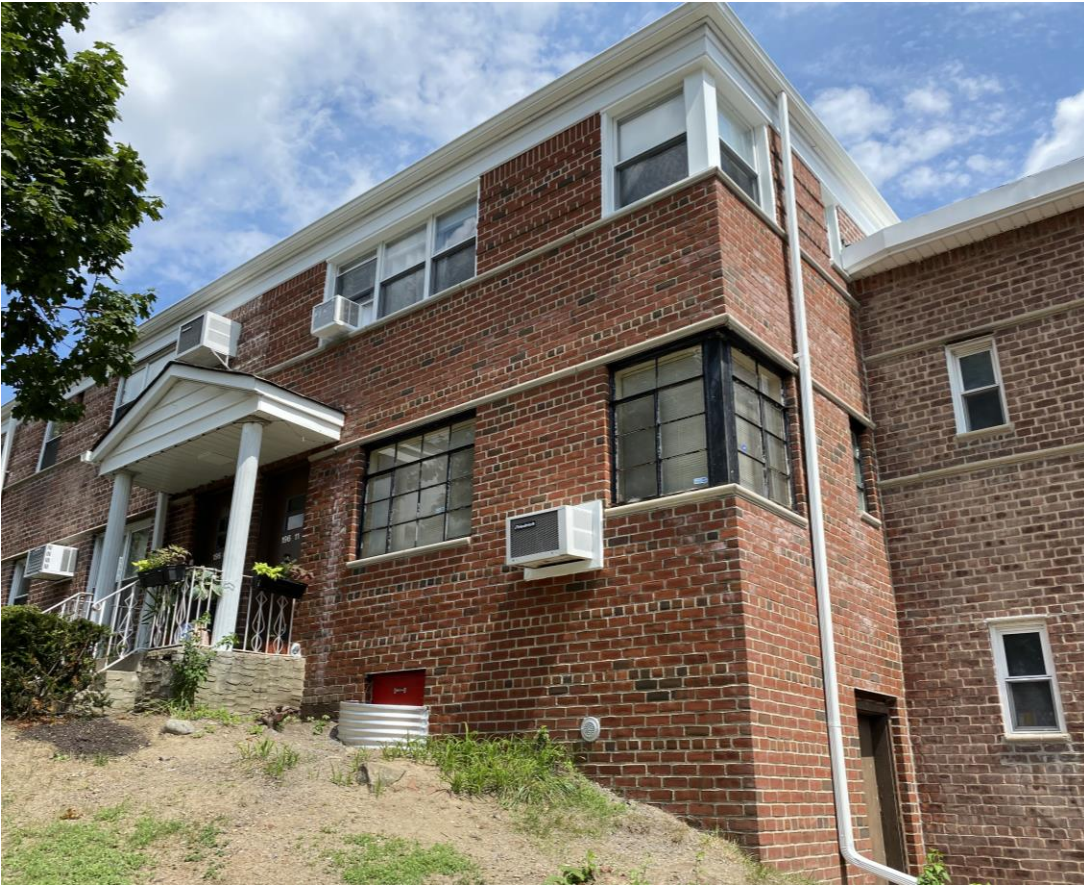
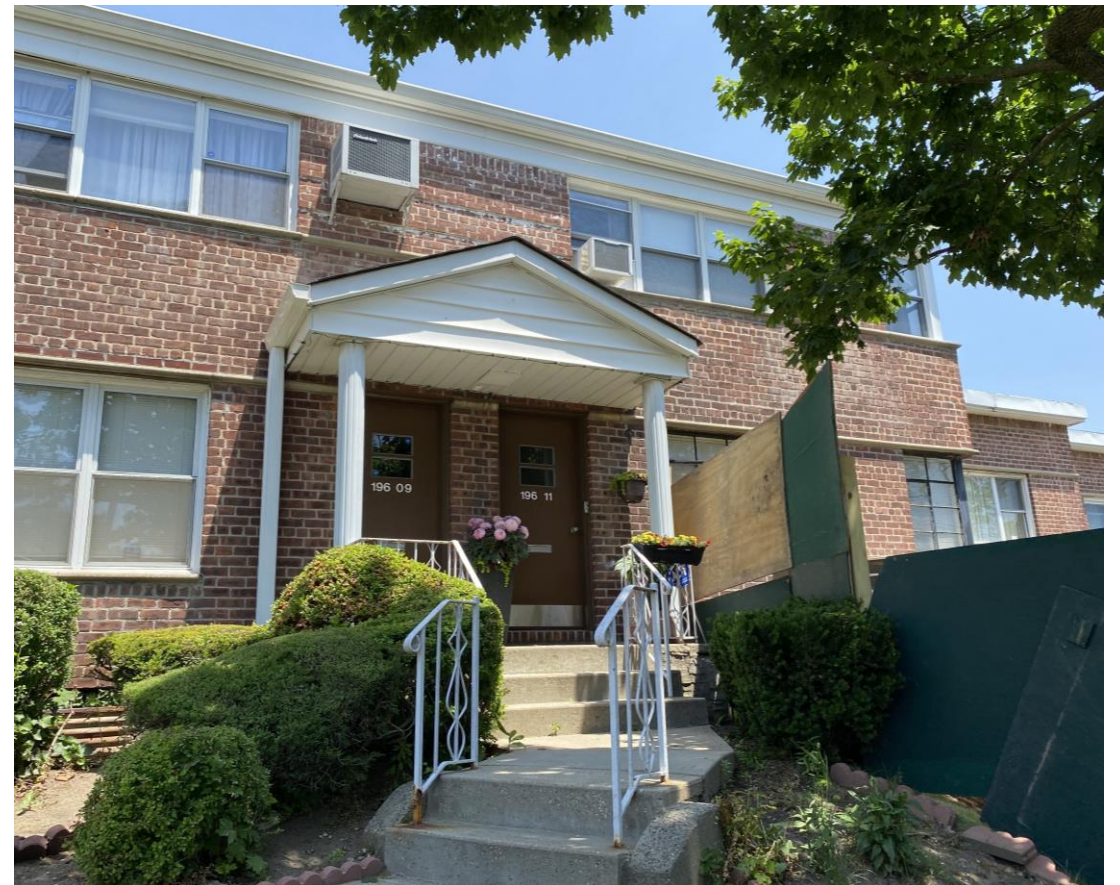
PHASE -2:

RESTORATION OF 39 STRUCTURALLY UNSTABLE FACADES

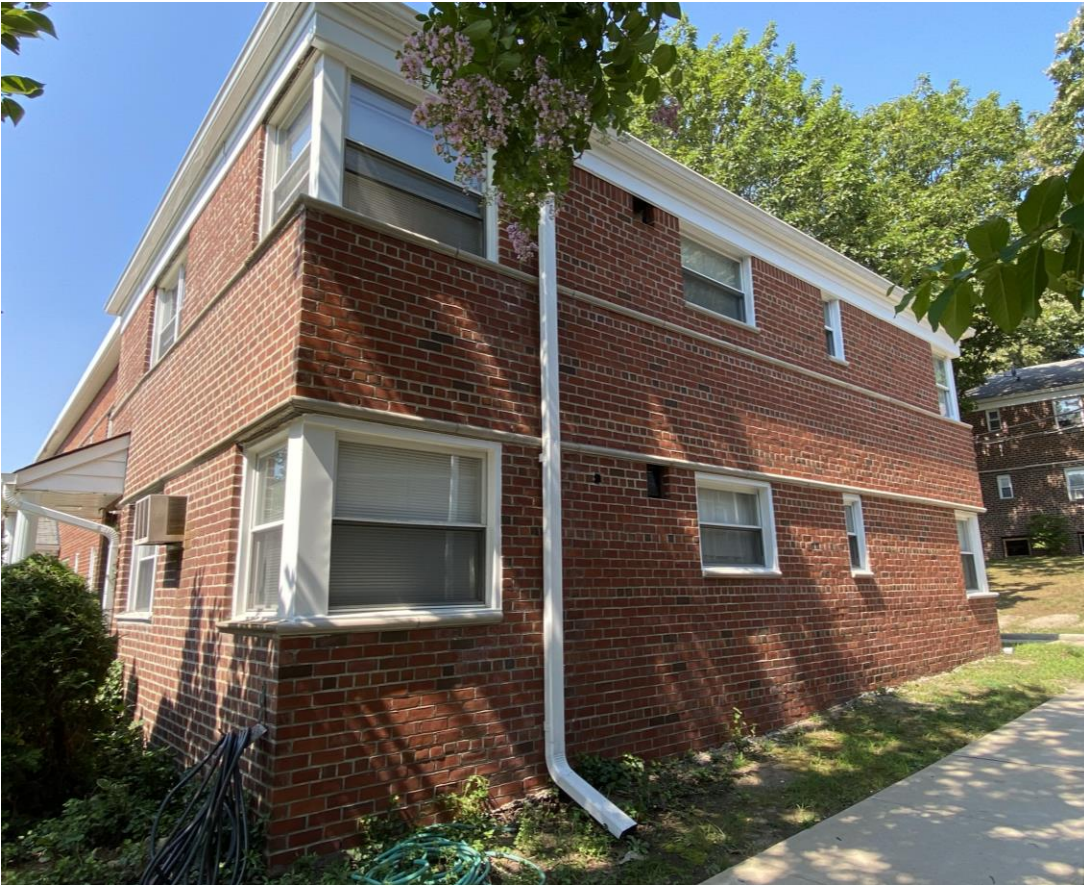
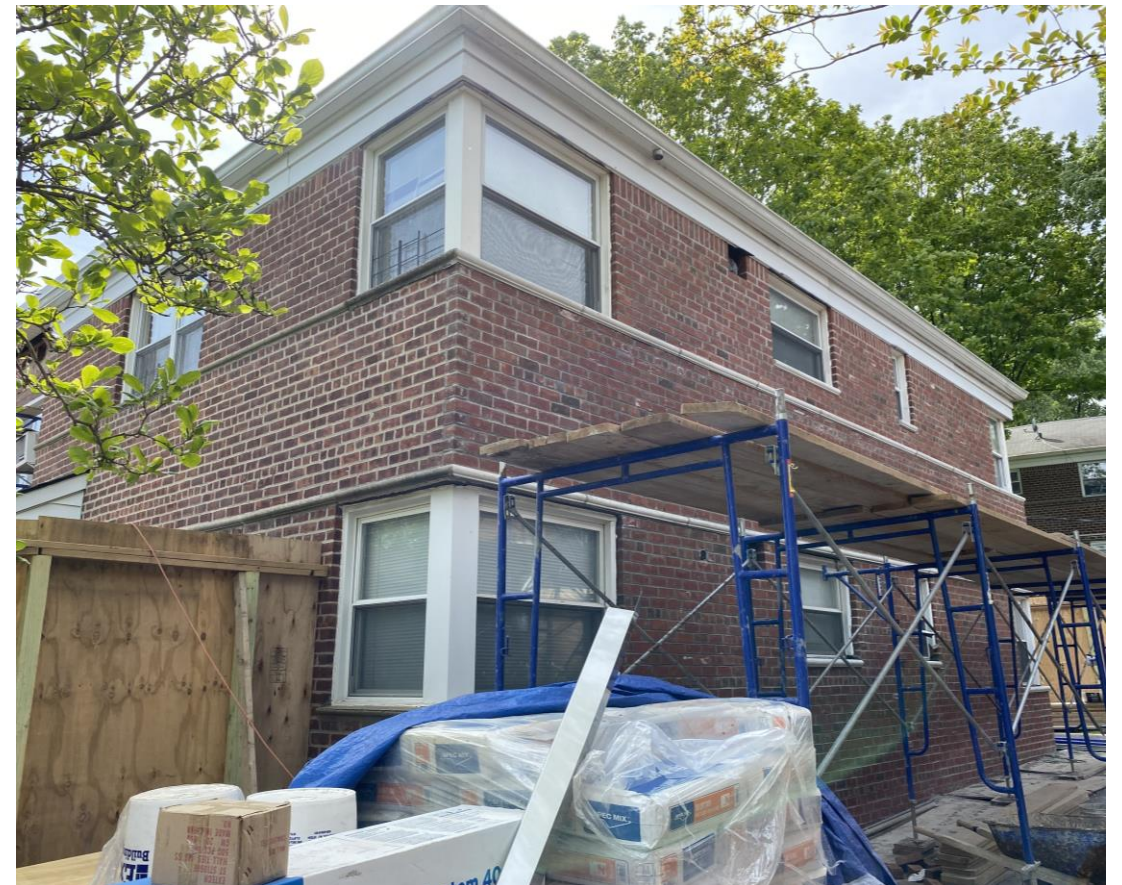
PHASE -2:

RESTORATION OF 39 STRUCTURALLY UNSTABLE FACADES

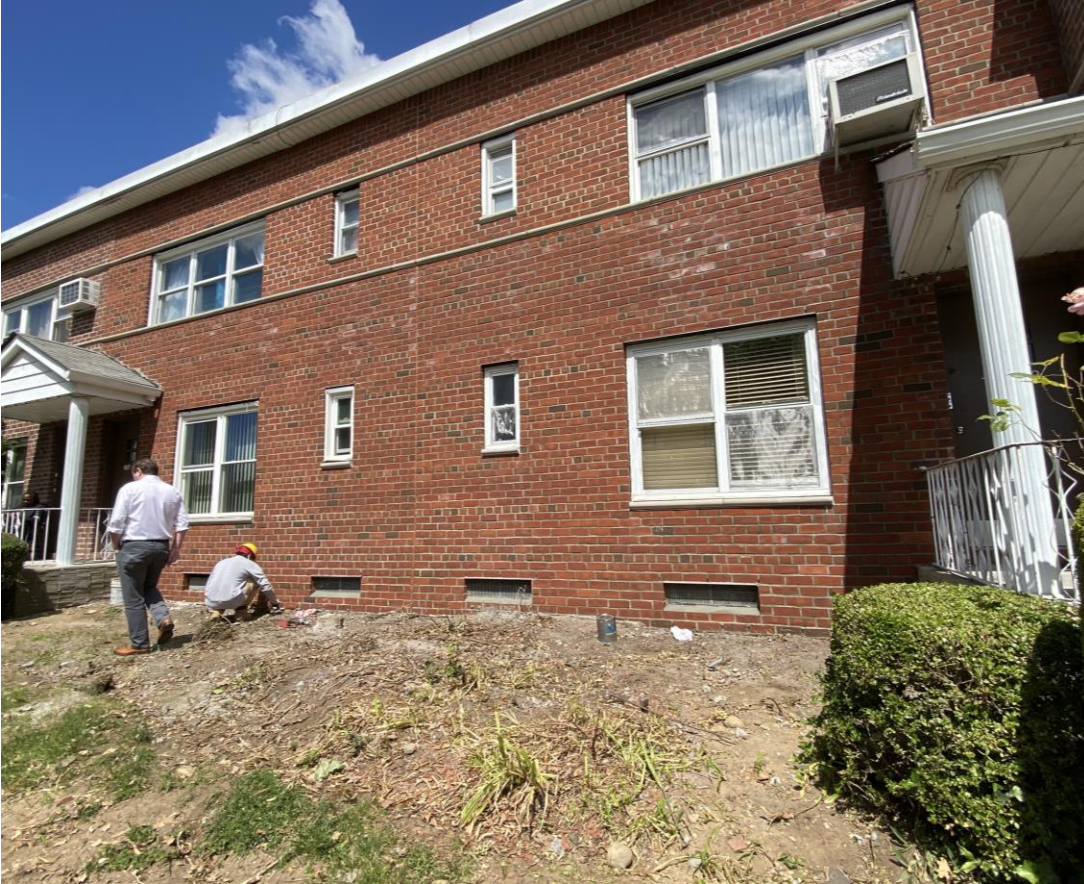
PHASE -2:

RESTORATION OF 39 STRUCTURALLY UNSTABLE FACADES

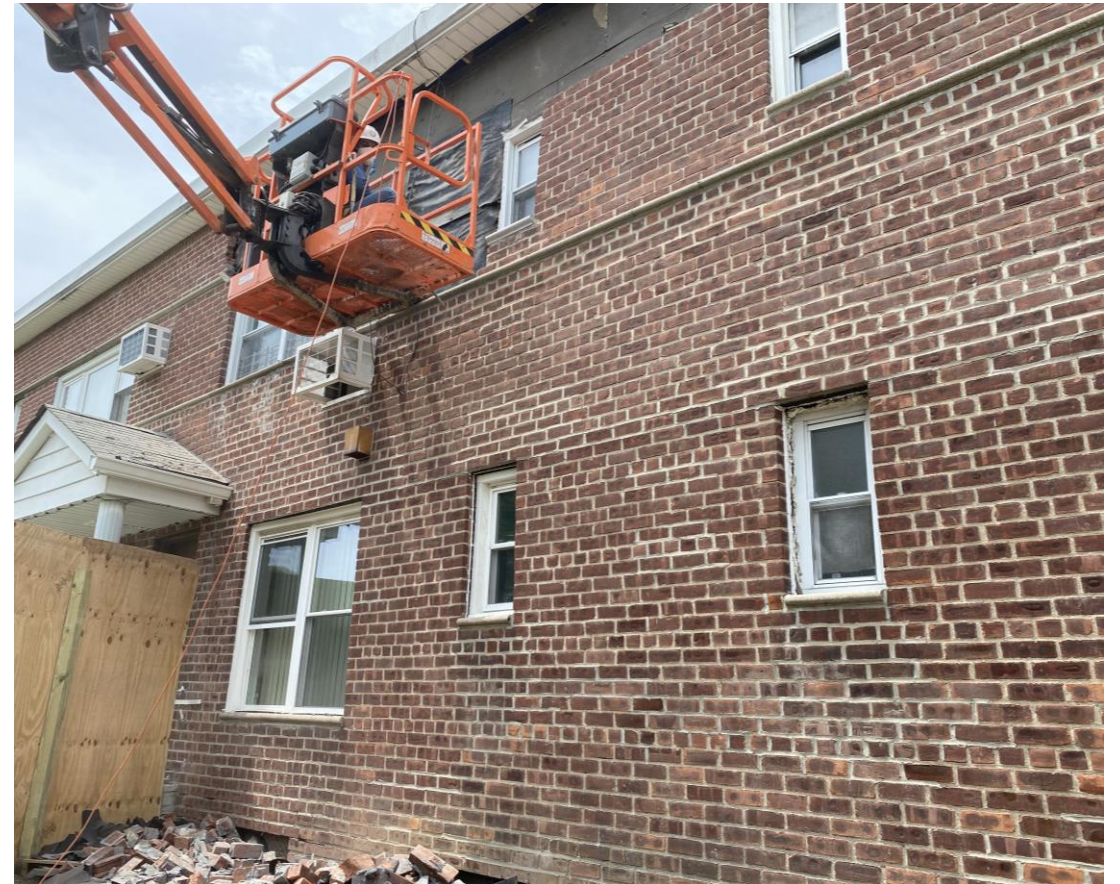
AFTER

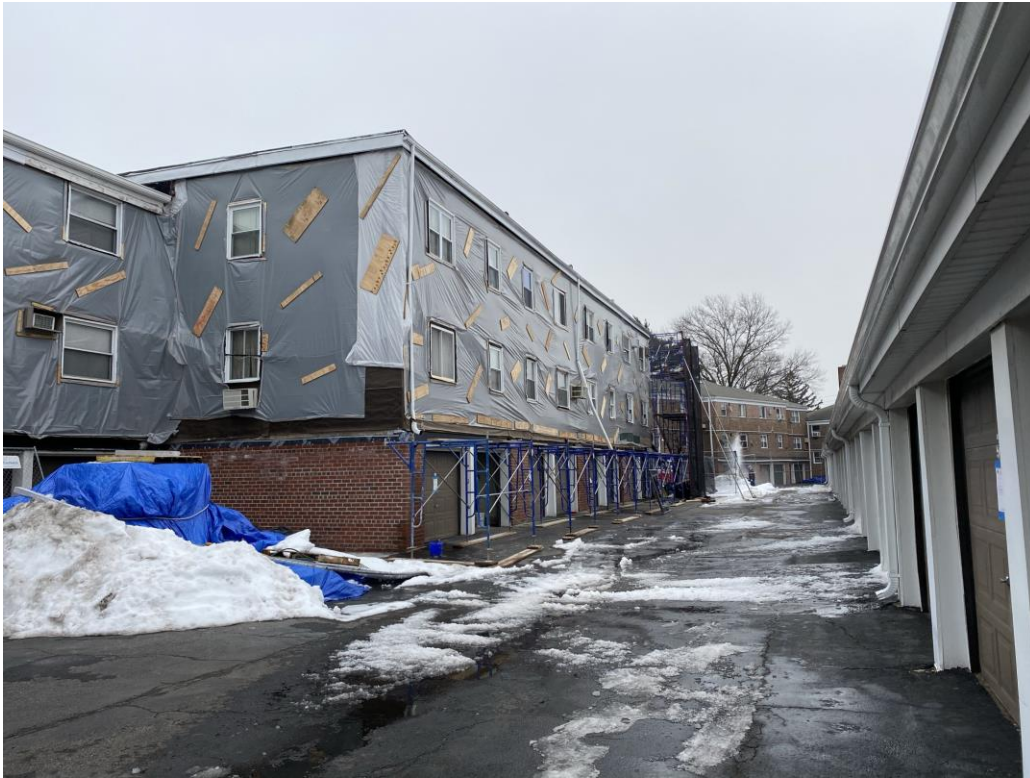
RESTORATION OF REAR WALL OF BUILDING No. 8

DURING RENOVATION

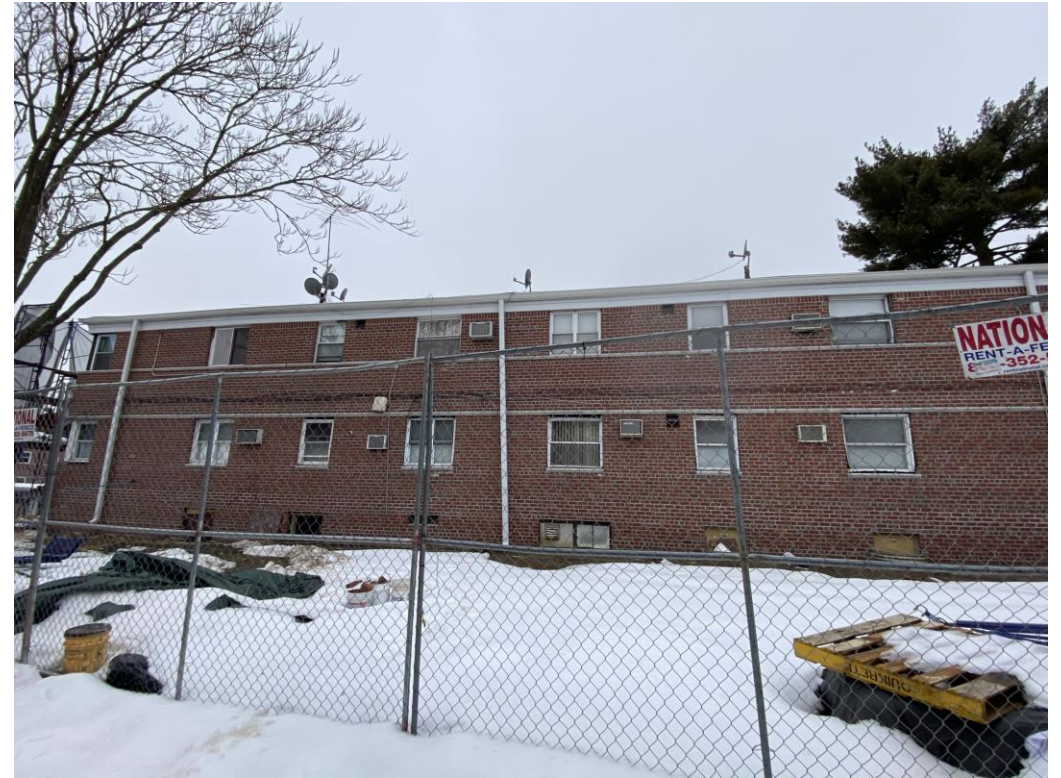
DURING RENOVATION

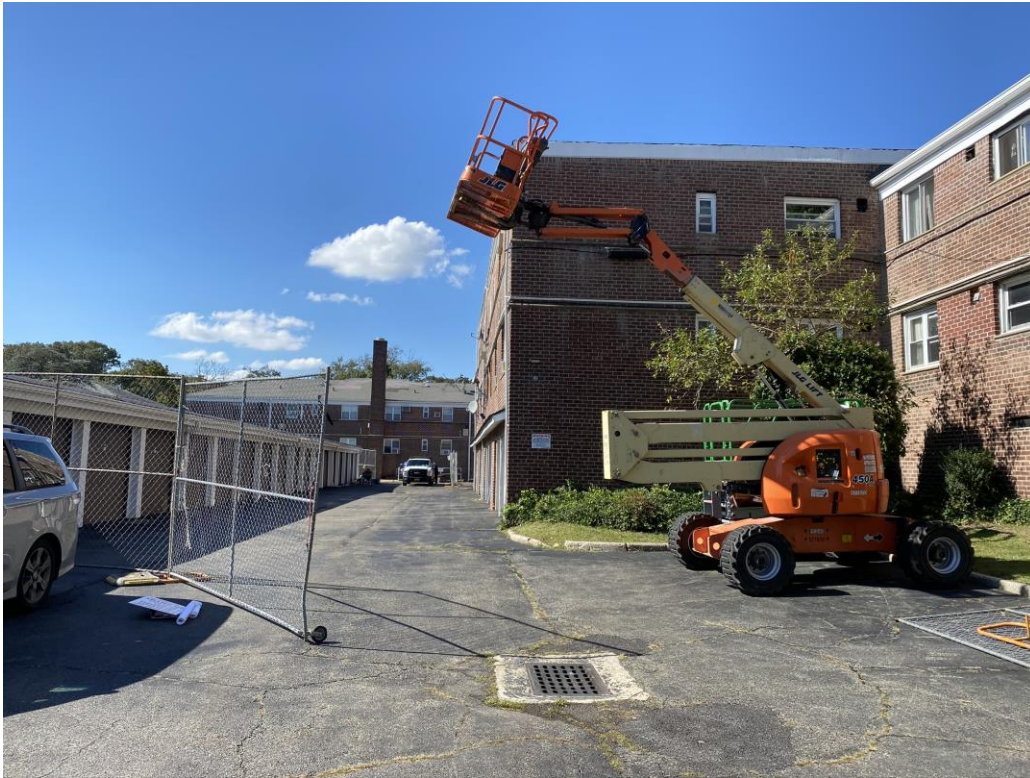
RESTORATION OF REAR WALL OF BUILDING No. 8

DURING RENOVATION
