COMPLETION OF 5-YEAR CAPITAL IMPROVEMENT PLAN

CAPITAL IMPROVEMENT PROGRAM (C.I.P.)

PHASING OF COMPLETED WORK:

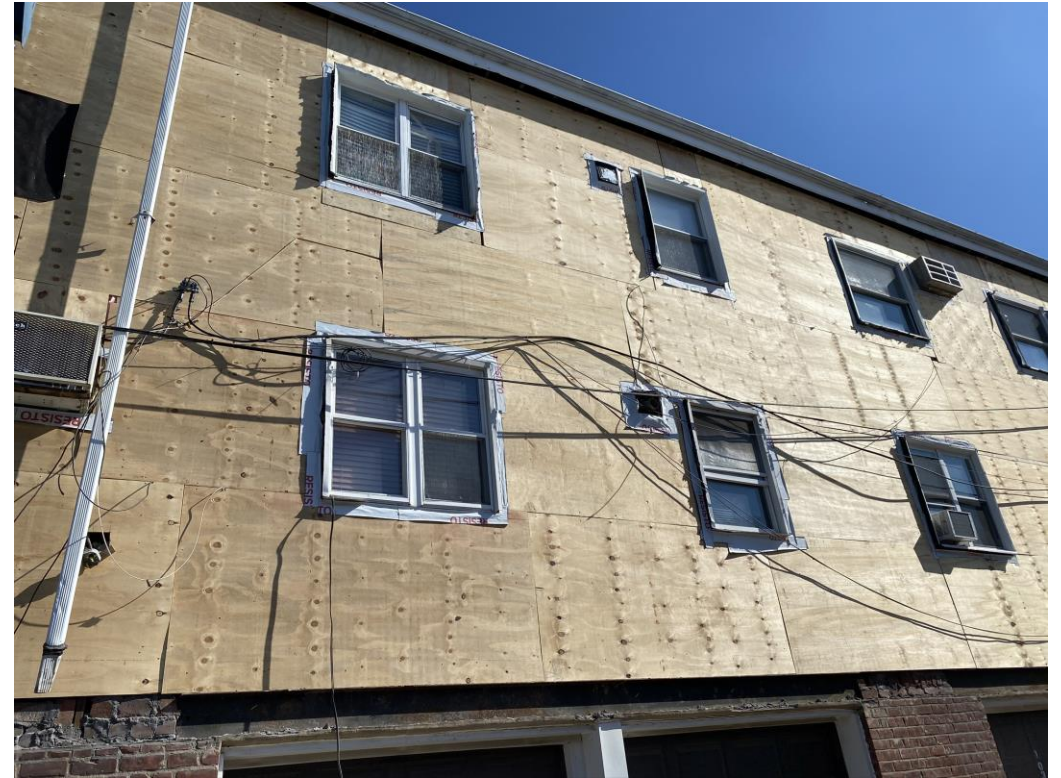
DURING RENOVATION

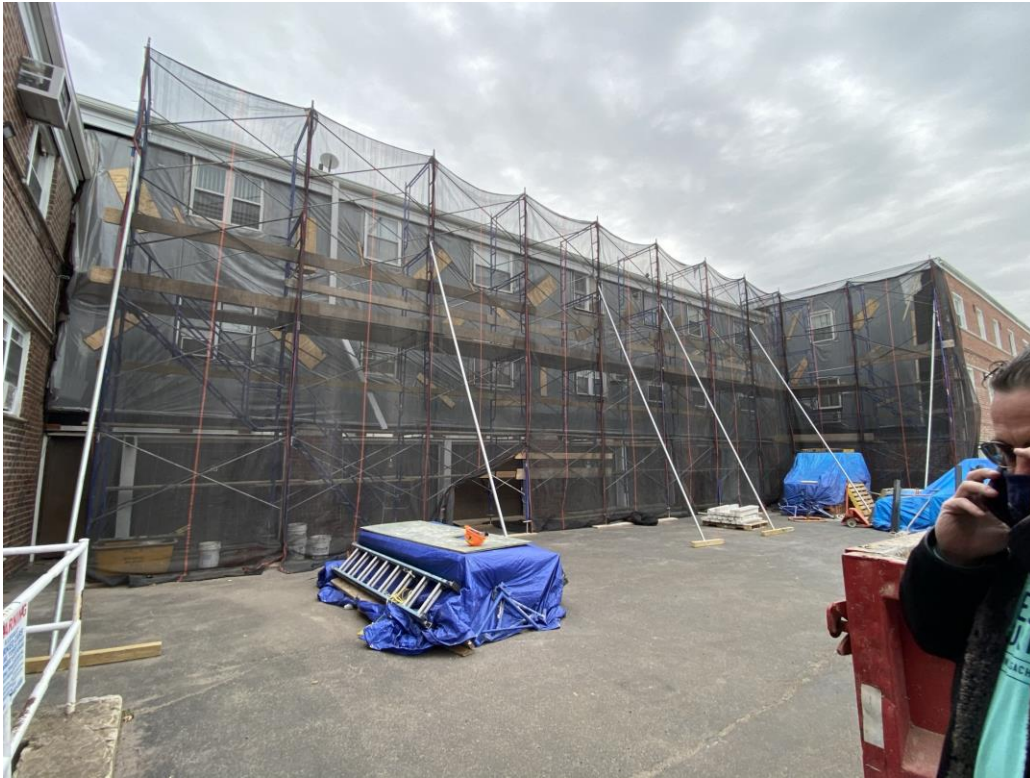
RESTORATION OF REAR WALL OF BUILDING No. 8

DURING RENOVATION

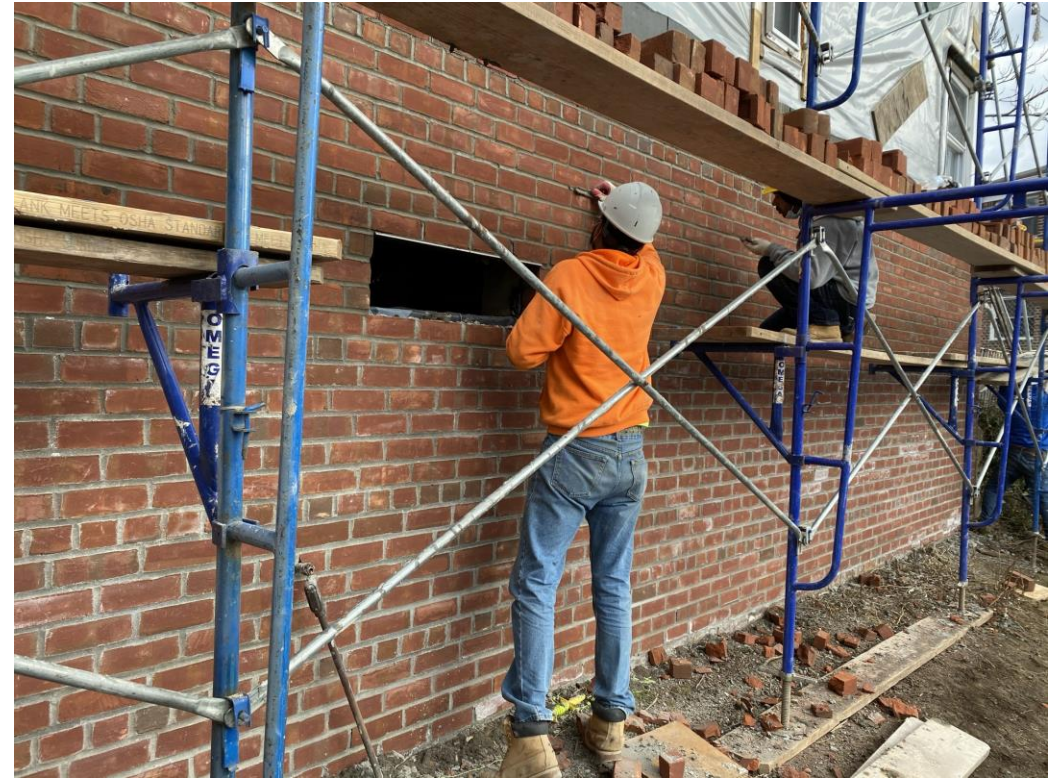
DURING RENOVATION

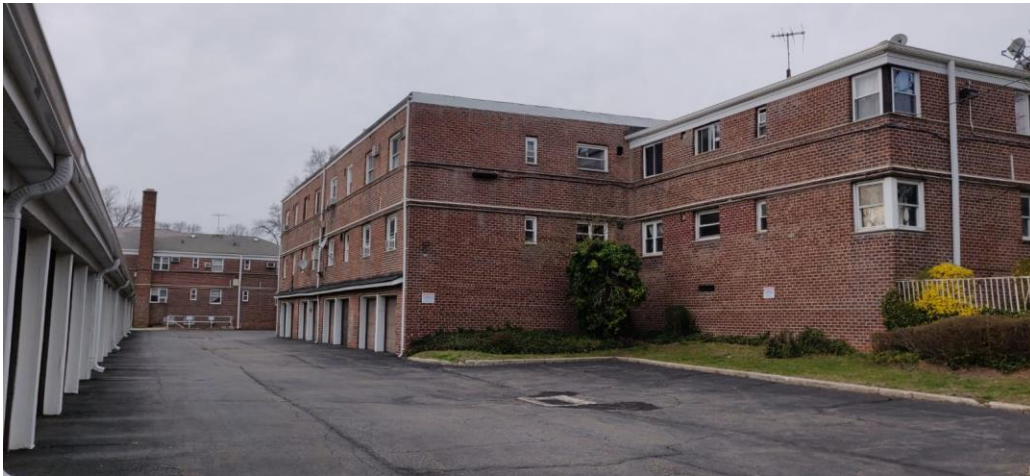
RESTORATION OF REAR WALL OF BUILDING No. 8

BEFORE

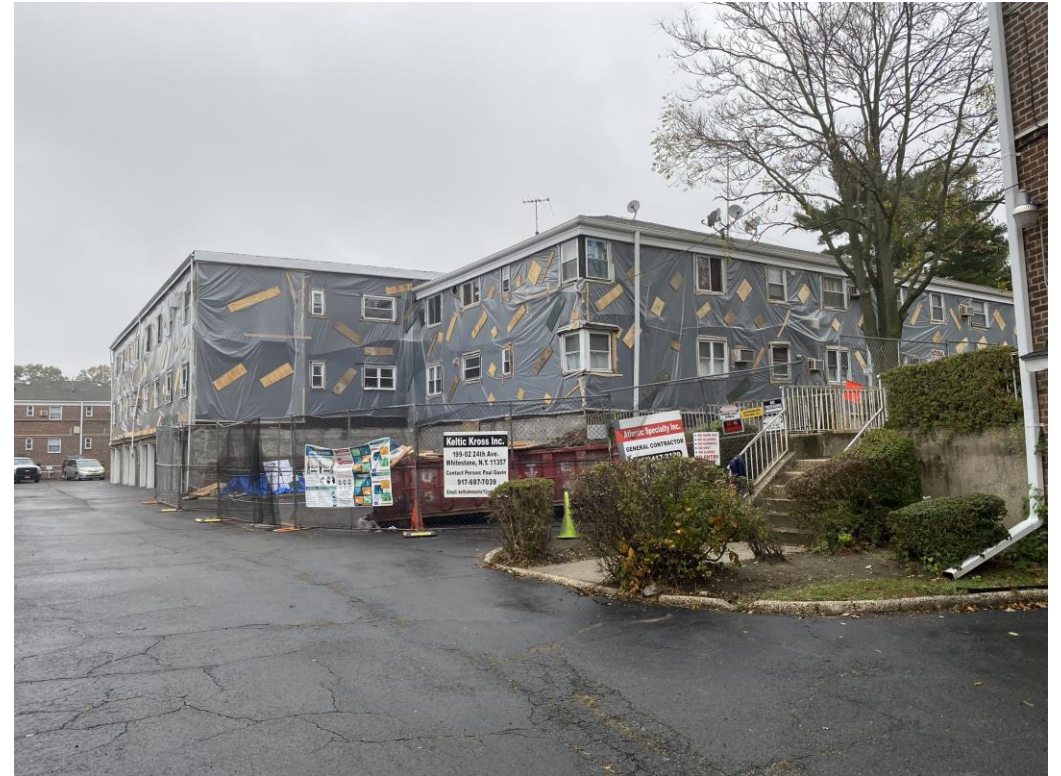
DURING RENOVATION

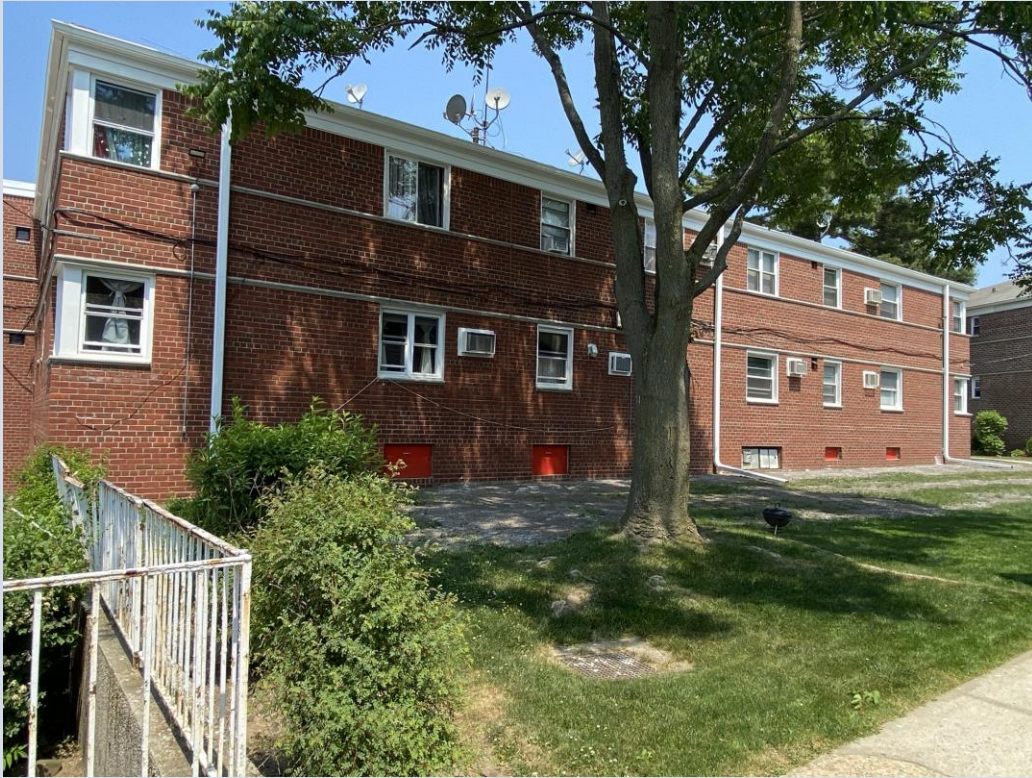
RESTORATION OF REAR WALL OF BUILDING No. 8

AFTER RENOVATION

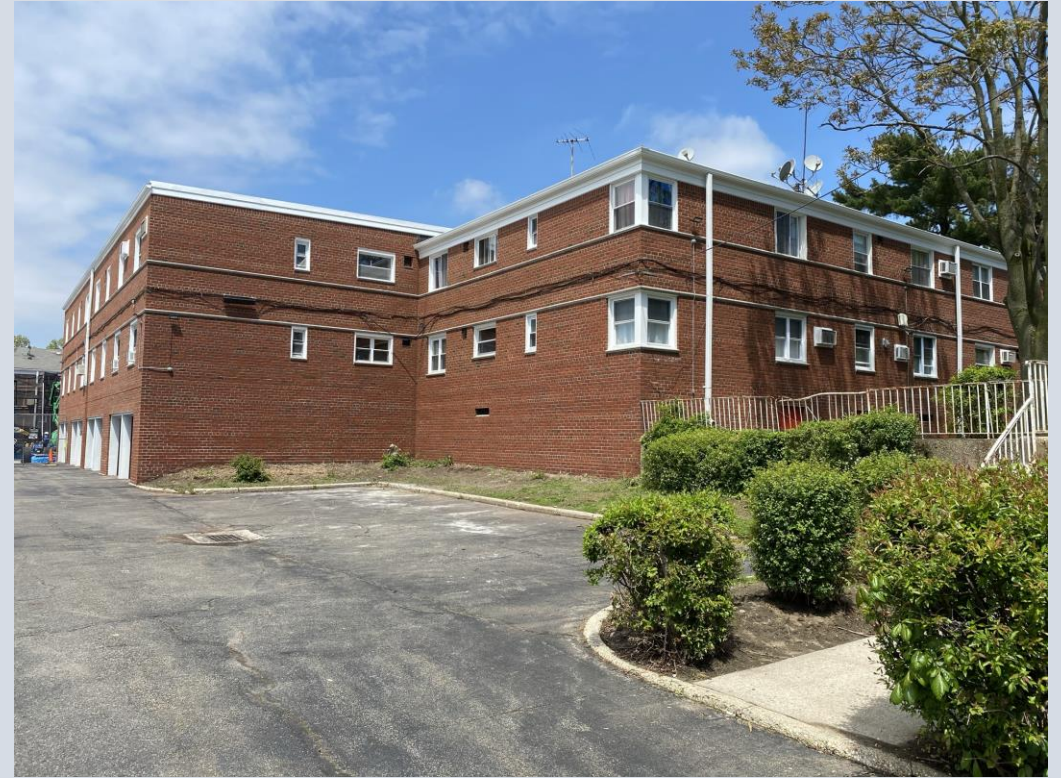
AFTER RENOVATION

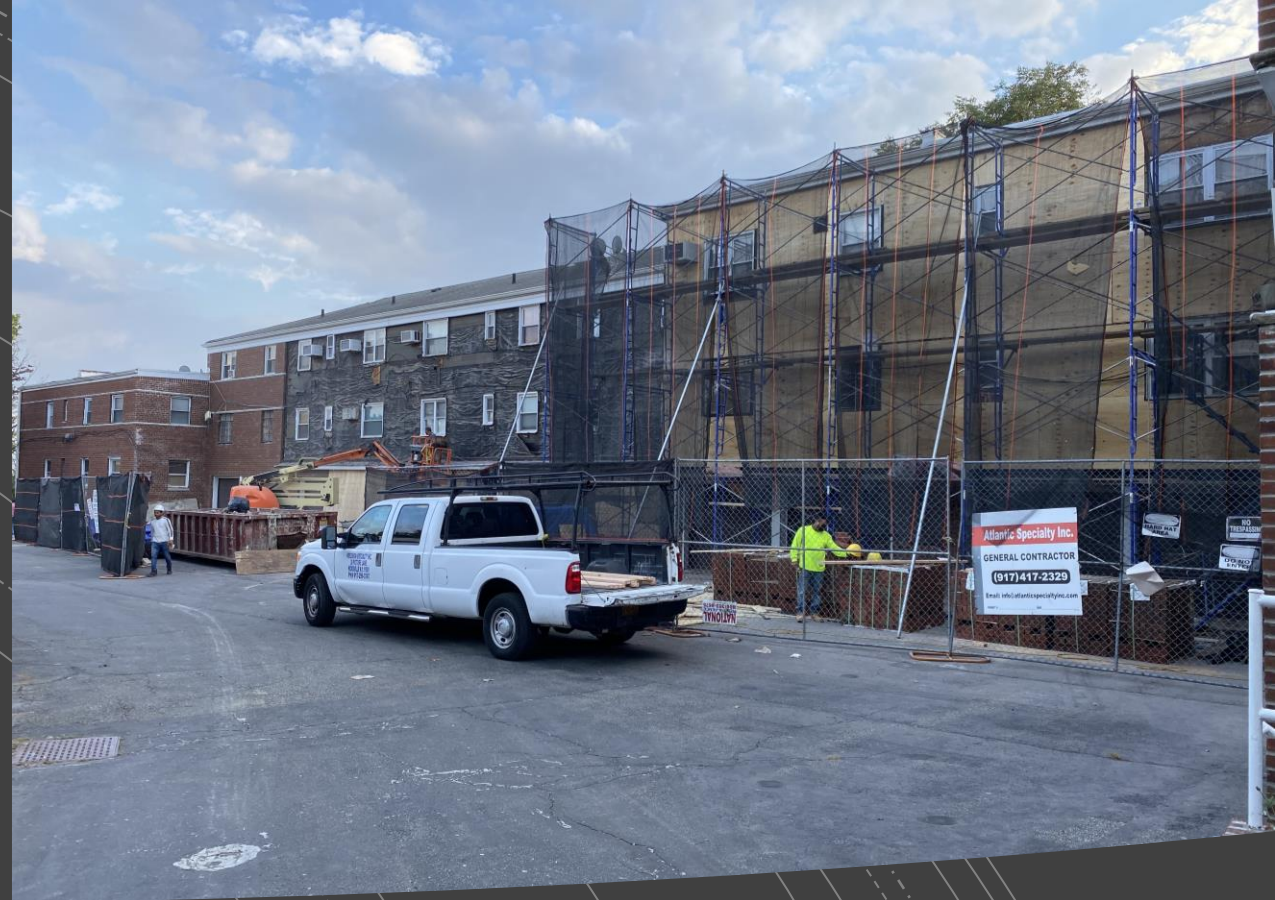
BUILDING-1

DURING RENOVATION

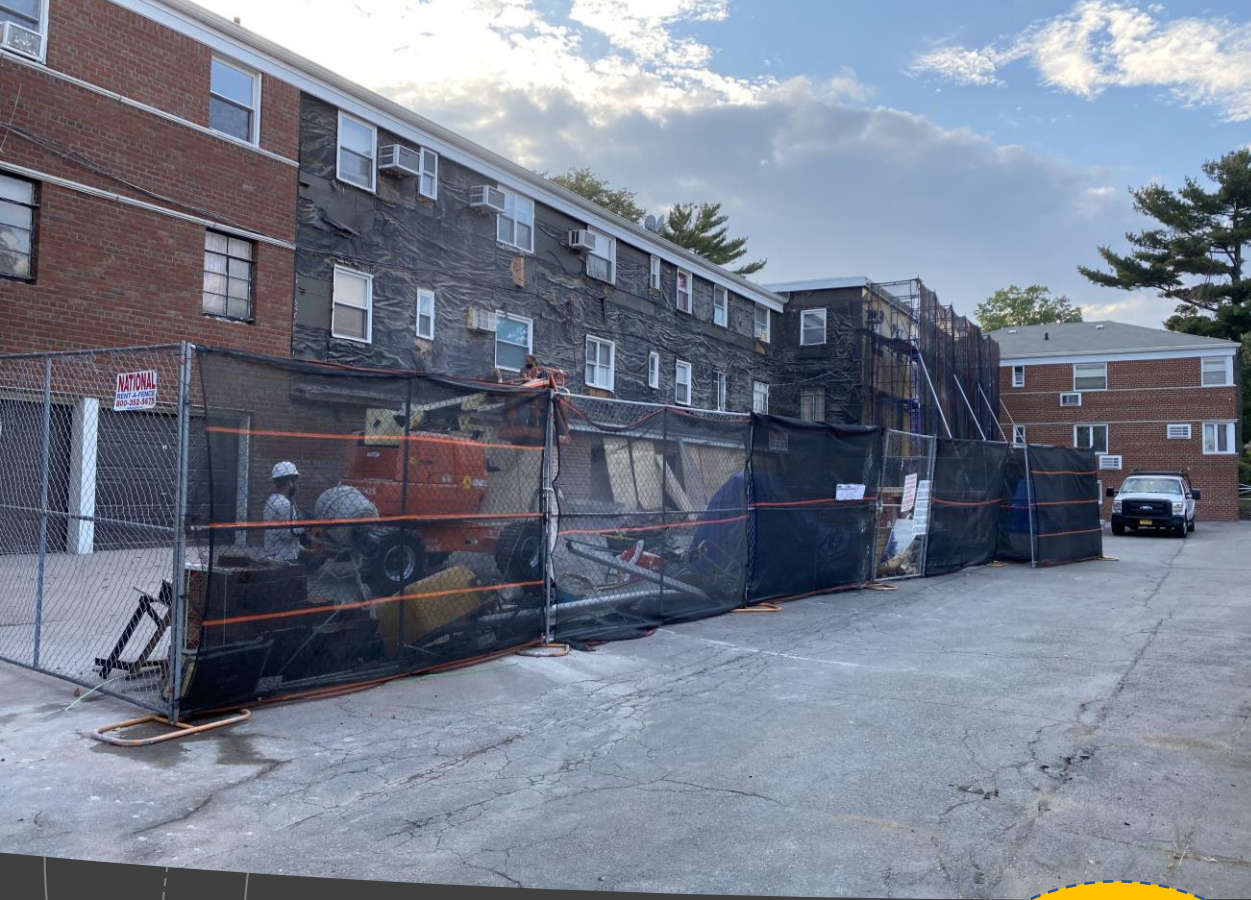
DURING RENOVATION

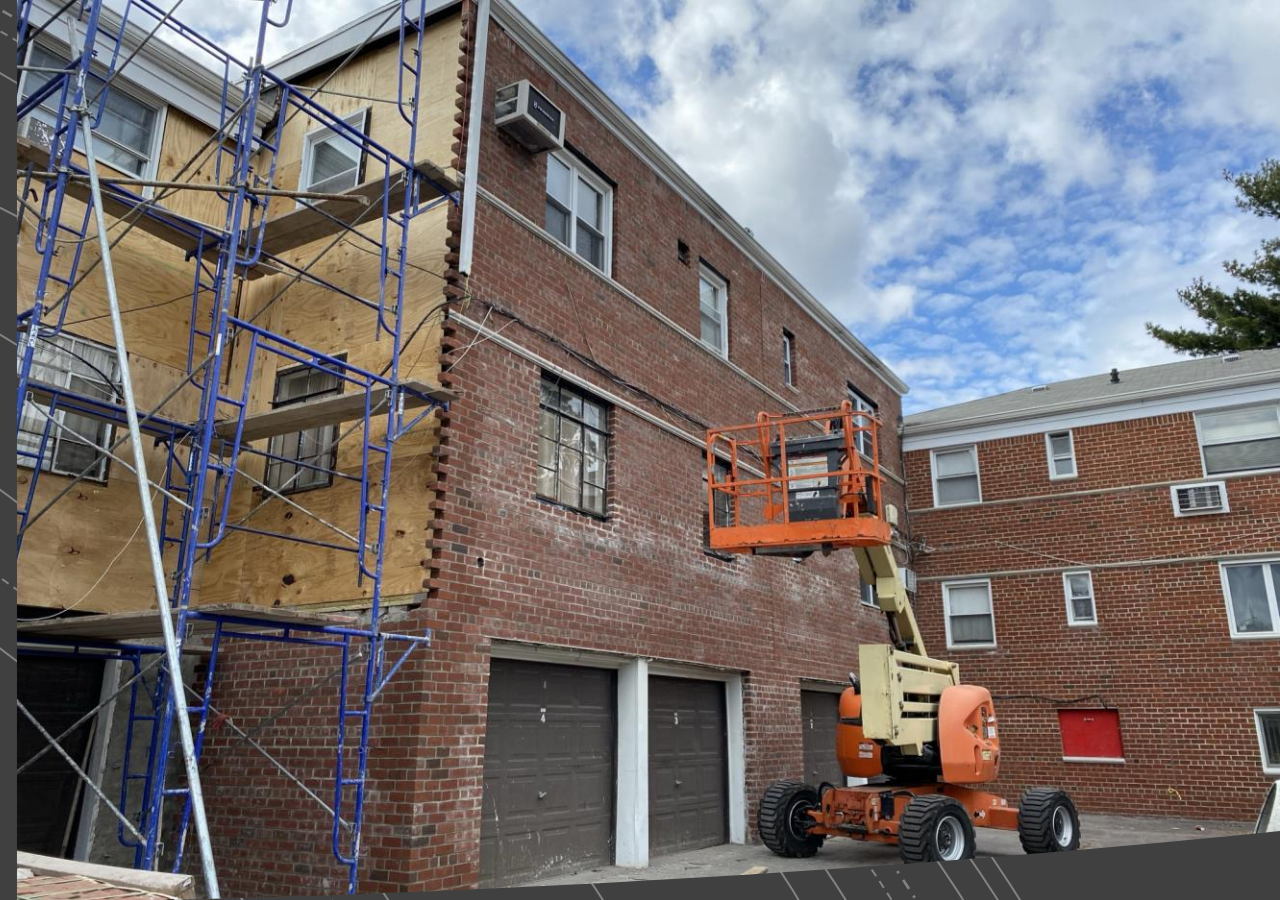
BUILDING-1

DURING RENOVATION

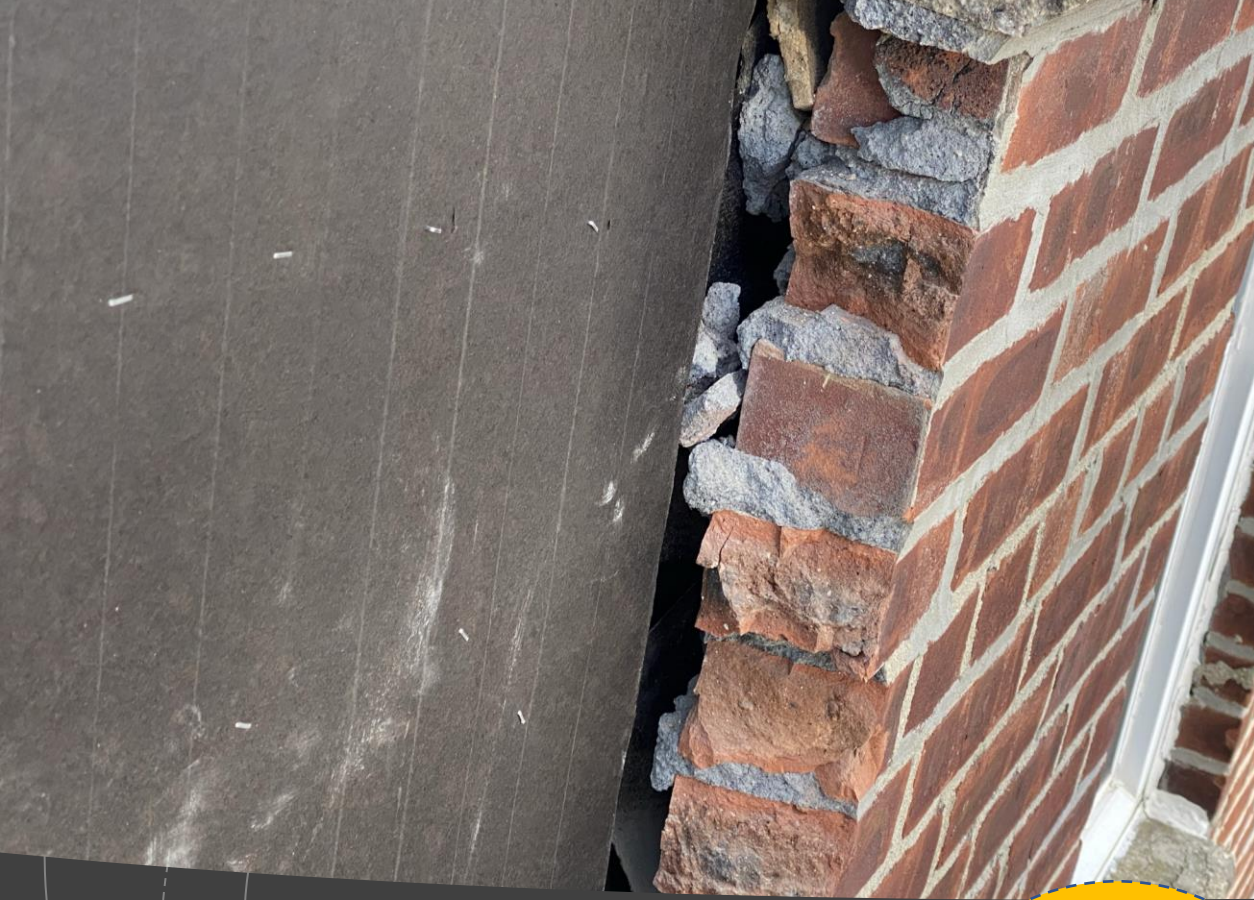
DURING RENOVATION

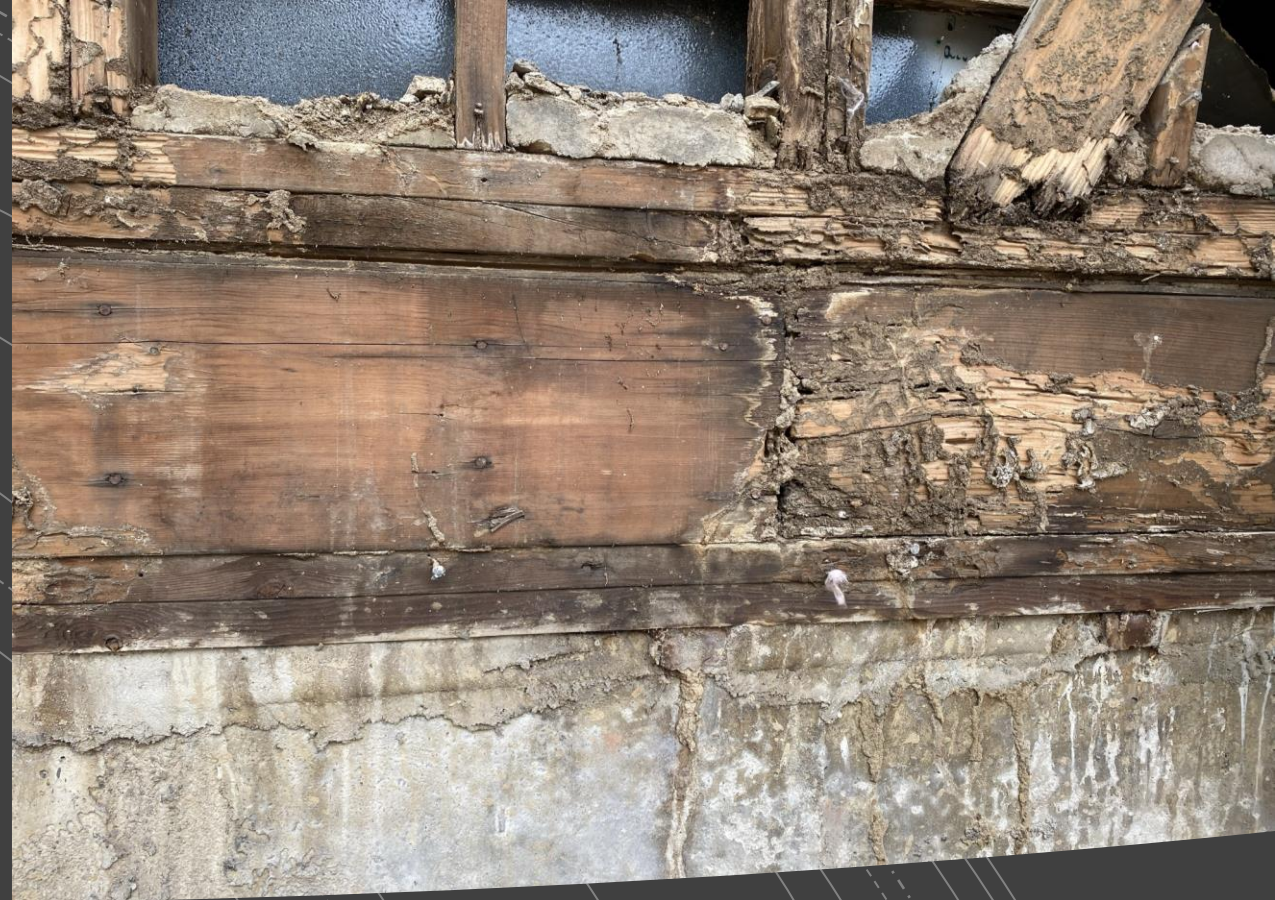
BUILDING-1

DURING RENOVATION

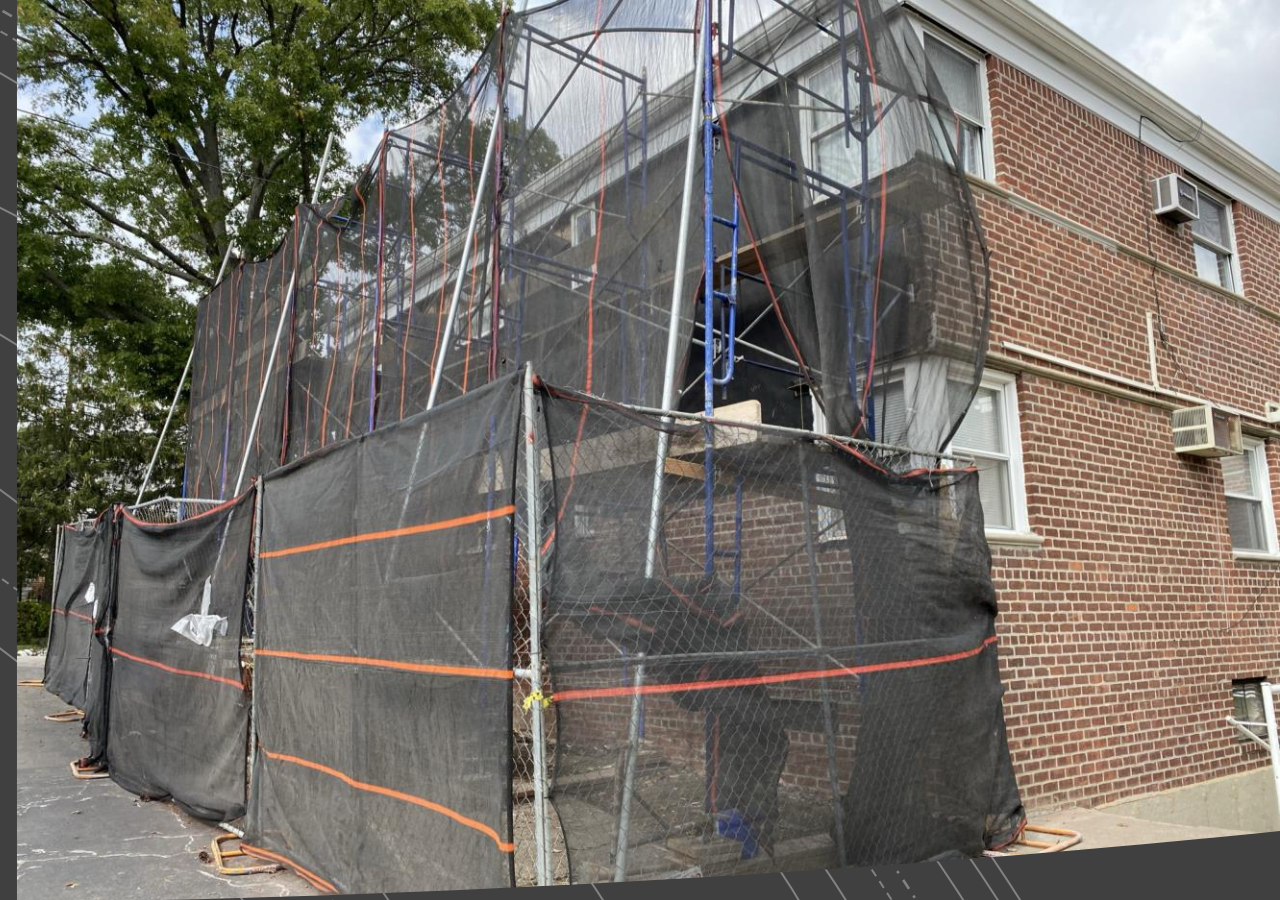
BUILDING-2

DURING RENOVATION

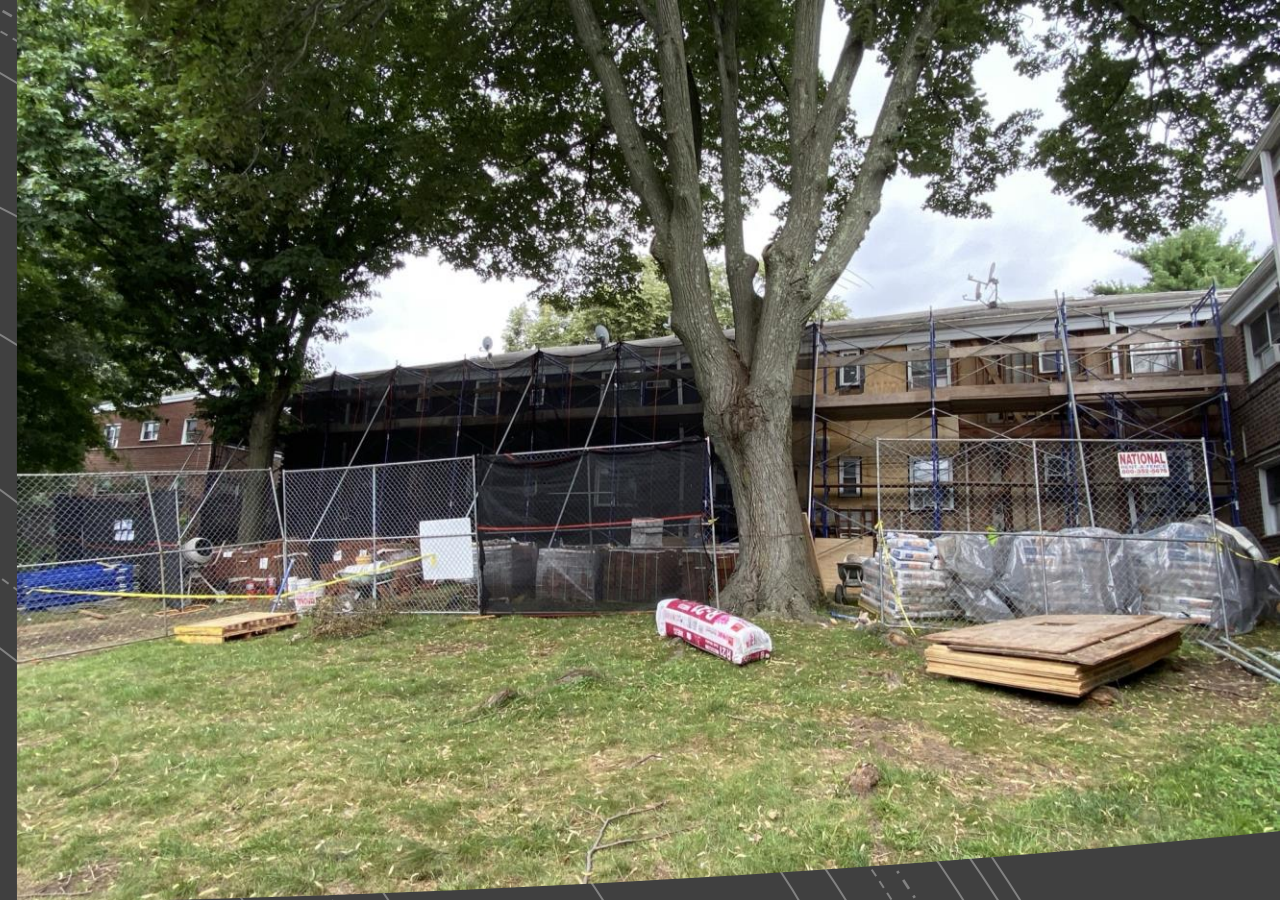
BUILDING-4

DURING RENOVATION

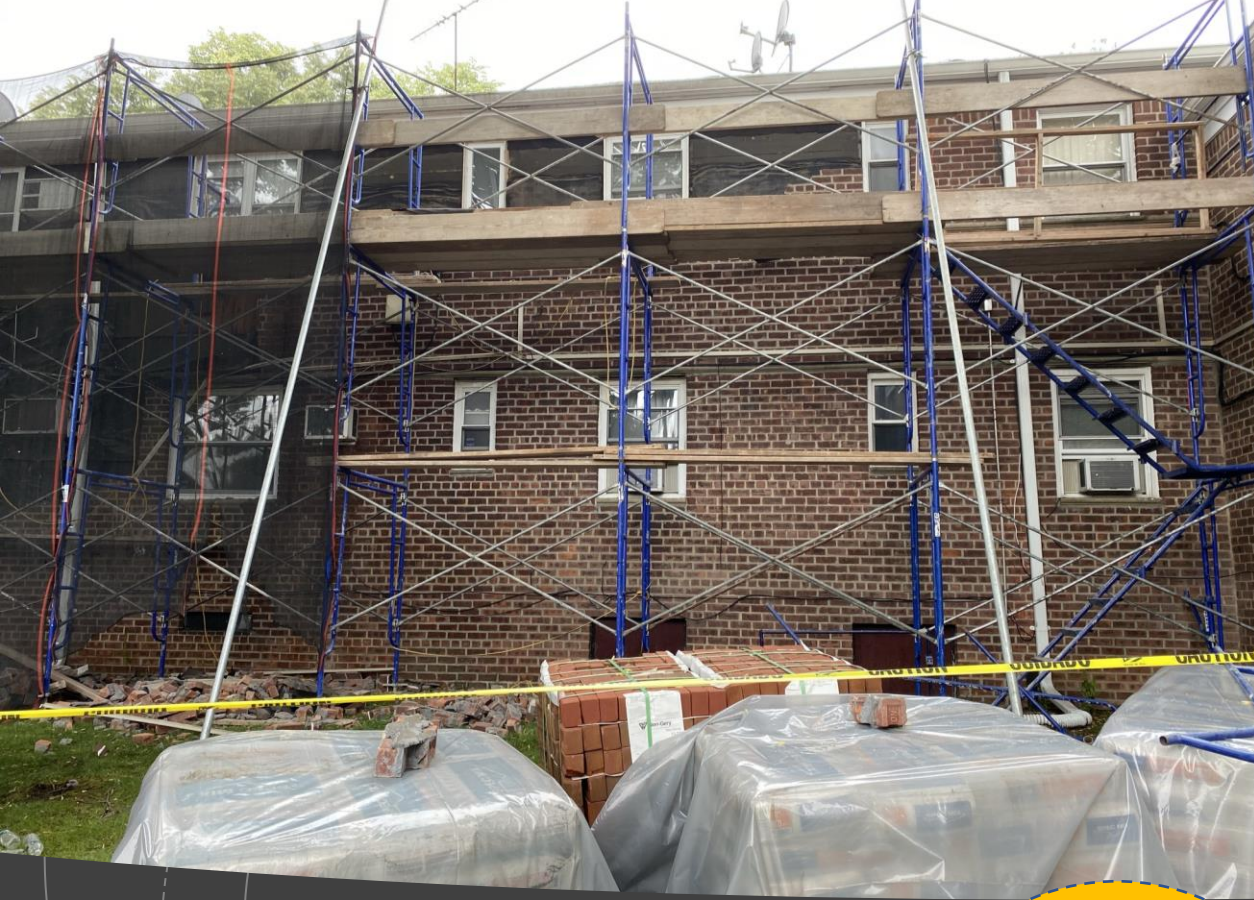
DURING RENOVATION

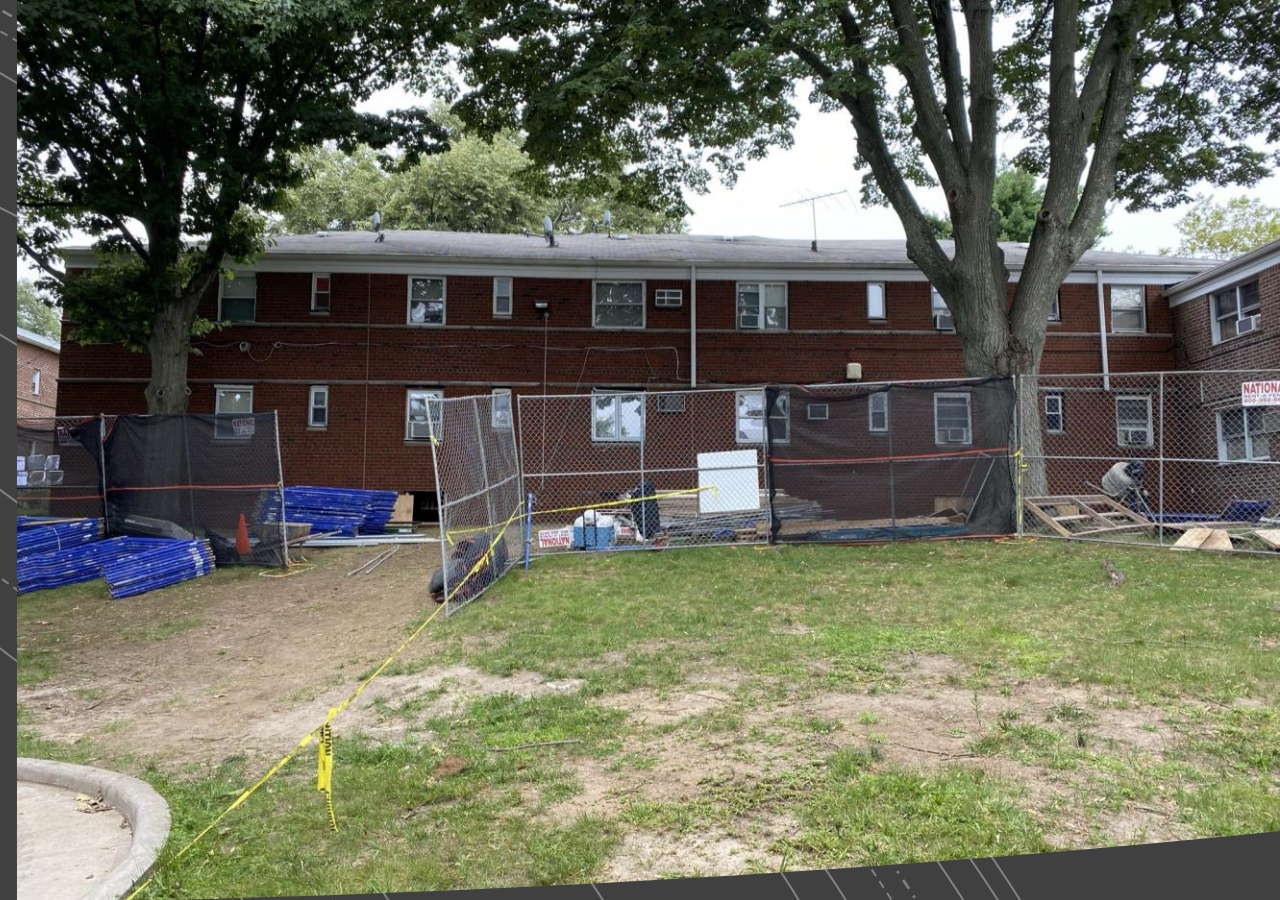
BUILDING-4

AFTER RENOVATION

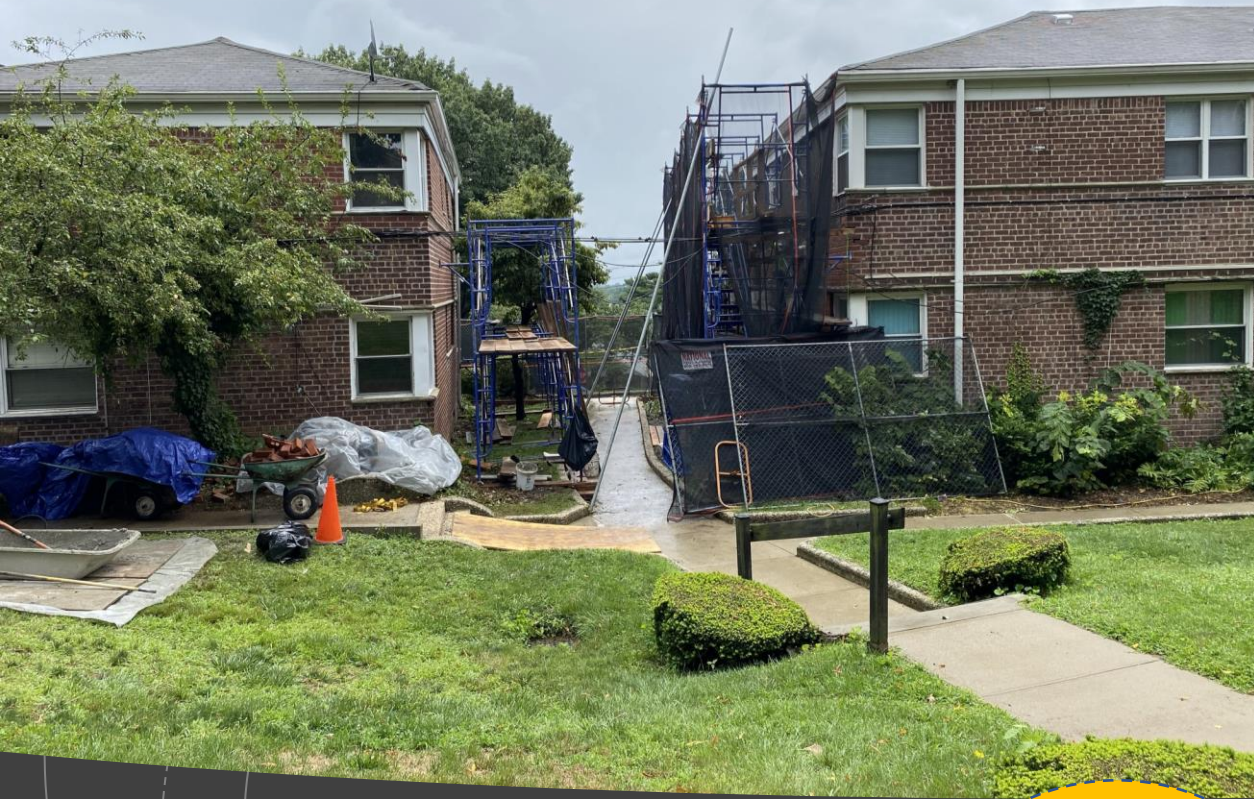
DURING RENOVATION

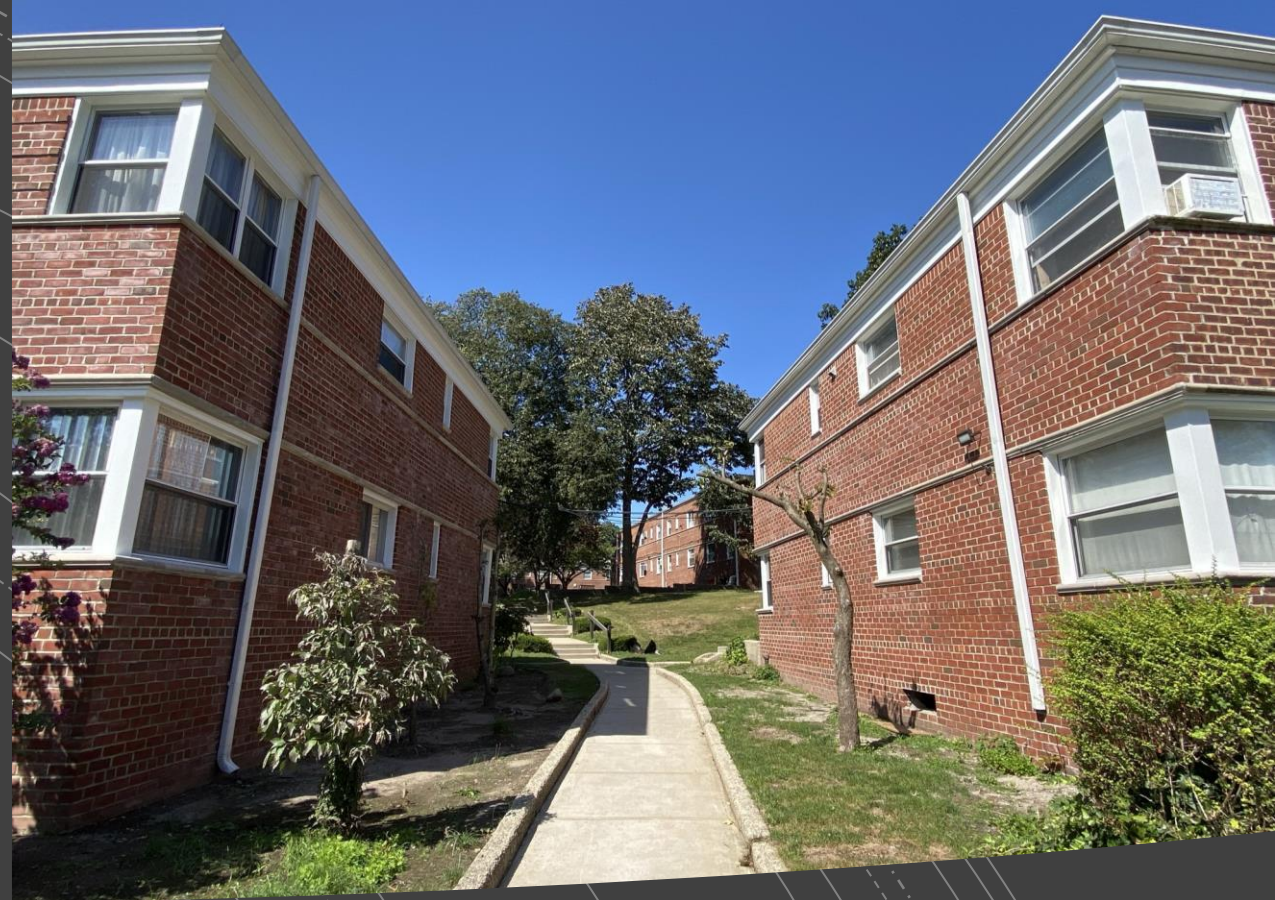
**BUILDING-
5 & 6**

AFTER RENOVATION

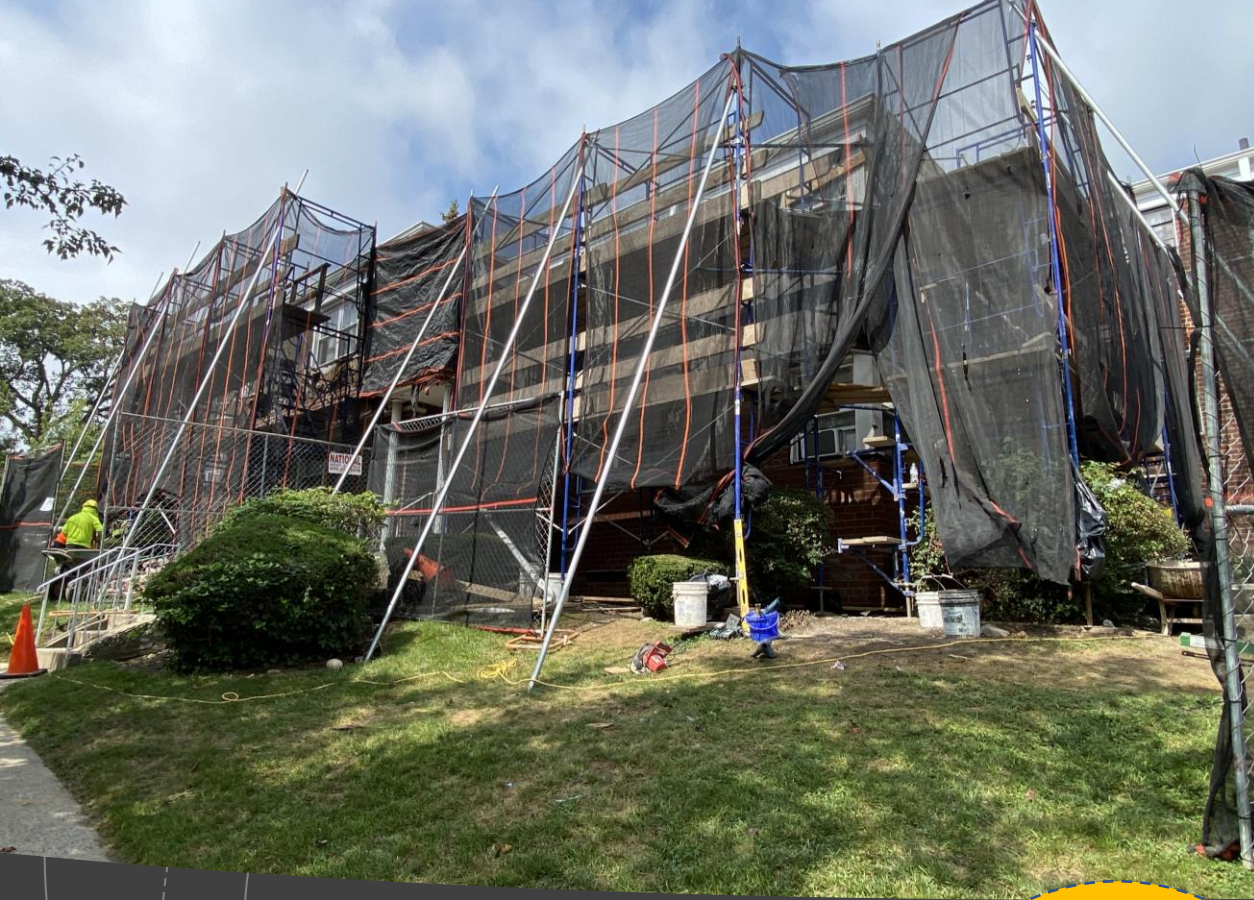
BUILDING-6

DURING RENOVATION

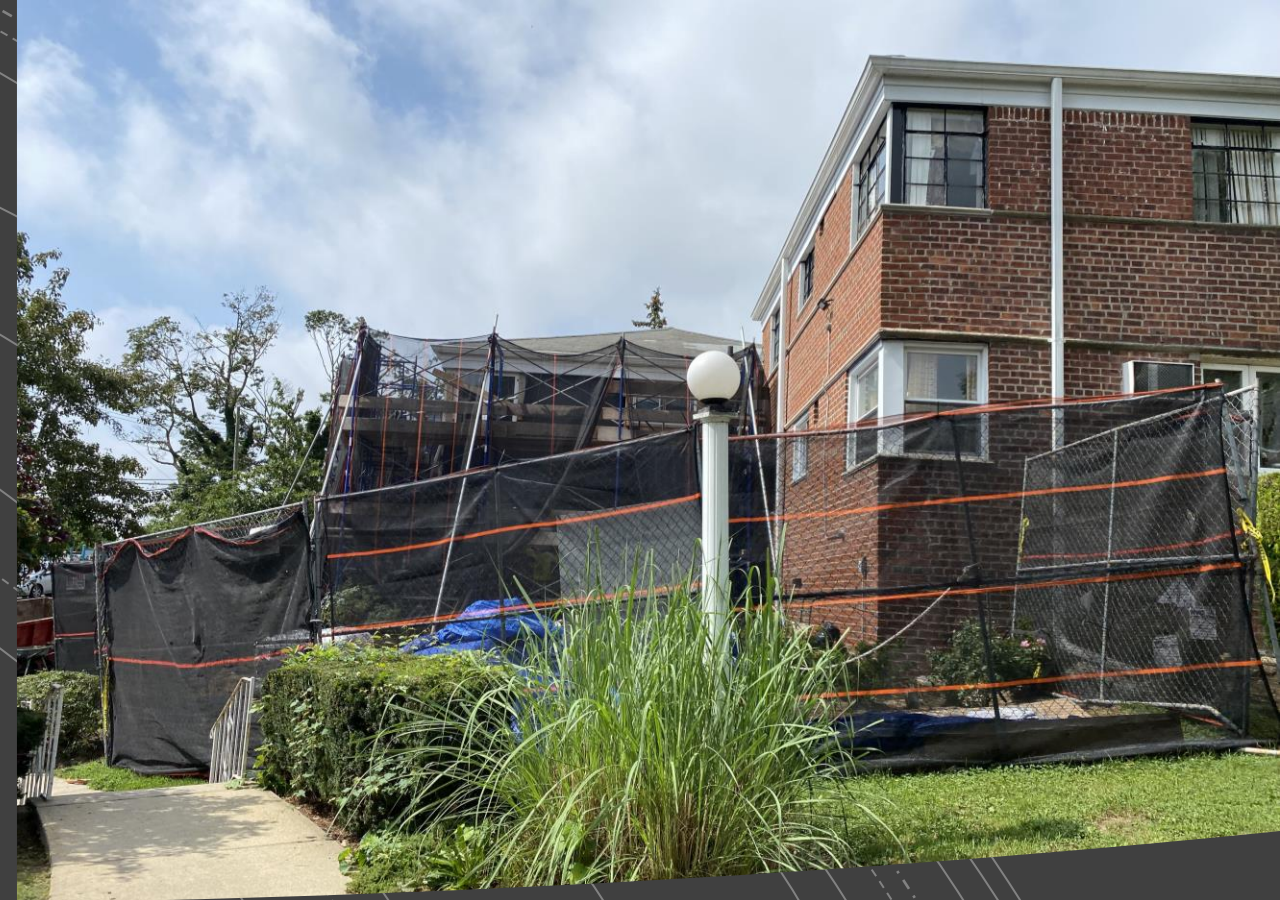
DURING RENOVATION

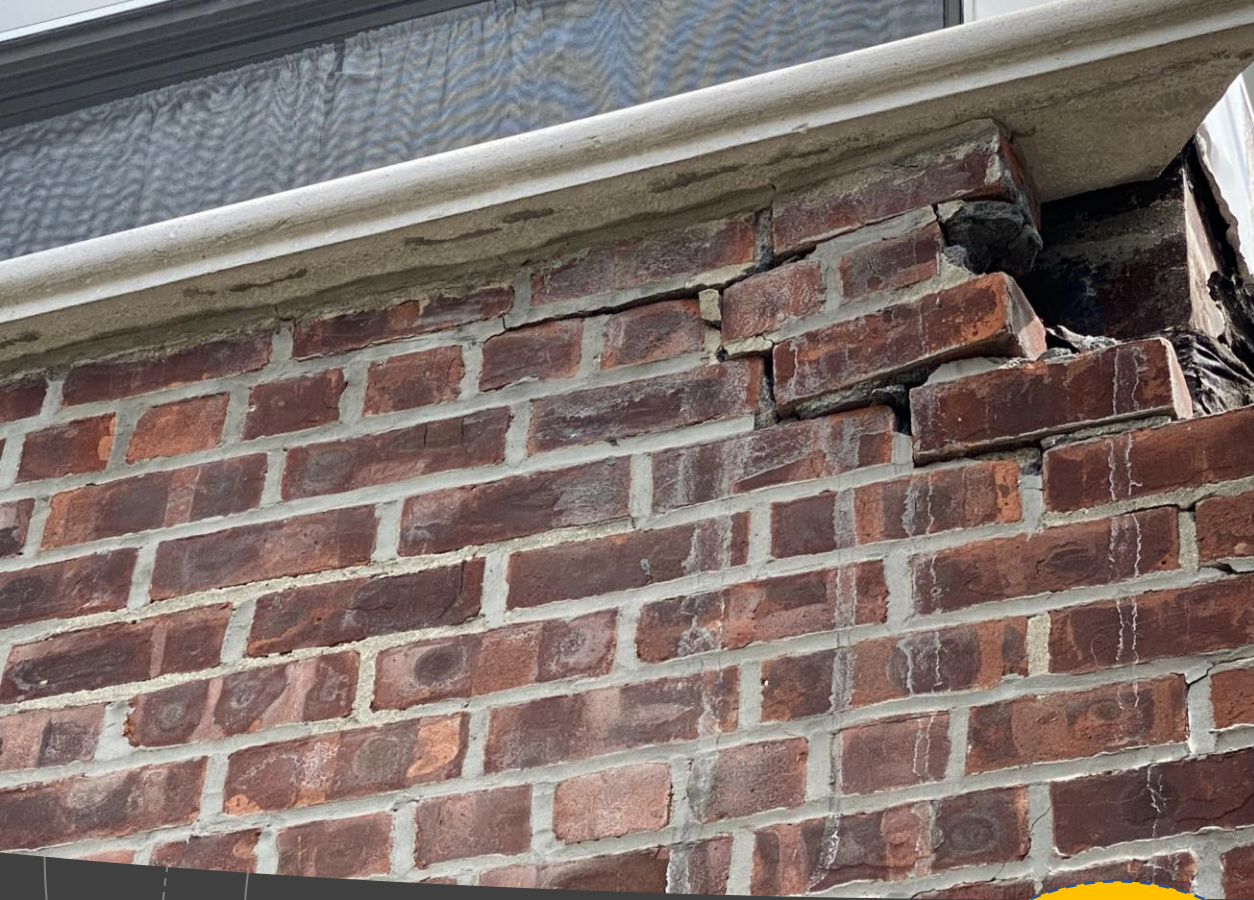
BUILDING-6

DURING RENOVATION

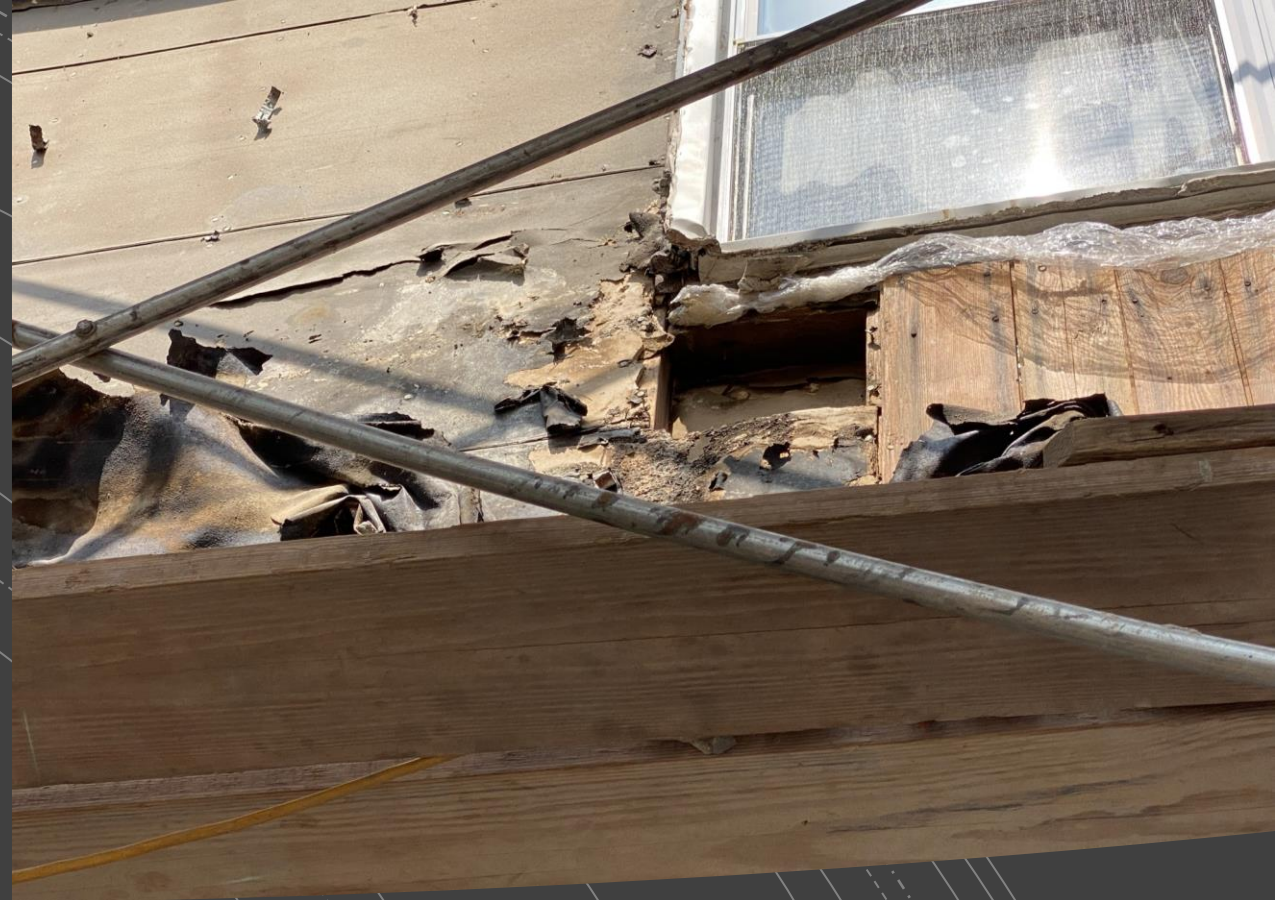
DURING RENOVATION
