COMPLETION OF 5-YEAR CAPITAL IMPROVEMENT PLAN

CAPITAL IMPROVEMENT PROGRAM (C.I.P.)

PHASING OF COMPLETED WORK:

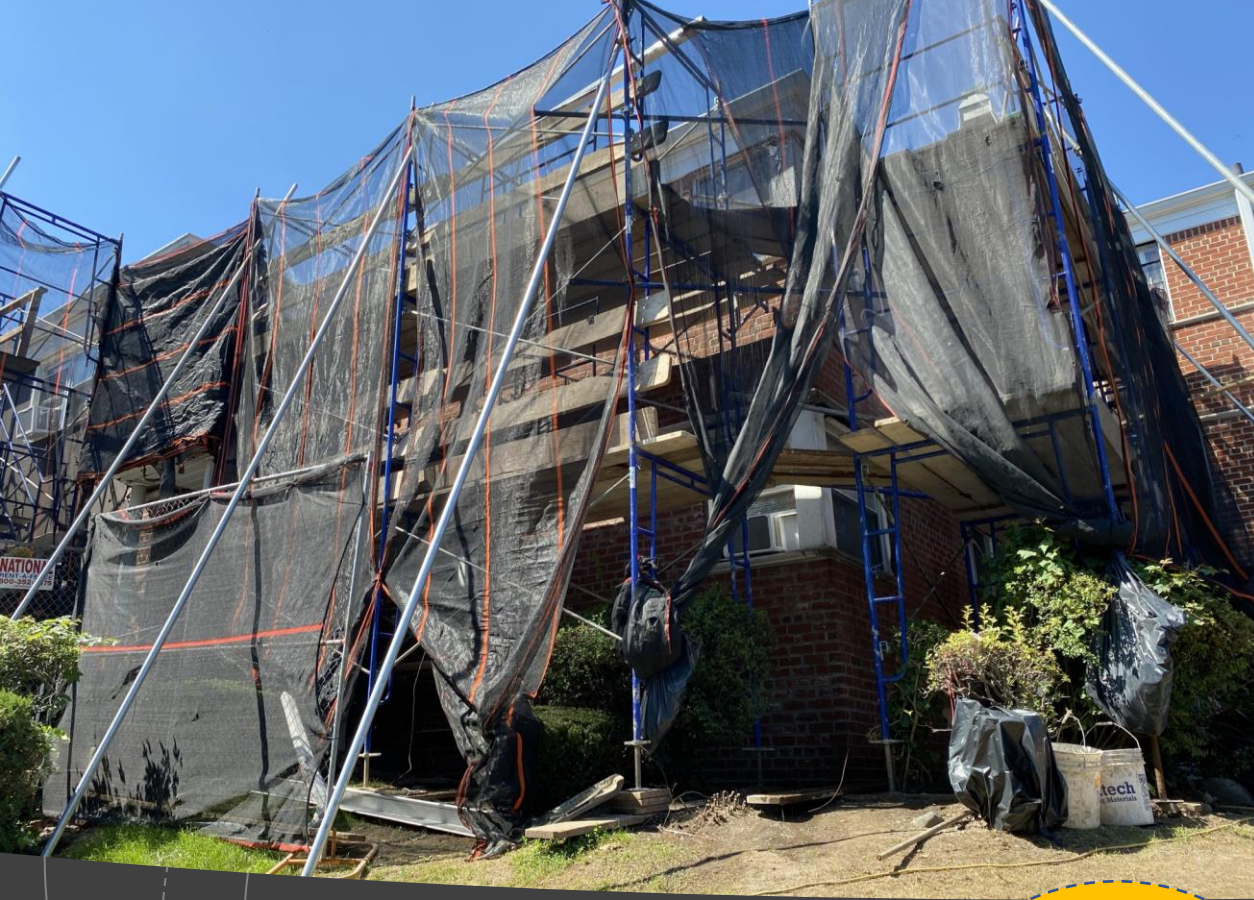
BUILDING-6

DURING RENOVATION

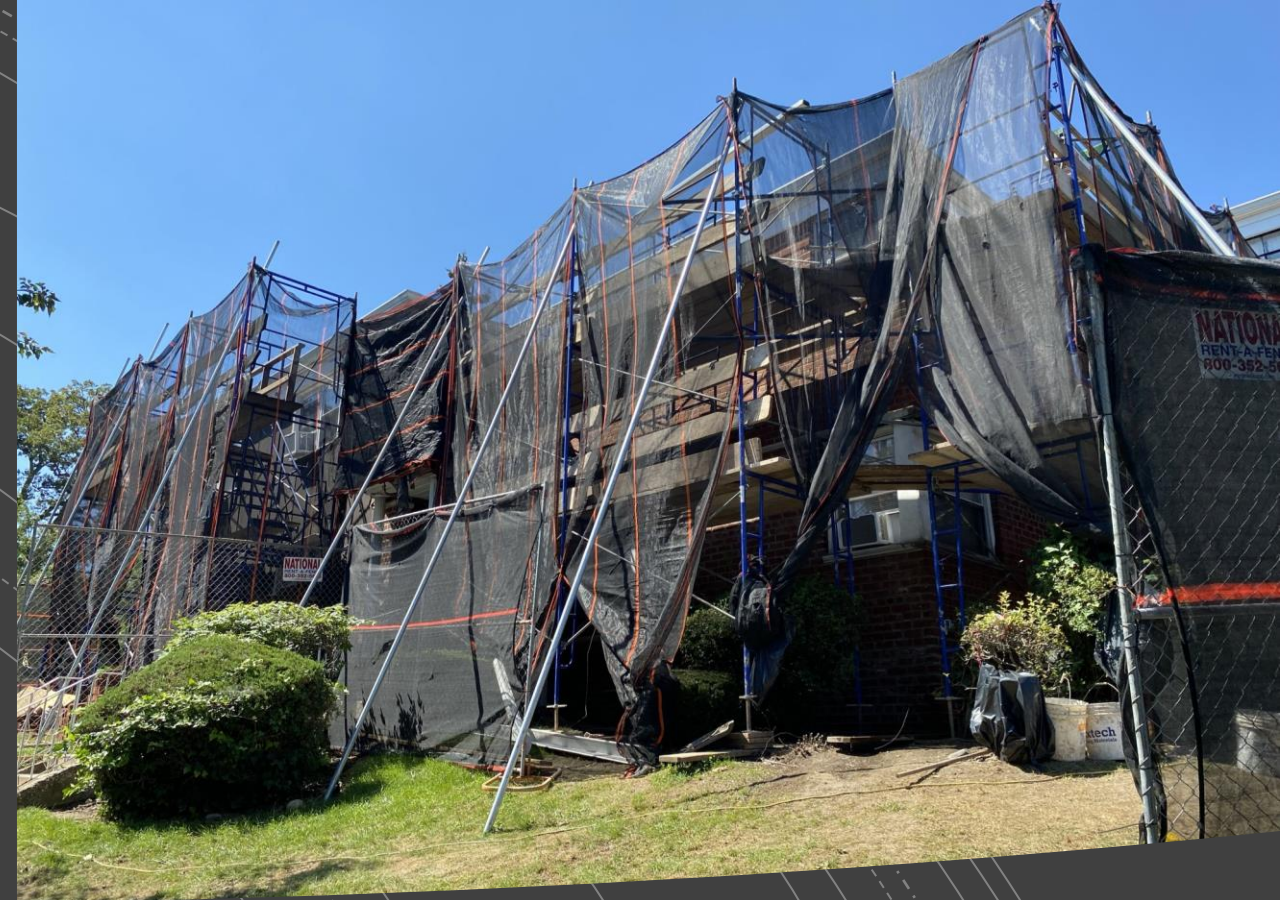
DURING RENOVATION

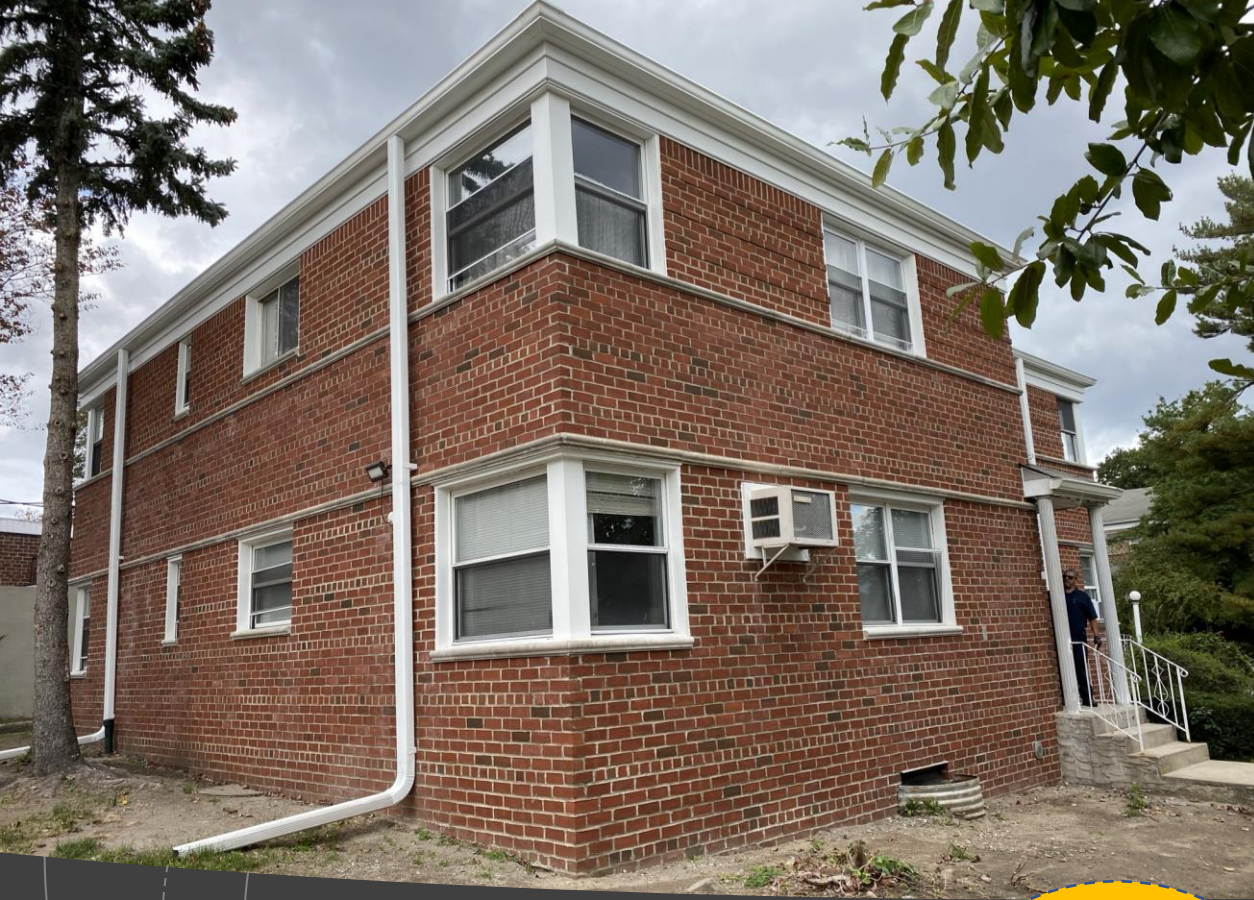
BUILDING-6

AFTER RENOVATION

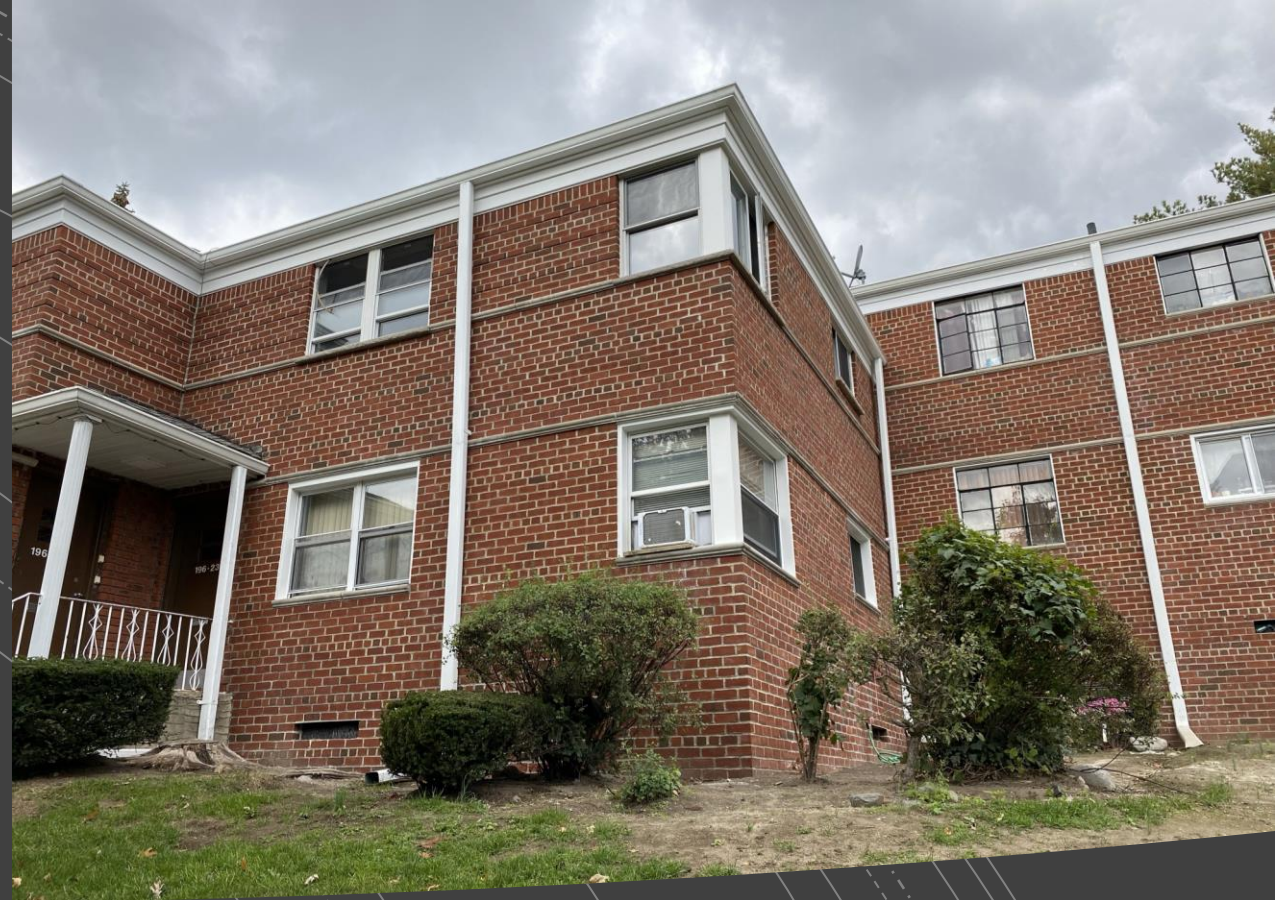
AFTER RENOVATION

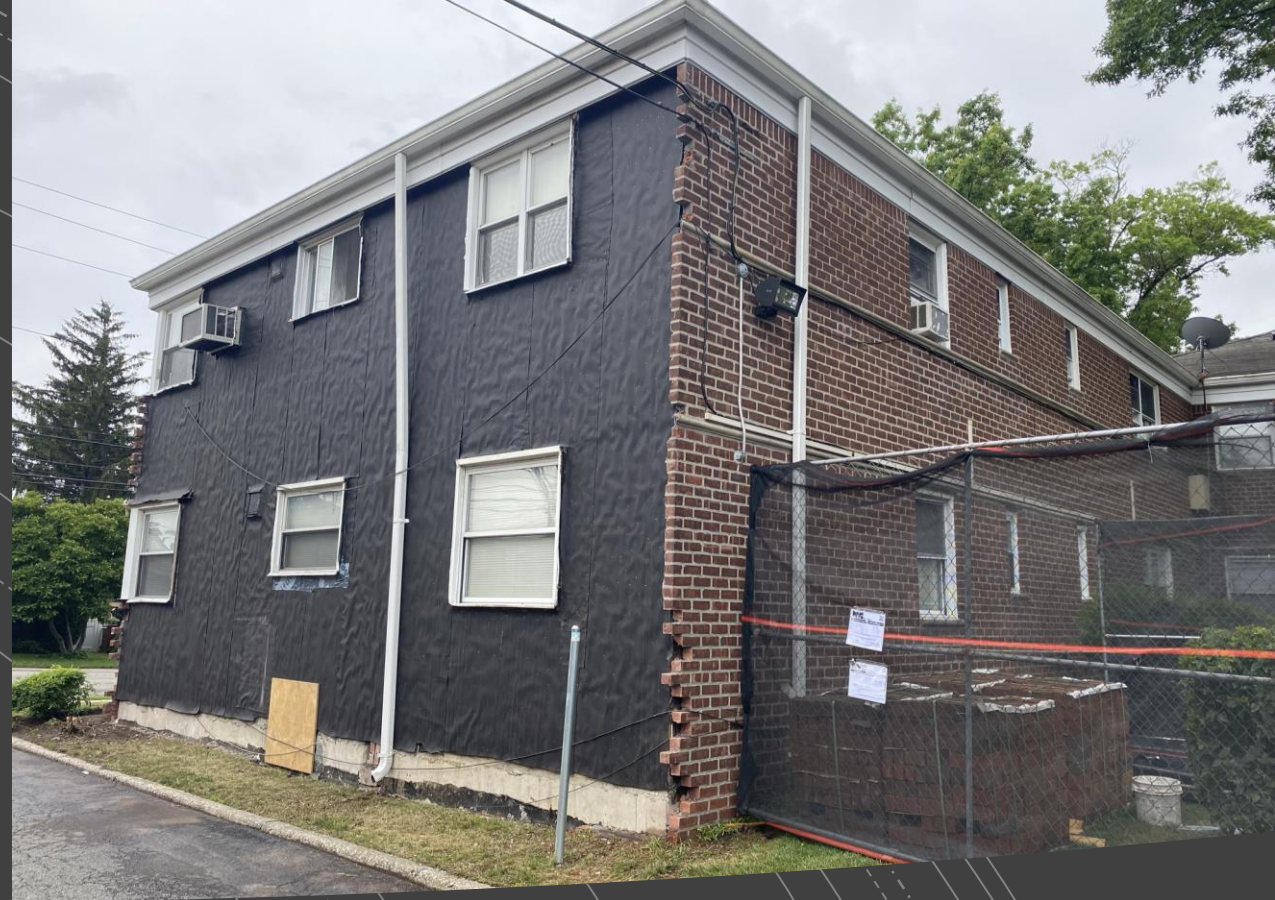
BUILDING-7

DURING RENOVATION

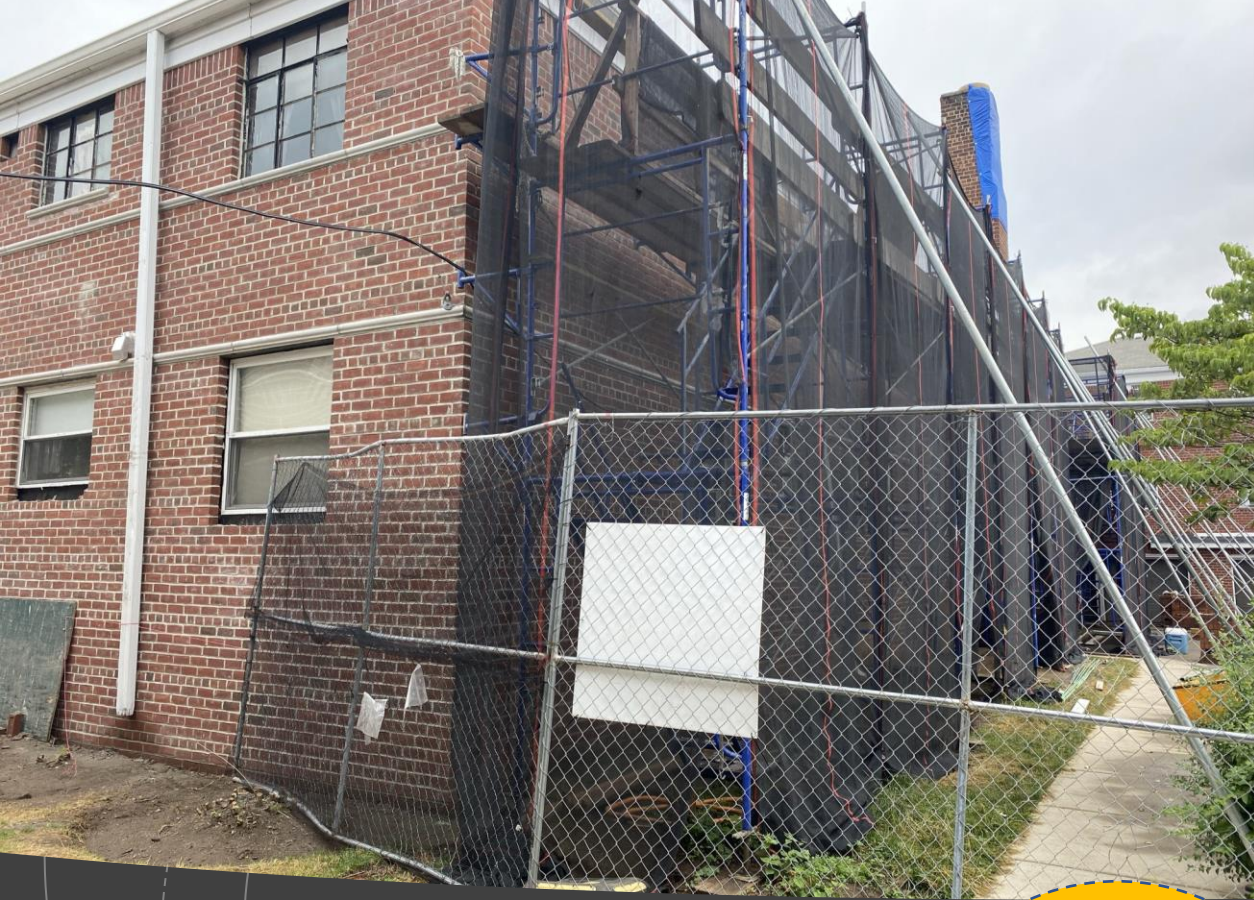
BUILDING-7

DURING RENOVATION

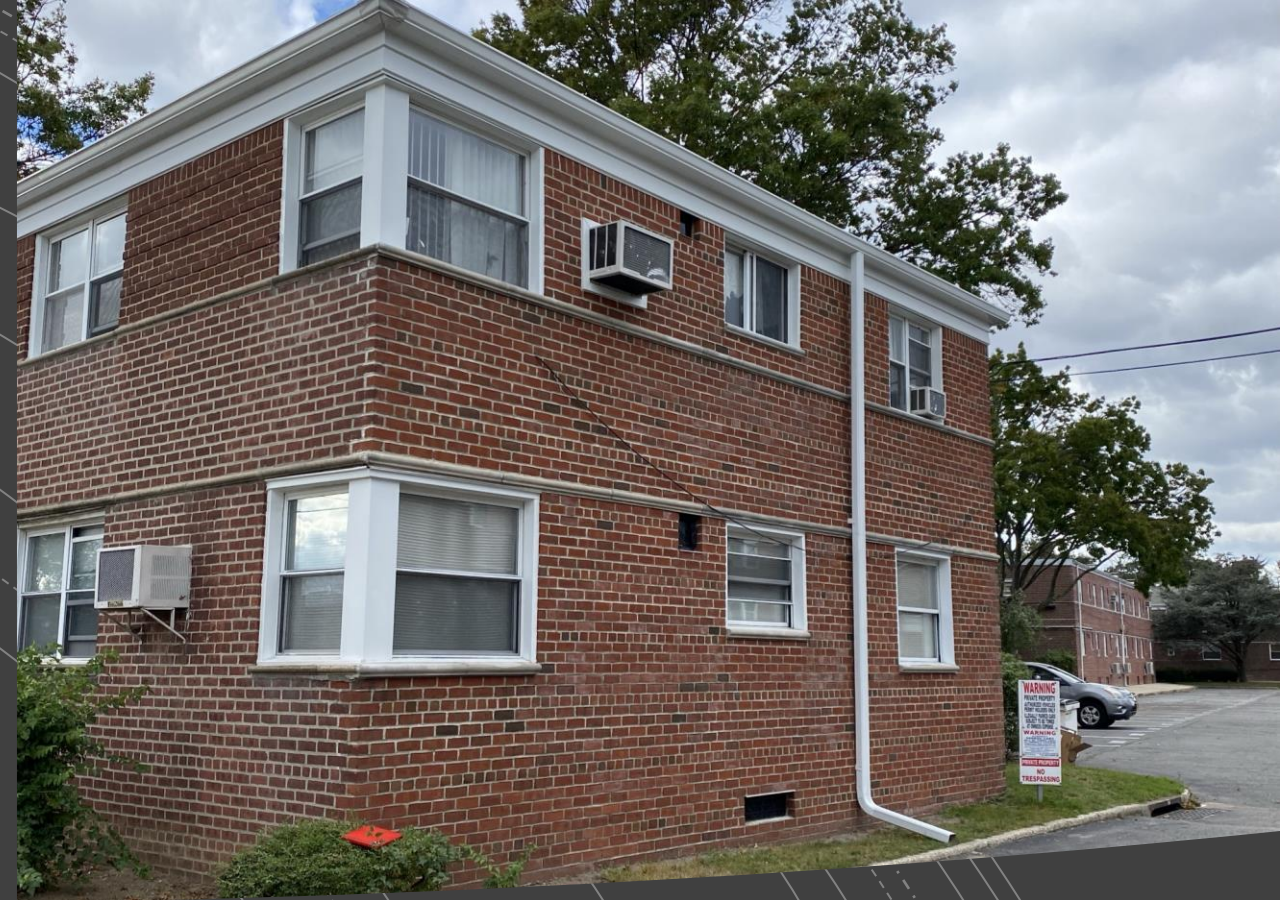
AFTER RENOVATION

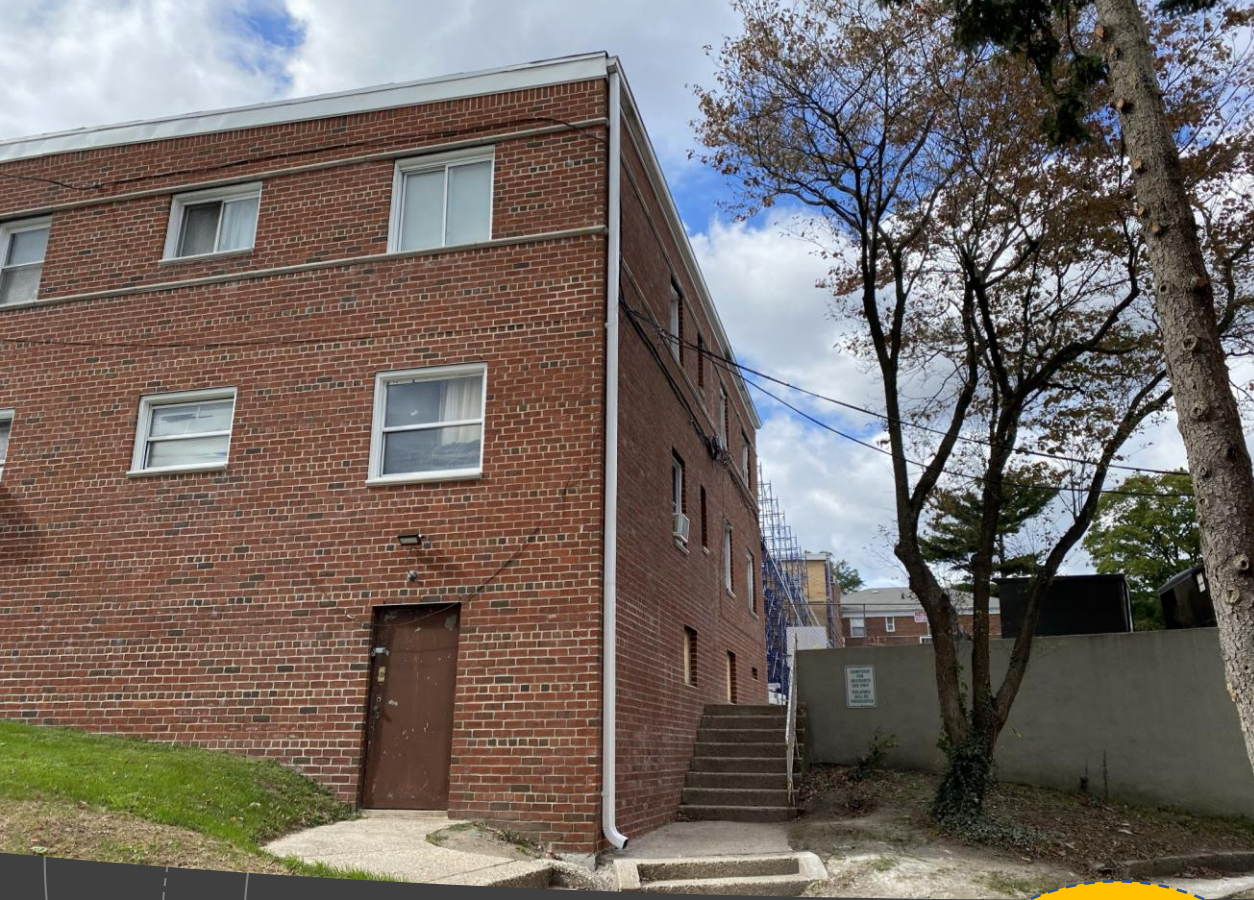
BUILDING-1

AFTER RENOVATION

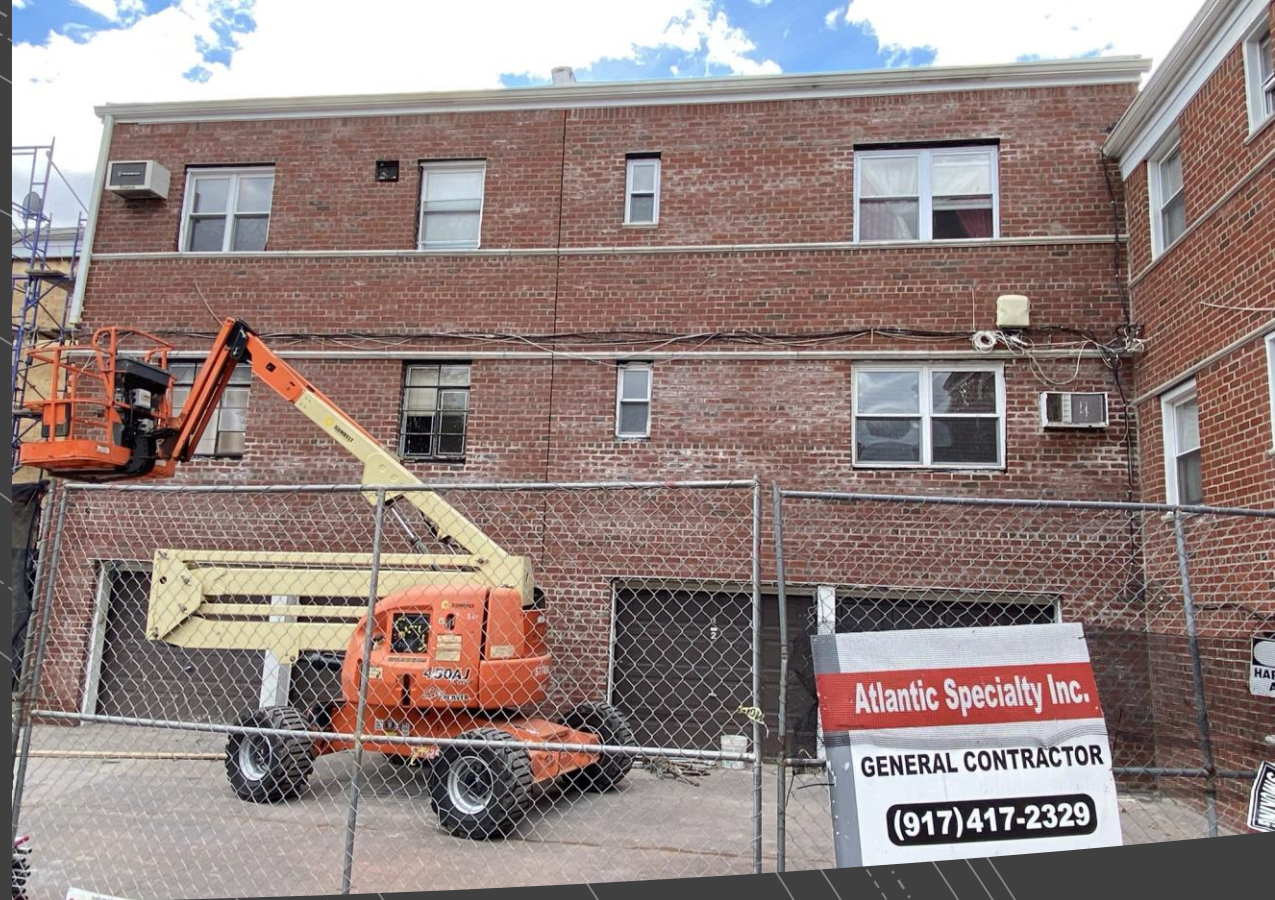
AFTER RENOVATION

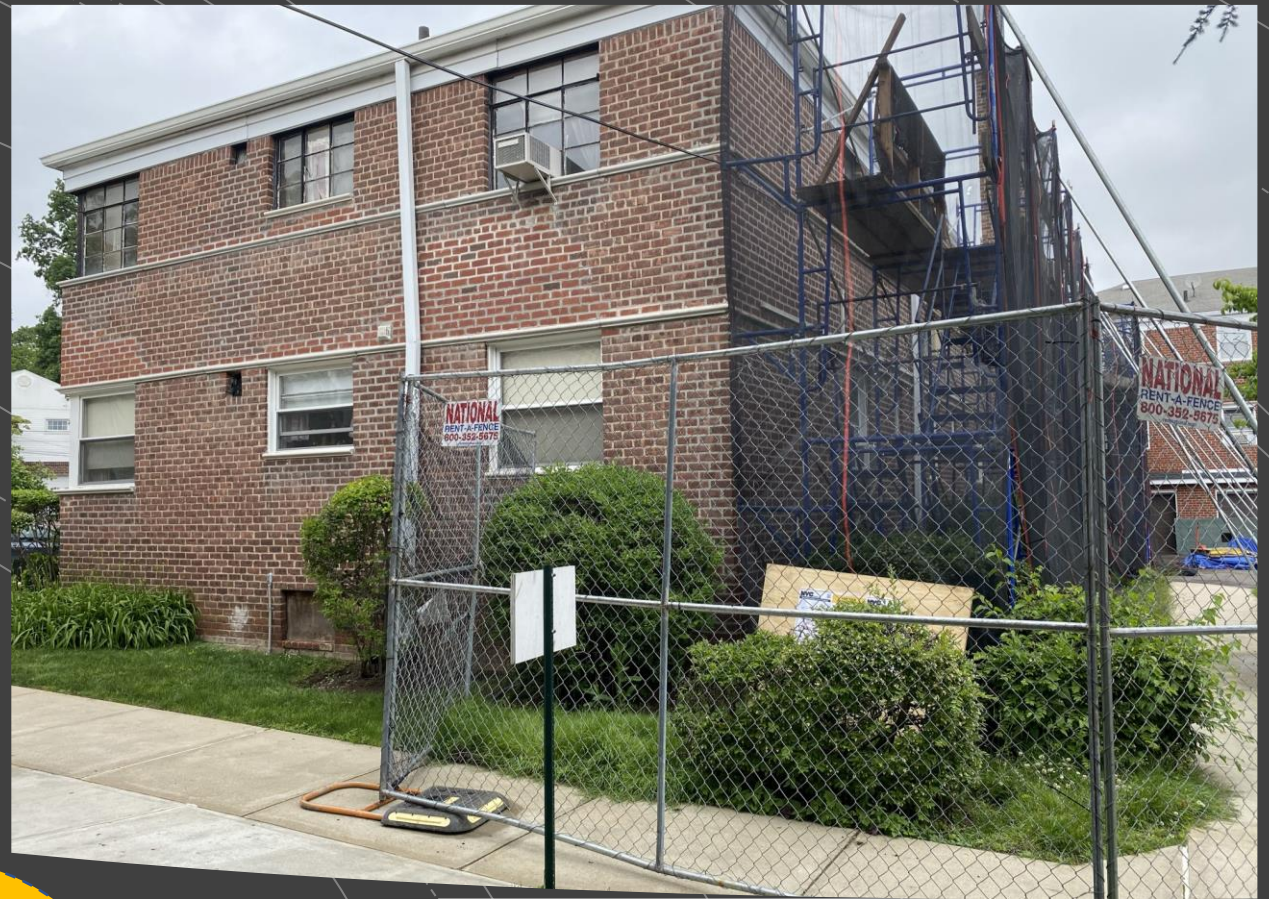
BUILDING-8

DURING RENOVATION

**FACADE WORK UNDER CIP AT
MULTIPLE BUILDINGS**

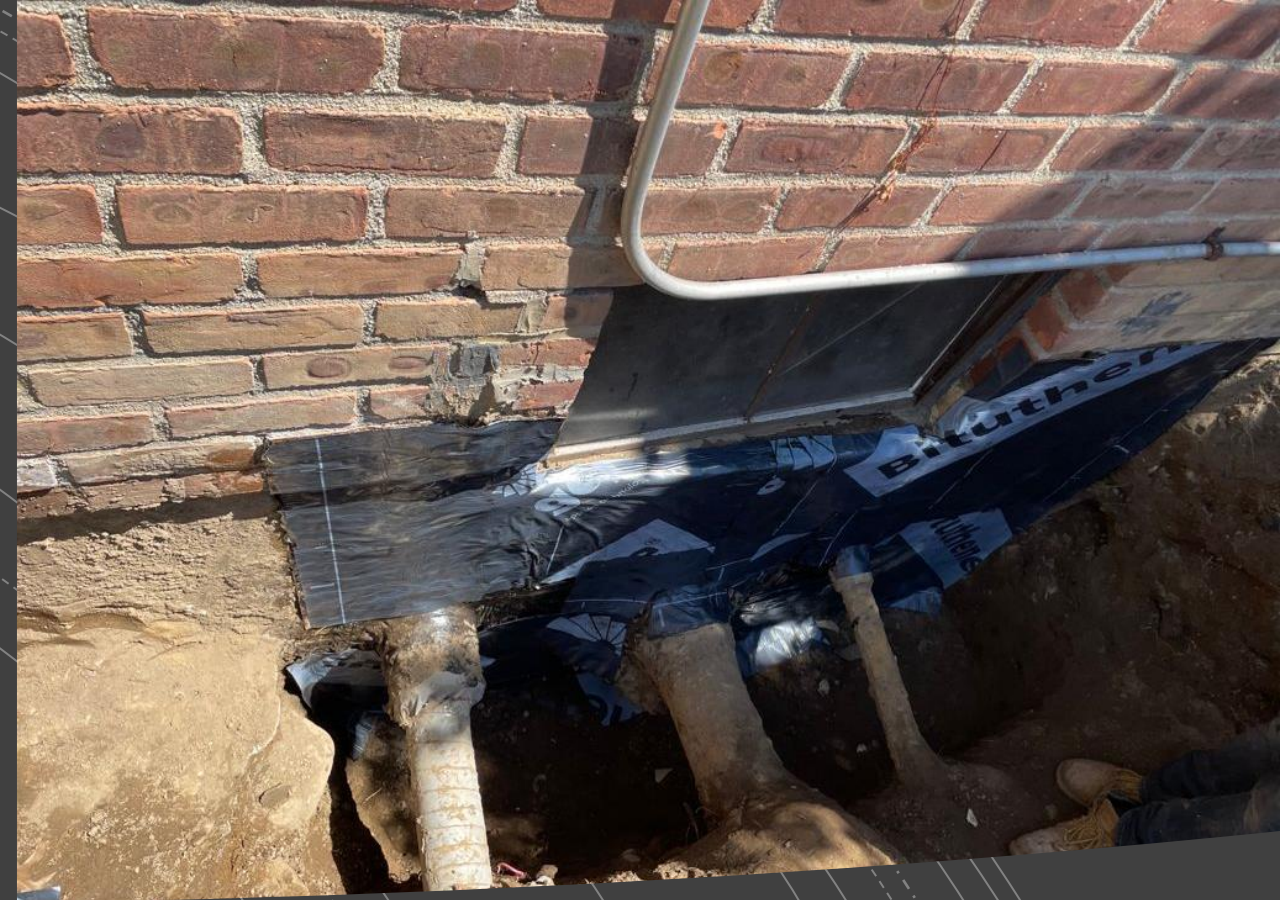
BUILDING-8

DURING RENOVATION

FOUNDATION WALL WATERPROOFING

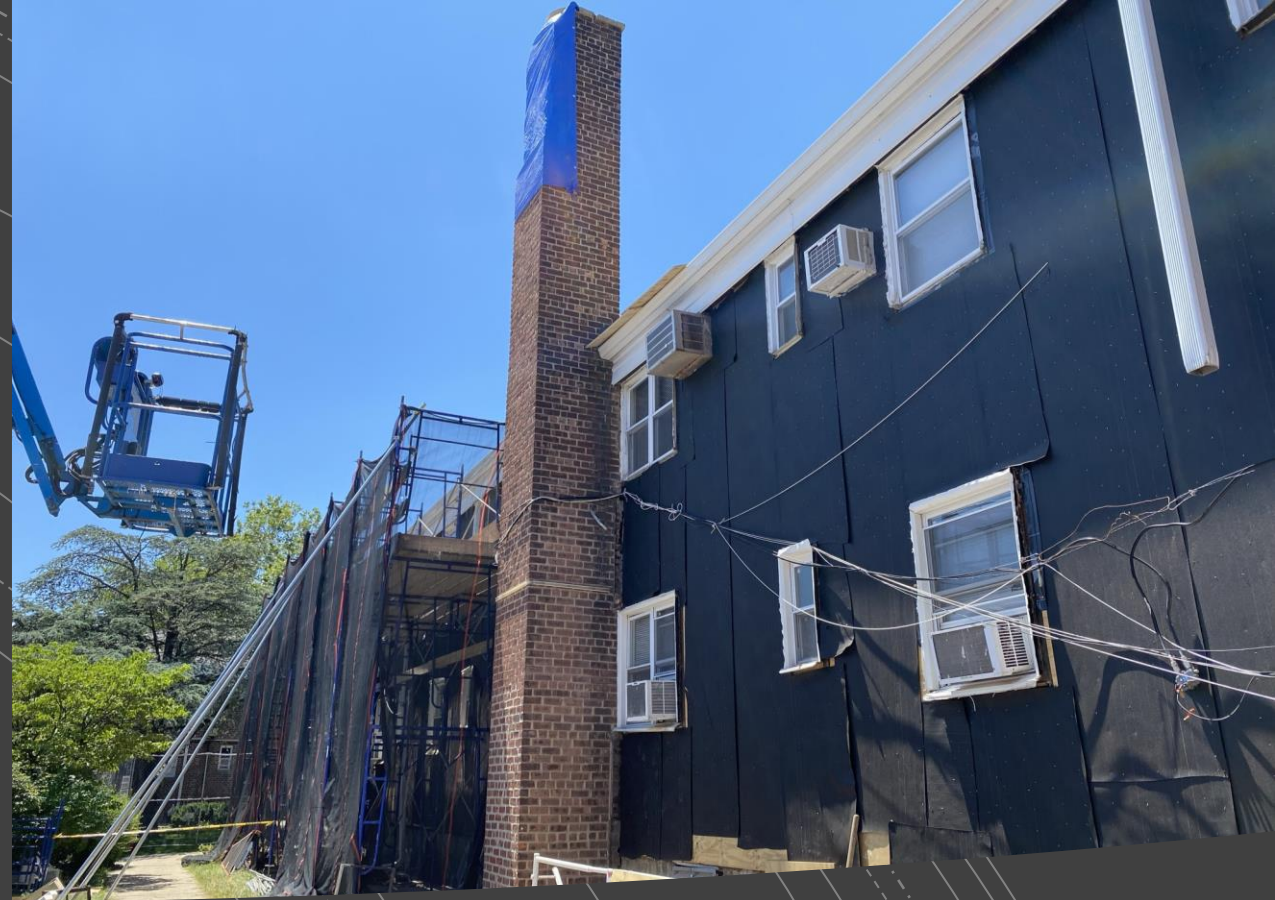
BUILDING-8

DURING RENOVATION

**STRUCTURAL RESTORATION OF
FOUNDATION WALL**

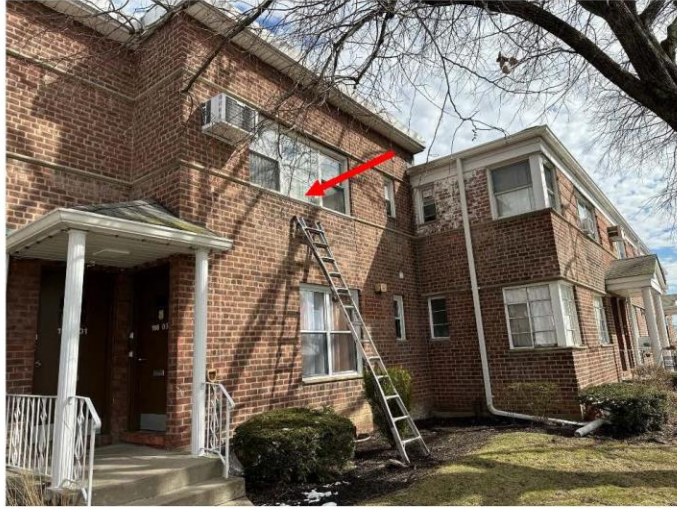
Photo-1:
Building No. 1: 196-03 Dunton Avenue.
General view of Apartment's wall where restoration work was performed.

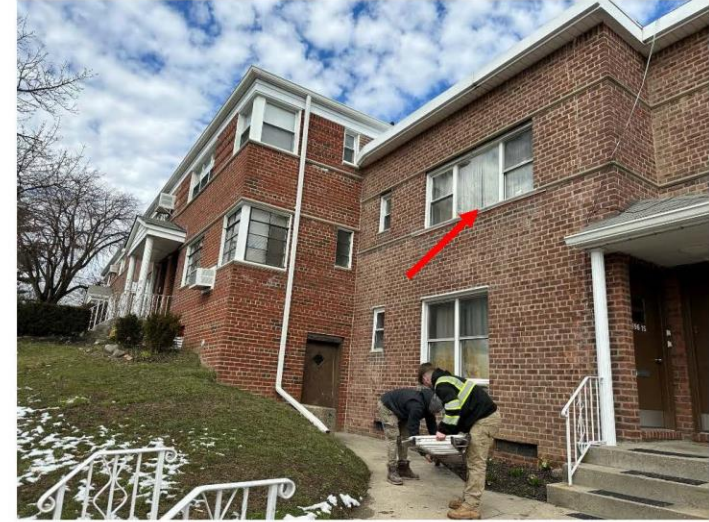
Photo-3:
Building No. 1: 196-15 Dunton Avenue.
General view of Apartment's wall where restoration work was performed.

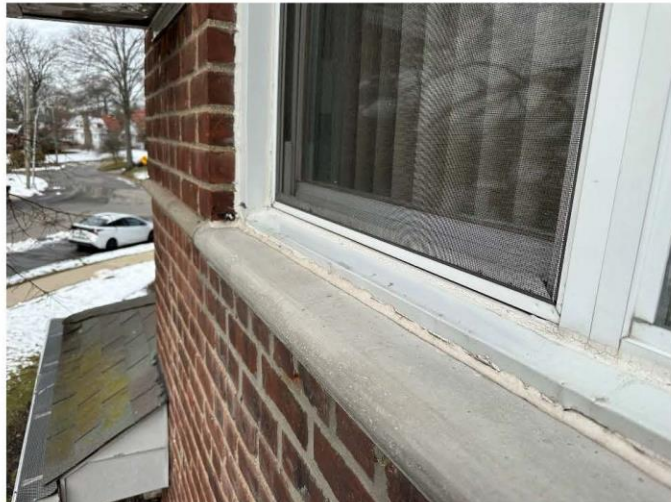
Photo-2:
Building No. 1: 196-03 Dunton Avenue.
Close-up view of properly installed windowsill.

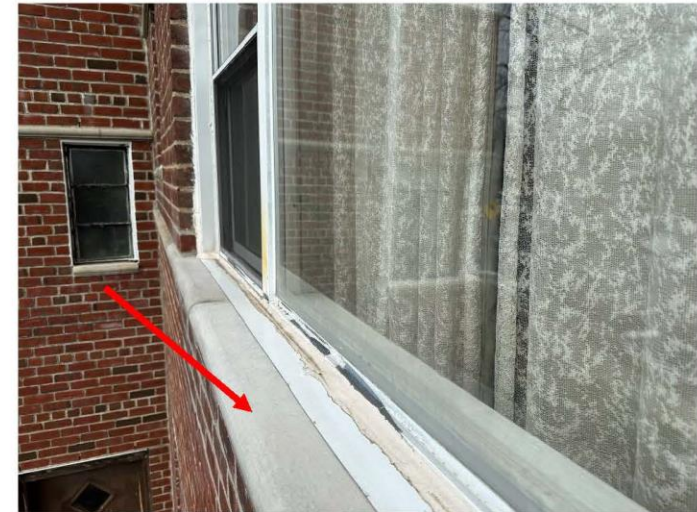
Photo-4:
Building No. 1: 196-15 Dunton Avenue.
Close-up view of properly installed windowsill.

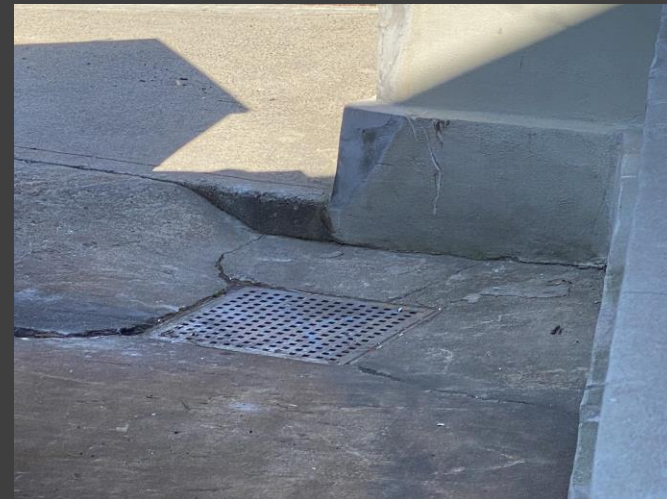
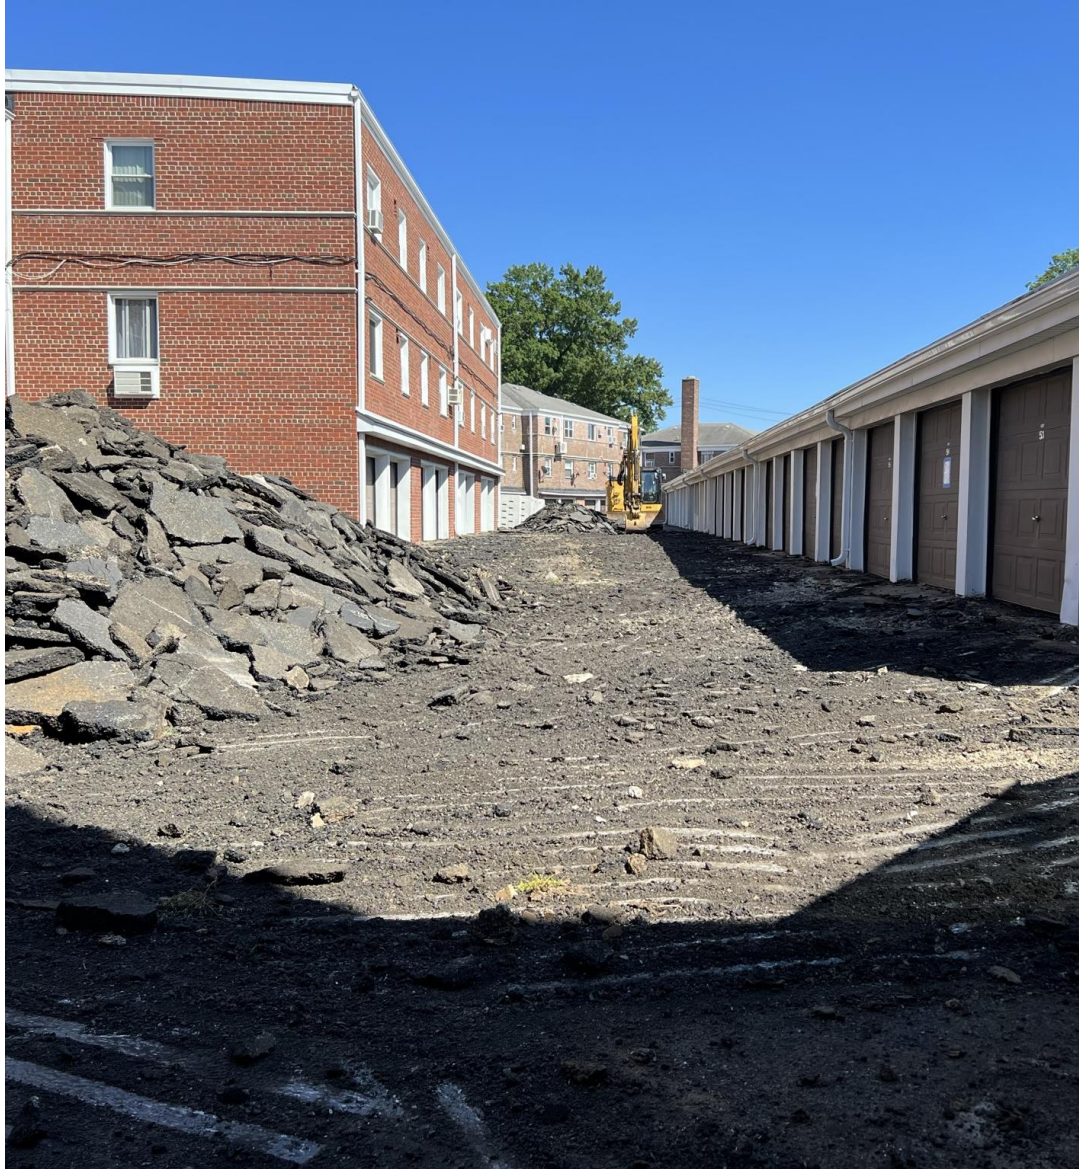
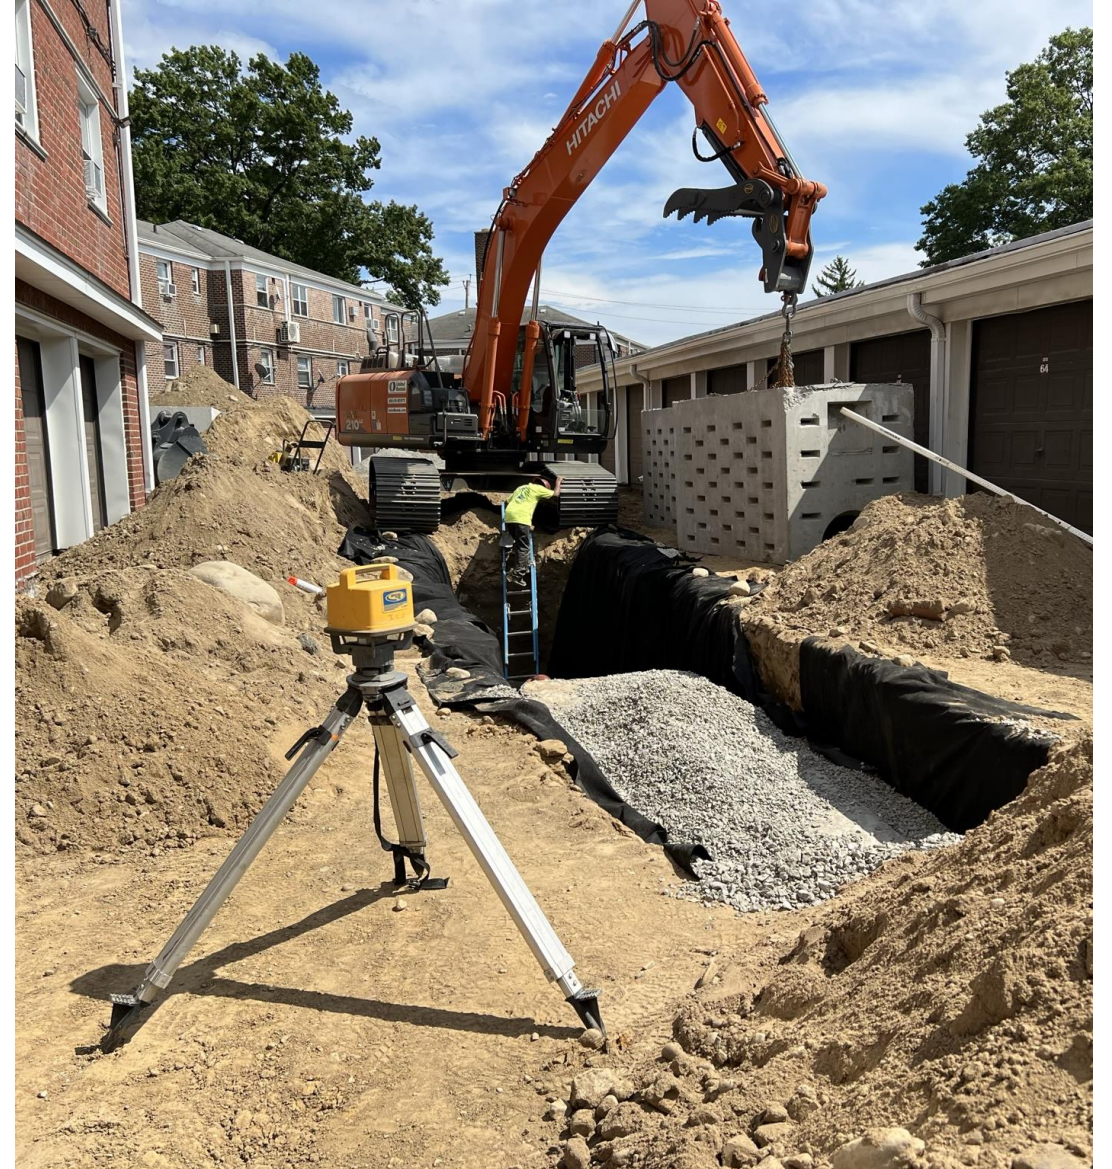
STORM &
PAVEMENT:
WATER
PONDING AND
VEHICULAR
RIDE ISSUE

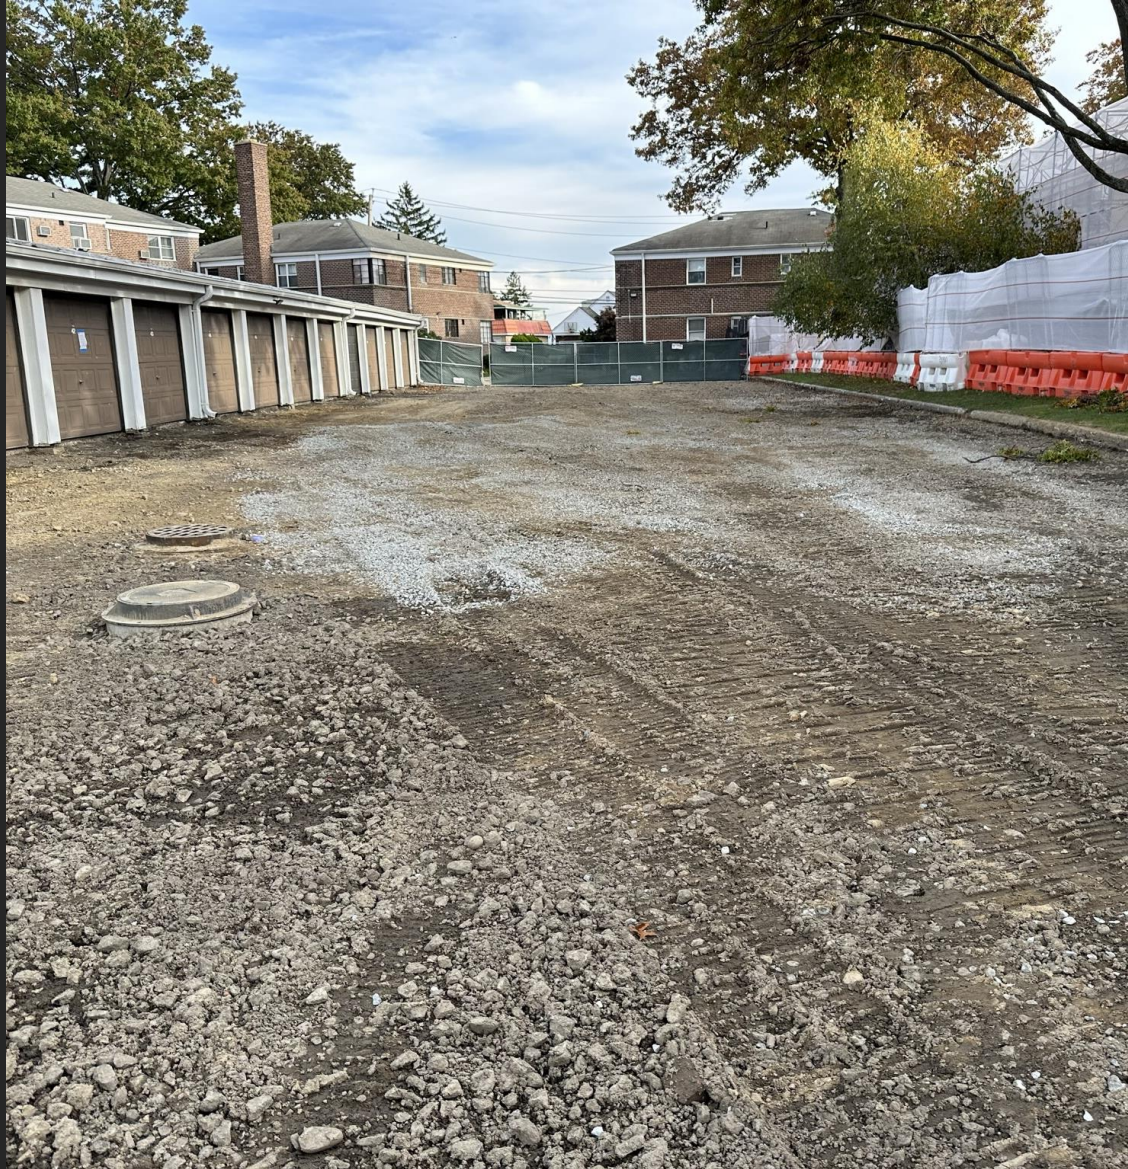
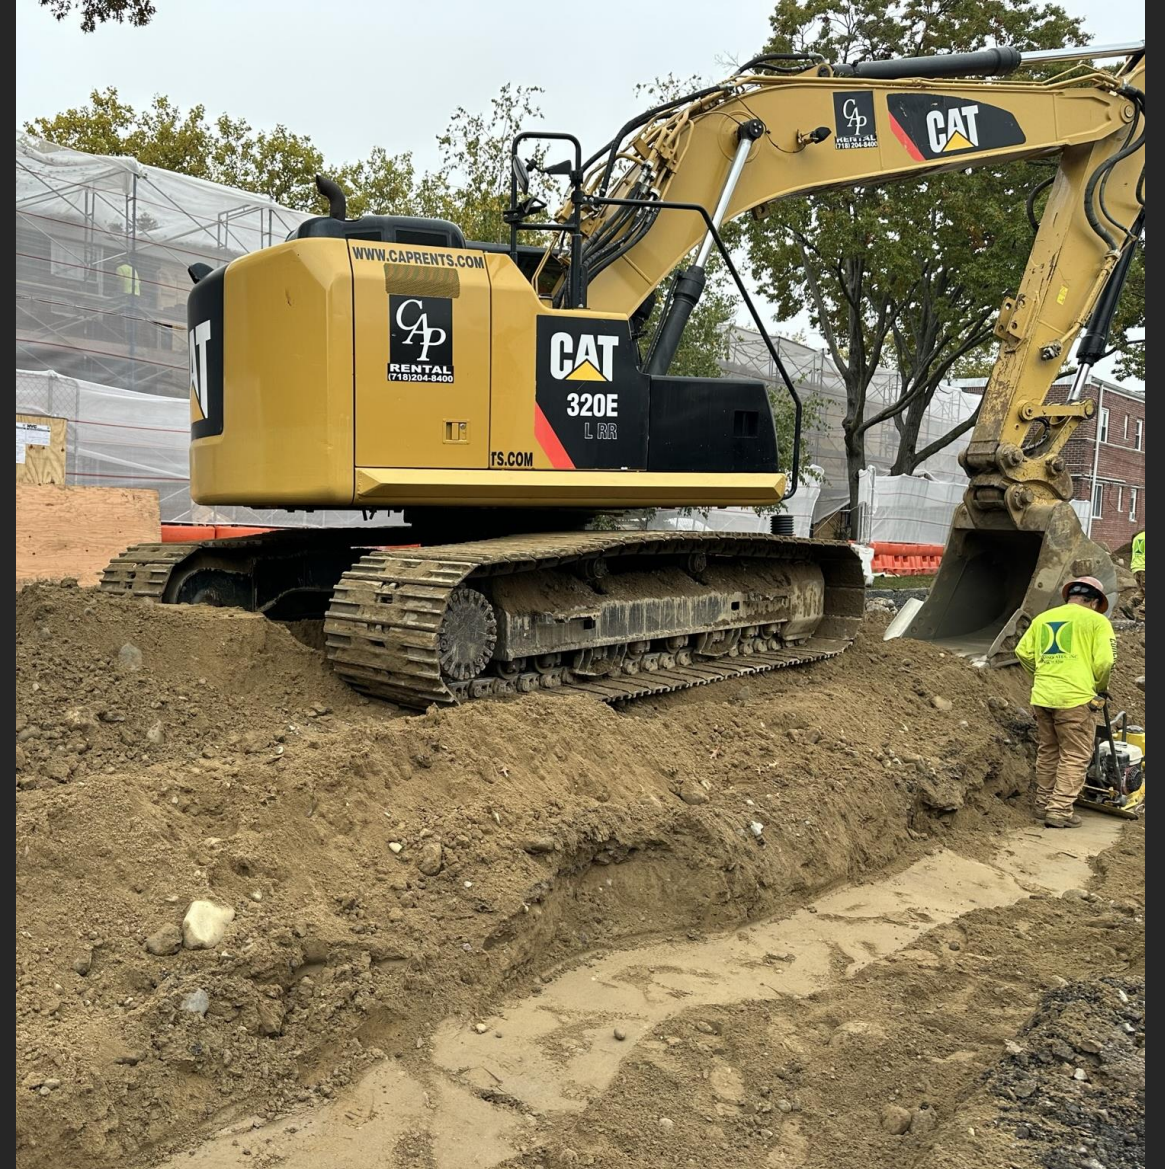
North Side of Parking Lot

AFTER RESTORATION

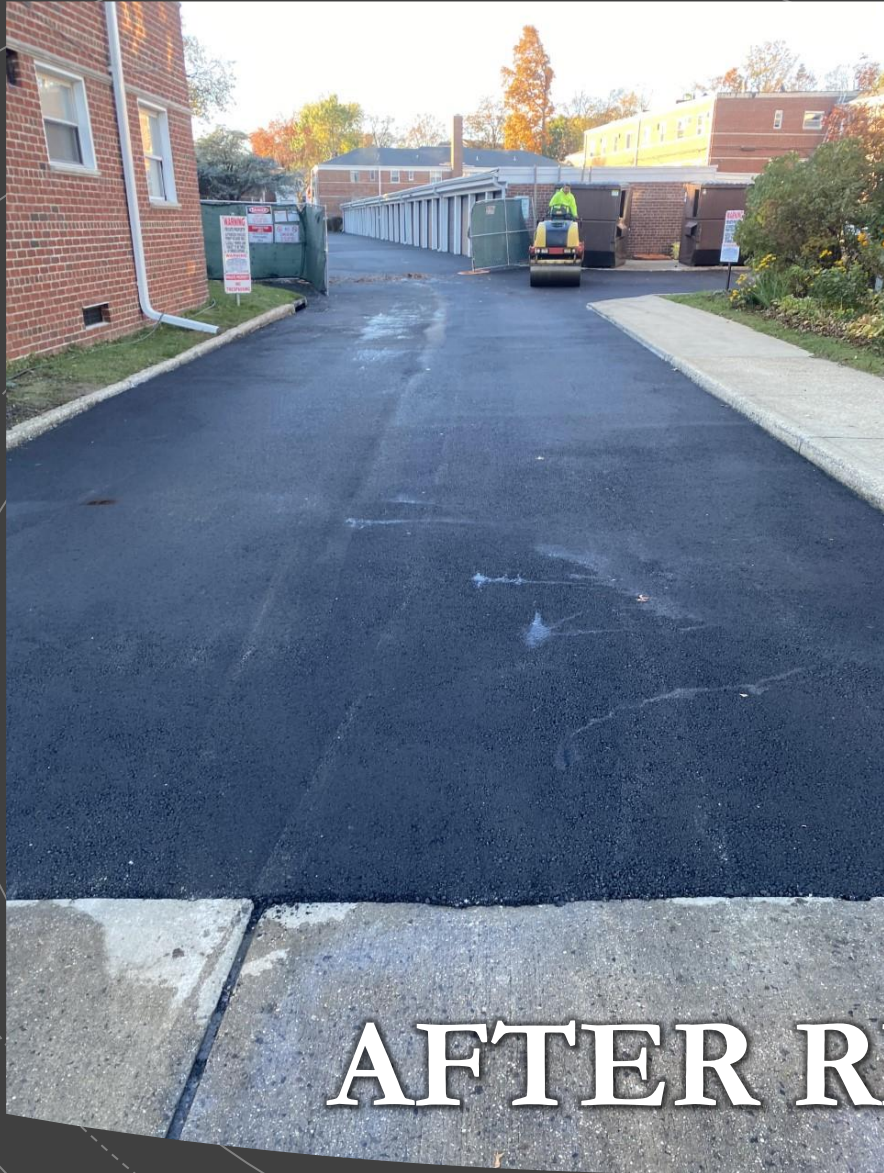
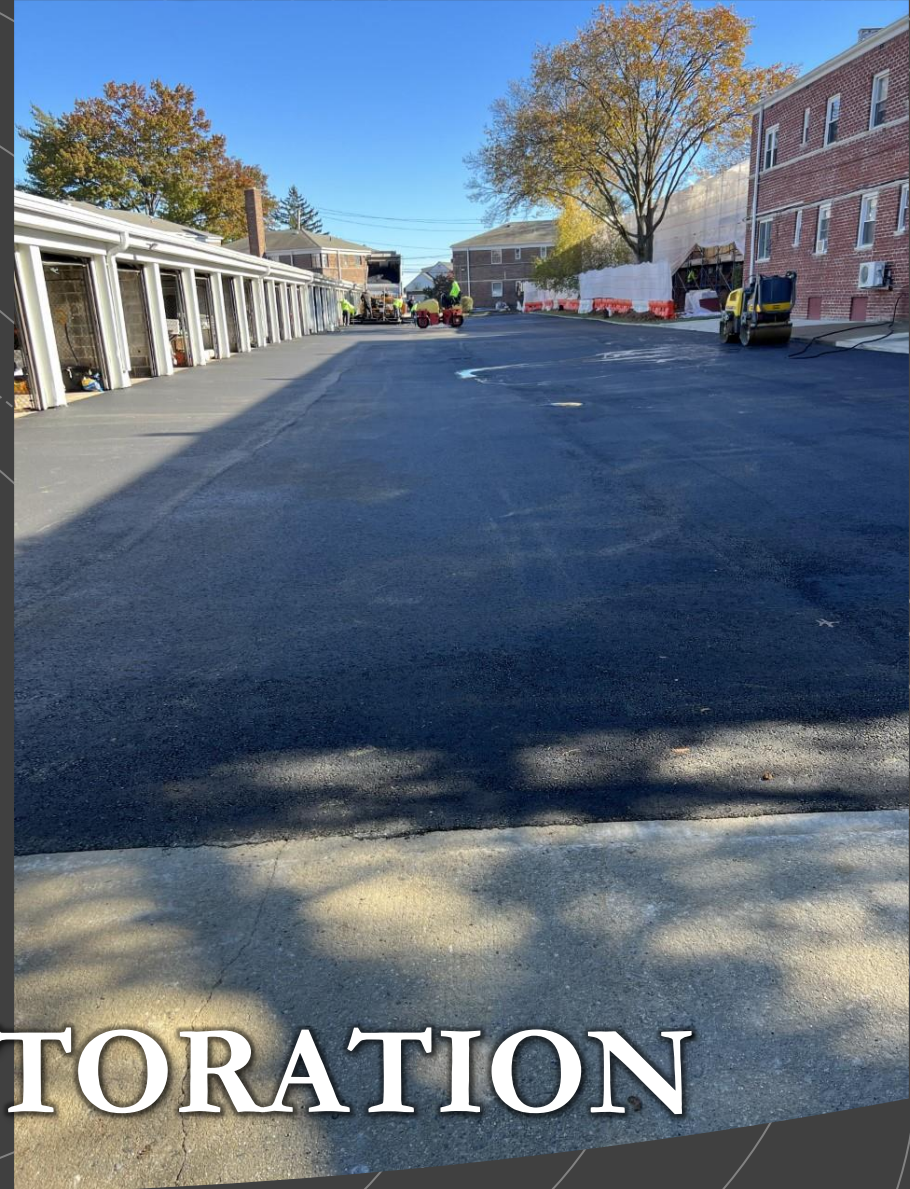
South Side of Parking Lot

AFTER RESTORATION
