COMPLETION OF 5-YEAR CAPITAL IMPROVEMENT PLAN

CAPITAL IMPROVEMENT PROGRAM (C.I.P.)

PHASING OF COMPLETED WORK:

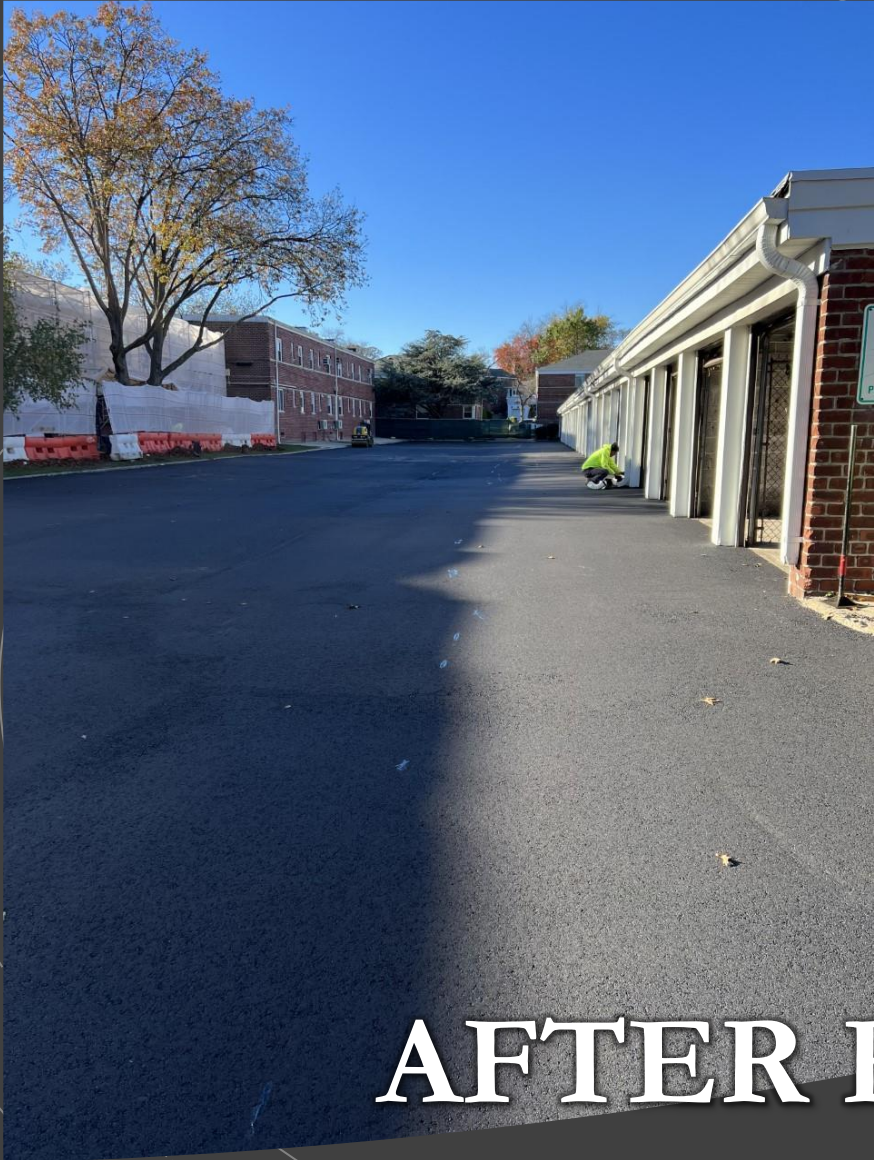
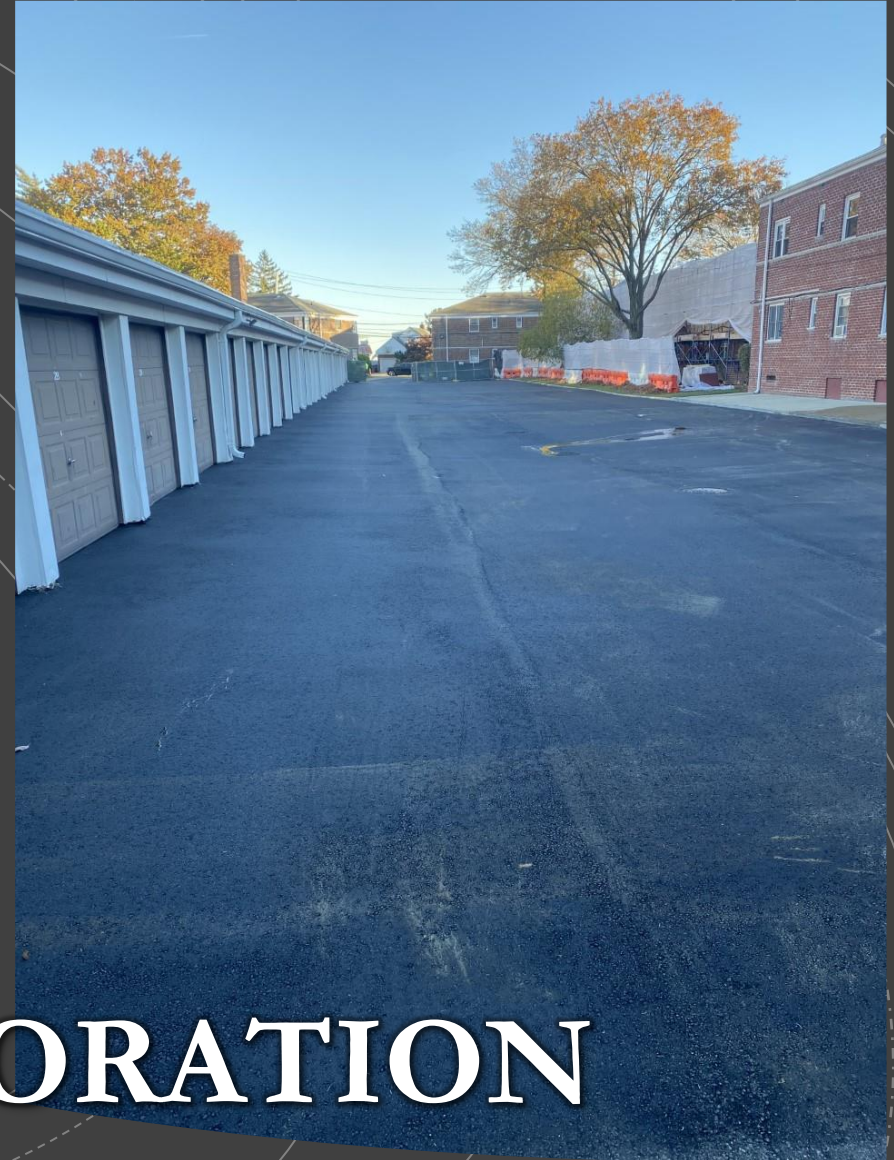
South Side of Parking Lot

AFTER RESTORATION

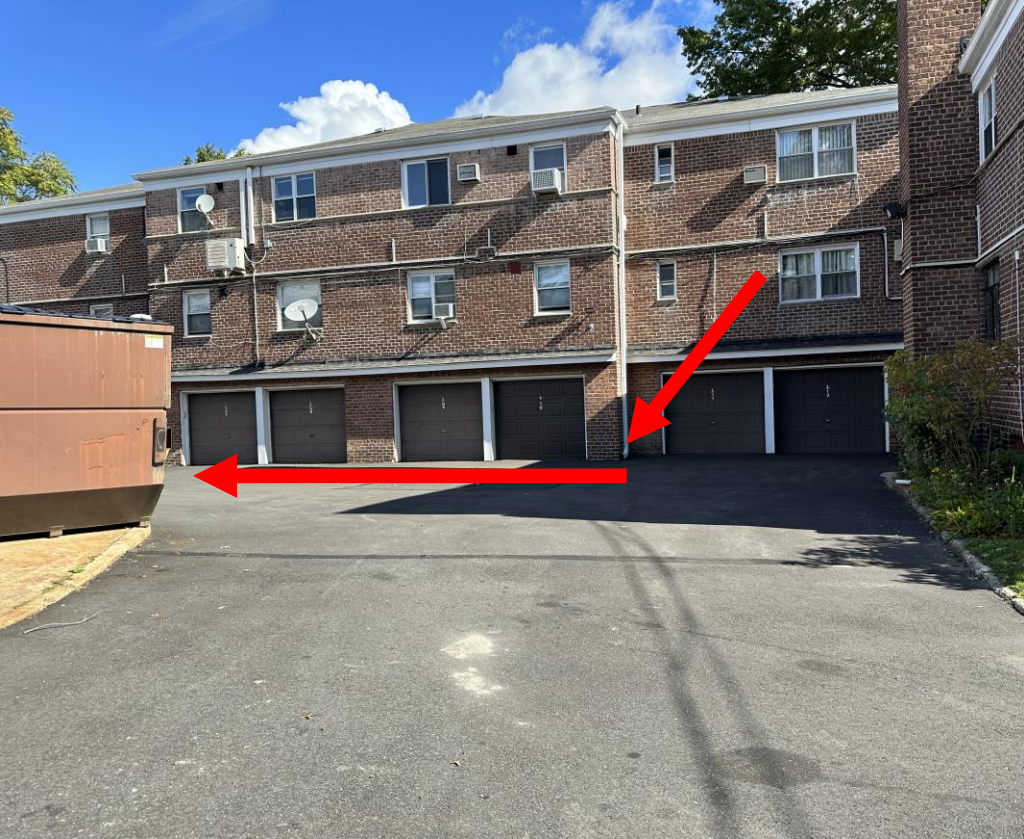
Relocation of Roof Leaders to Balance out
the Storm Runoff Load Distribution

POST CONSTRUCTION ADJUSTMENTS

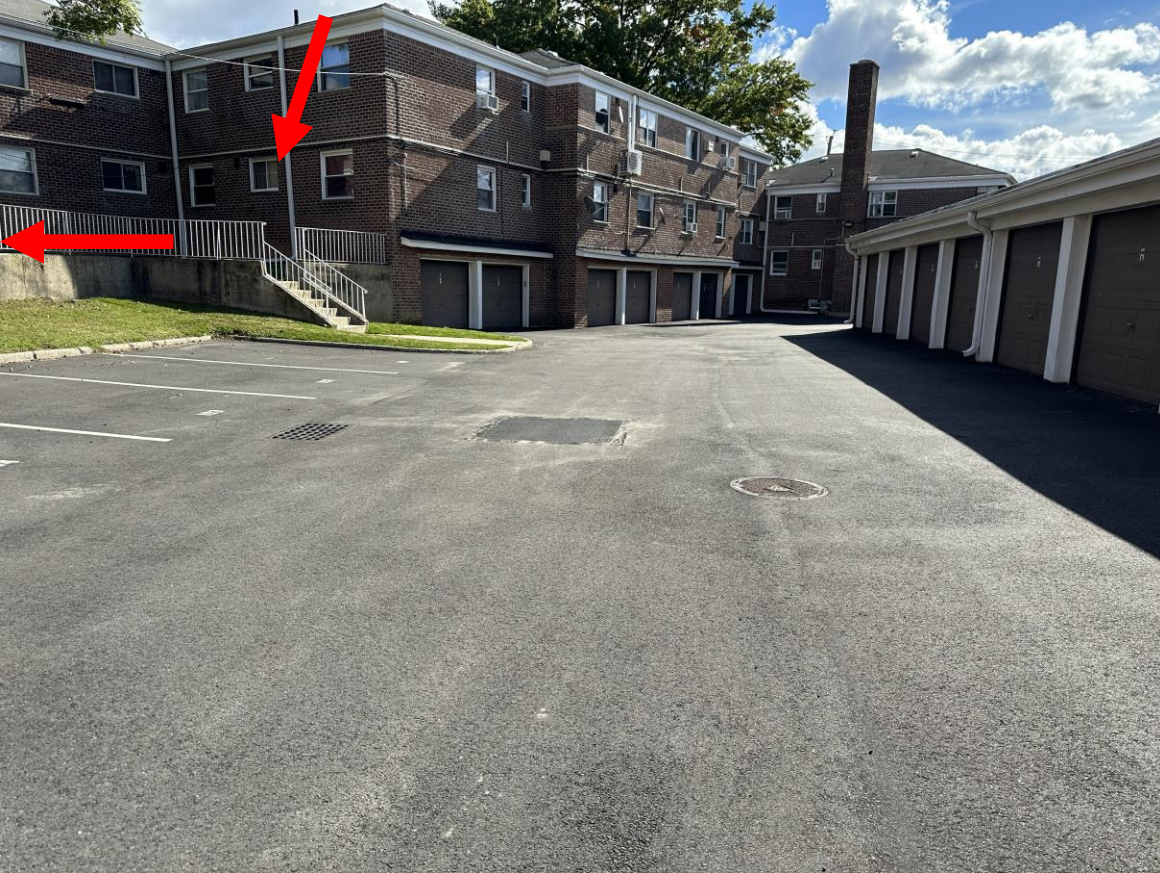
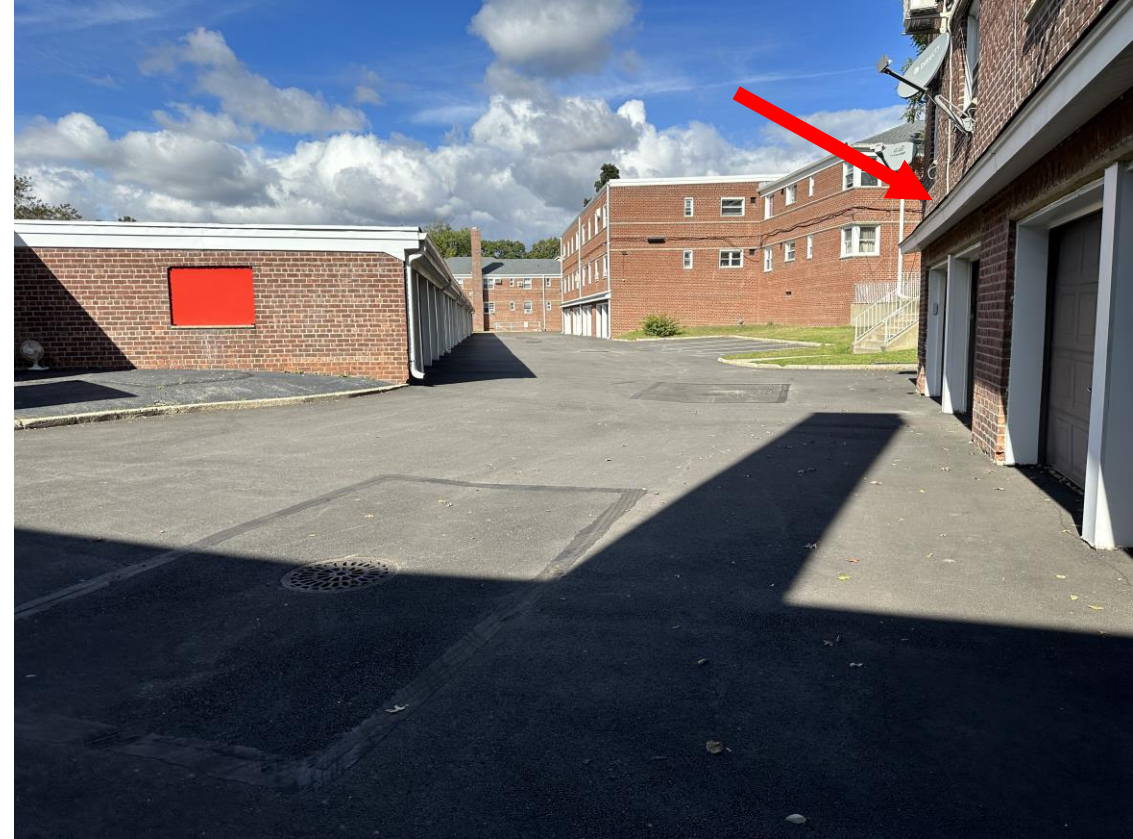
Relocation of Roof Leaders to Balance out
the Storm Runoff Load Distribution

POST CONSTRUCTION ADJUSTMENTS
